Attachment 1: Gosford Library Building Review - Draft Report - 20 December 2024 – Complete Urban 3

GOSFORD LIBRARY BUILDING REVIEW
DRAFT REPORT | 20 DECEMBER 2024

GOSFORD LIBRARY BUILDING REVIEW

PREPARED FOR	CENTRAL COAST COUNCIL
AUTHOR	COMPLETE URBAN PTY LTD
REVISION	A
REVISION DATE	20 DECEMBER 2024
ISSUED BY	SCOTT WILLIAMS

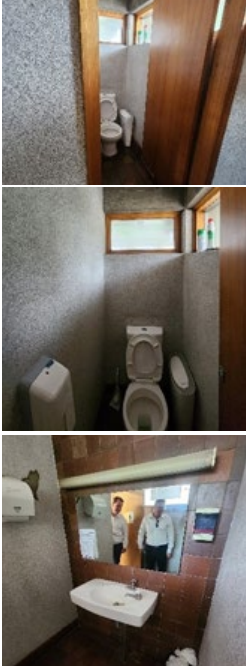
<p>Good condition.</p>	<p>Compliance with current NCC unlikely. There is no compliant PWD. No designated ambulant cubicles. Depending on thickness of wall finishes achieving a compliant width may not be possible without considerable demolition.</p>

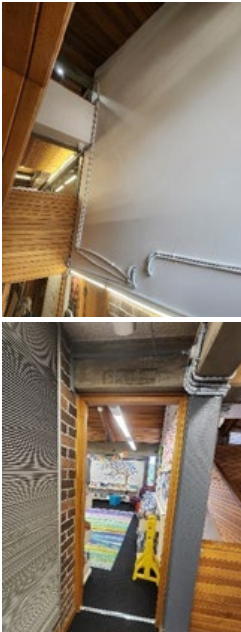
<p>Poor</p>	<p>Considerable evidence of retrofitted electrical, lighting and communications cabling throughout the building. Given the solid concrete construction much of the retrofitted cabling is not concealed.</p>

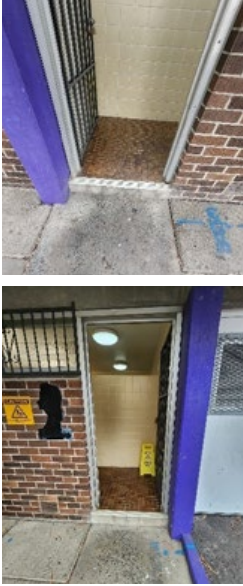
ITEM	PHOTO	COMMENTARY ON CONDITION	IDENTIFICATION OF CONCERN
<p>Entry to public toilets.</p>

<p>Access to the public toilets on the western side of building are accessed via a small step.</p>	<p>Non-compliant access at doorways to external public toilets – steps and width of opening (some doorways maybe undersized)</p>
<p>Public toilets. Mosaic floor tiles, terrazzo toilet partitions, wall tiling</p>

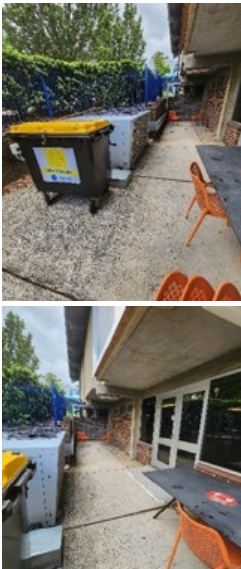
<p>Average</p>	<p>Eastern courtyard provide egress from the lower floor. The courtyard is hidden behind landscaping and provides a haven for antisocial behaviour.</p>

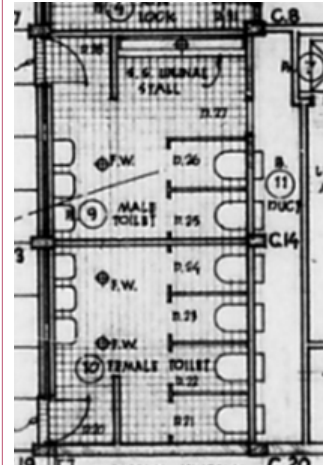
<p>Service corridor behind public toilets.</p>

<p>Space behind compactus.</p>
<p>Roof safety system. Access</p>
