CLIFF LINE HAZARD DEFINITION STUDY
at
TUDIBARING HEADLAND
COPACABANA NSW

Undertaken on Behalf of
GOSFORD CITY COUNCIL

Our Ref: 210896RN.DOC\X017-5

Prepared: 30 September, 1996

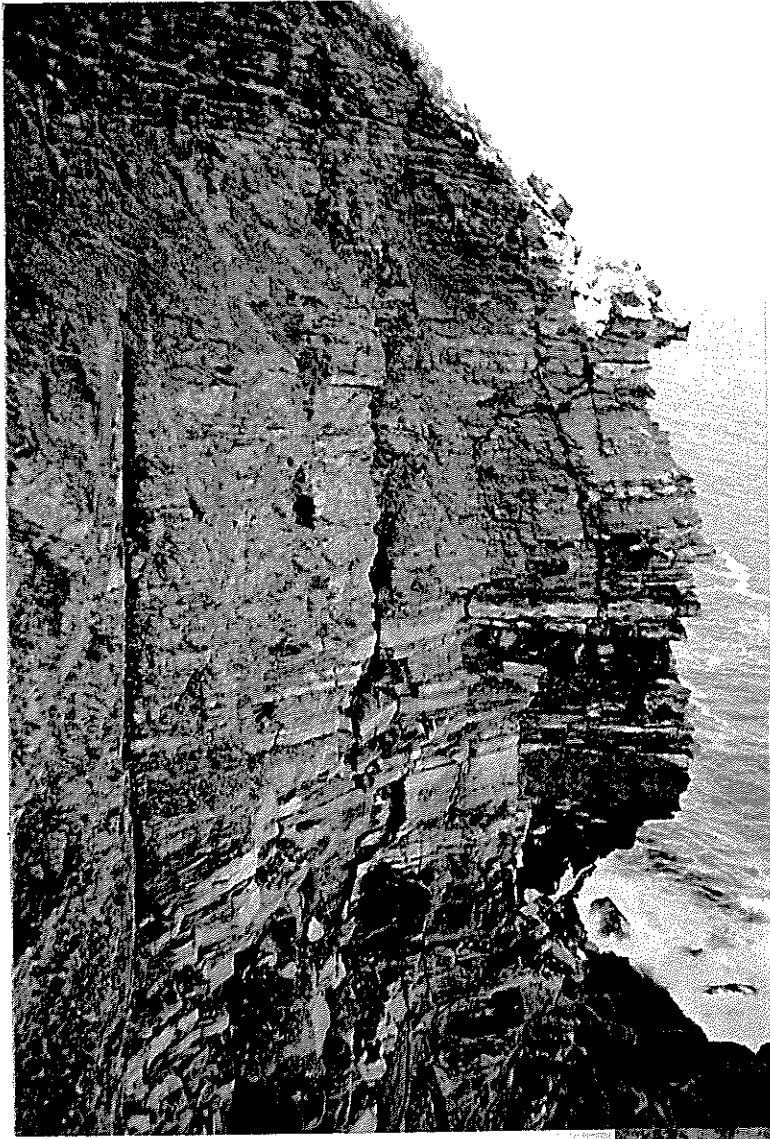
P.1.

UNDERCUT HEADLAND AREA
NORTH OF SECTION 1.

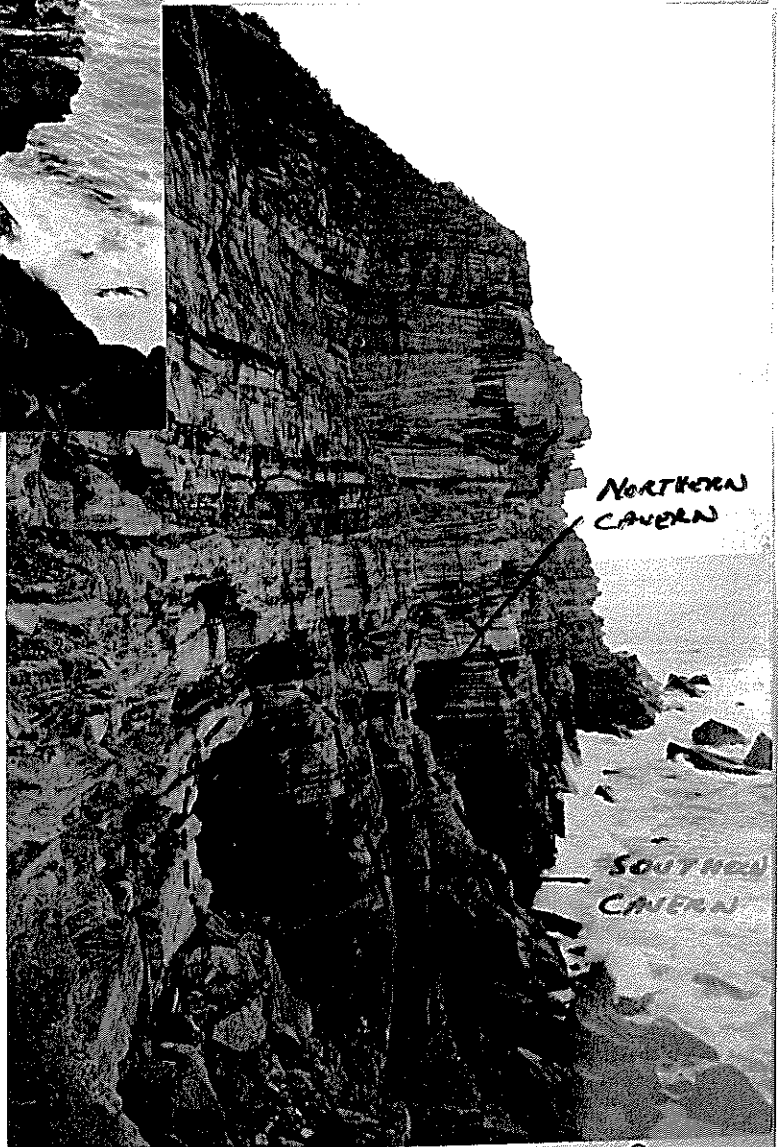
P.2.

GENERAL VIEW OF CAVERNS
IN CLIFF AREA FROM
SECTION 2.

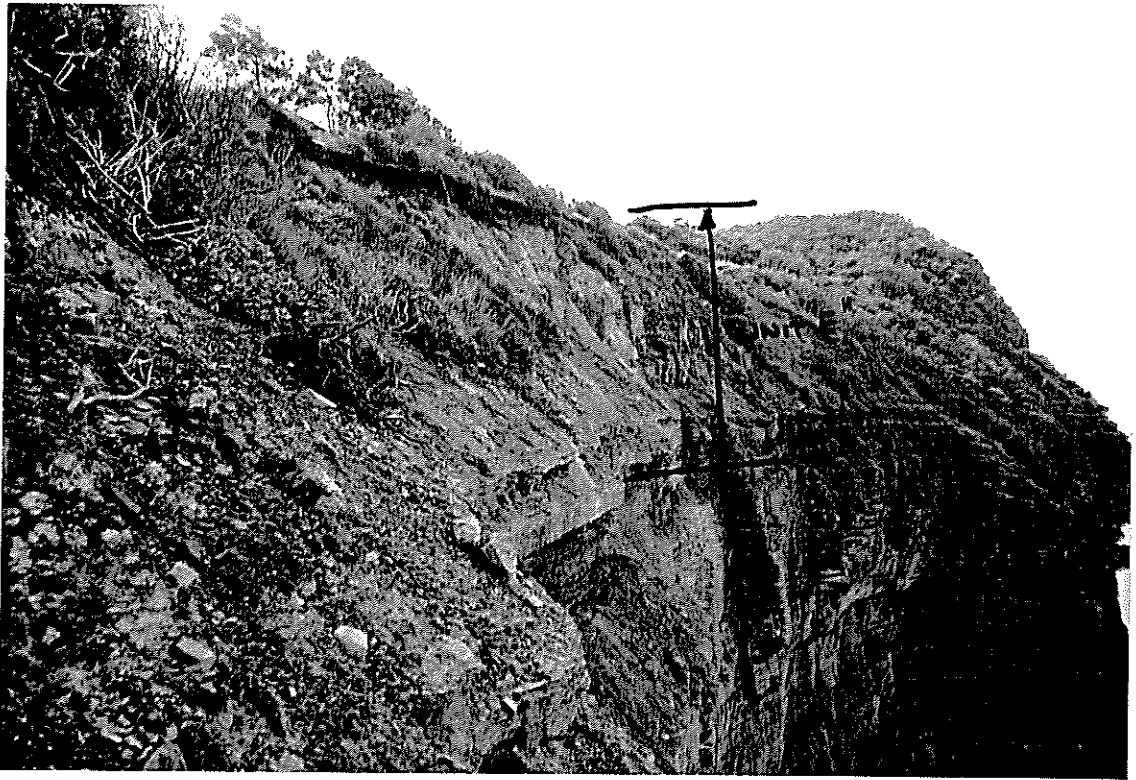
P.3. - SOFTER SILTSTONE / CLAYSTONE UNIT "E"
VIEW LOOKING NORTH FROM SECTION 2.

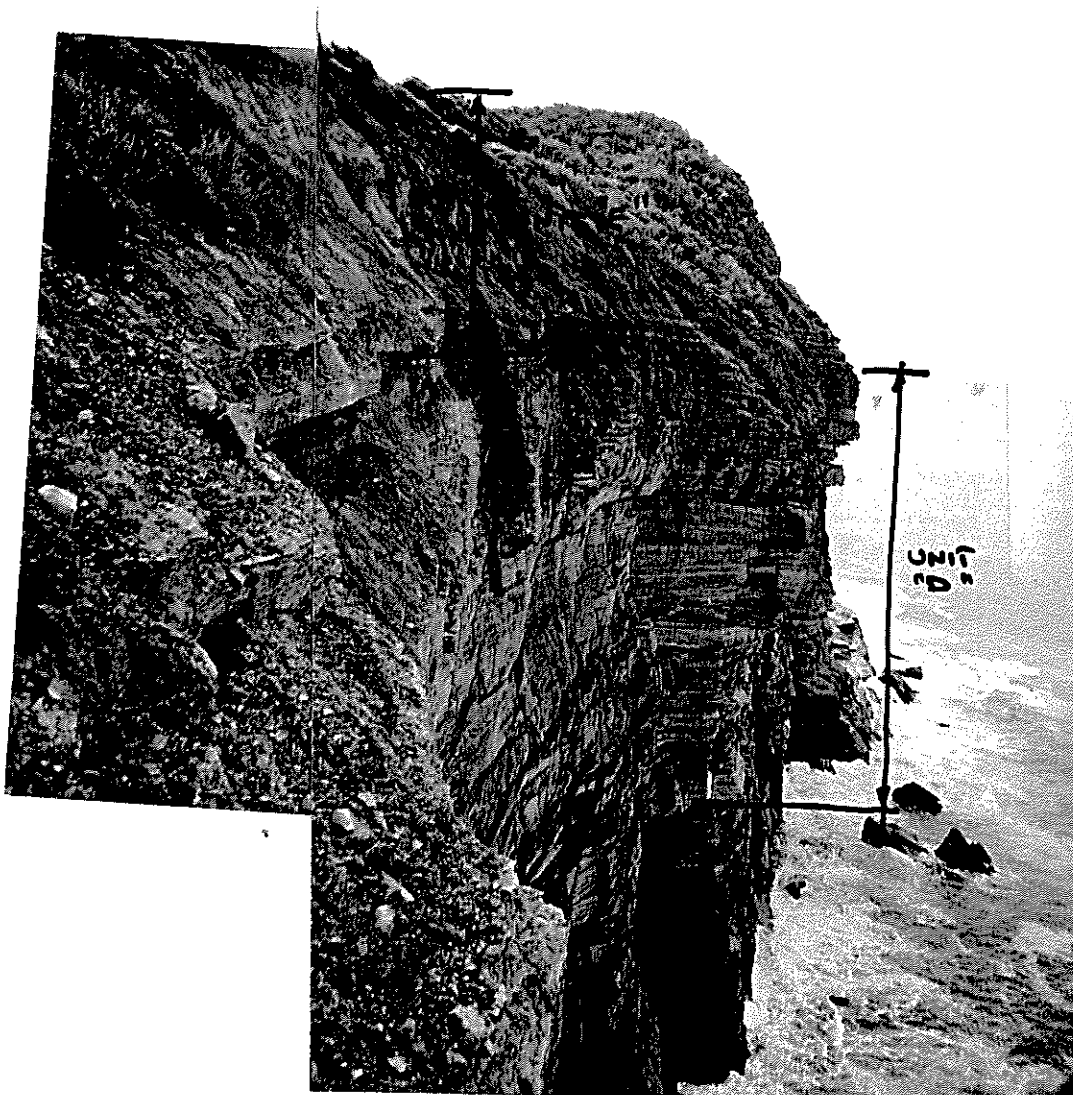
P.4. - GENERAL VIEW OF CLIFF AREA FROM SECTION 2
LOOKING NORTH

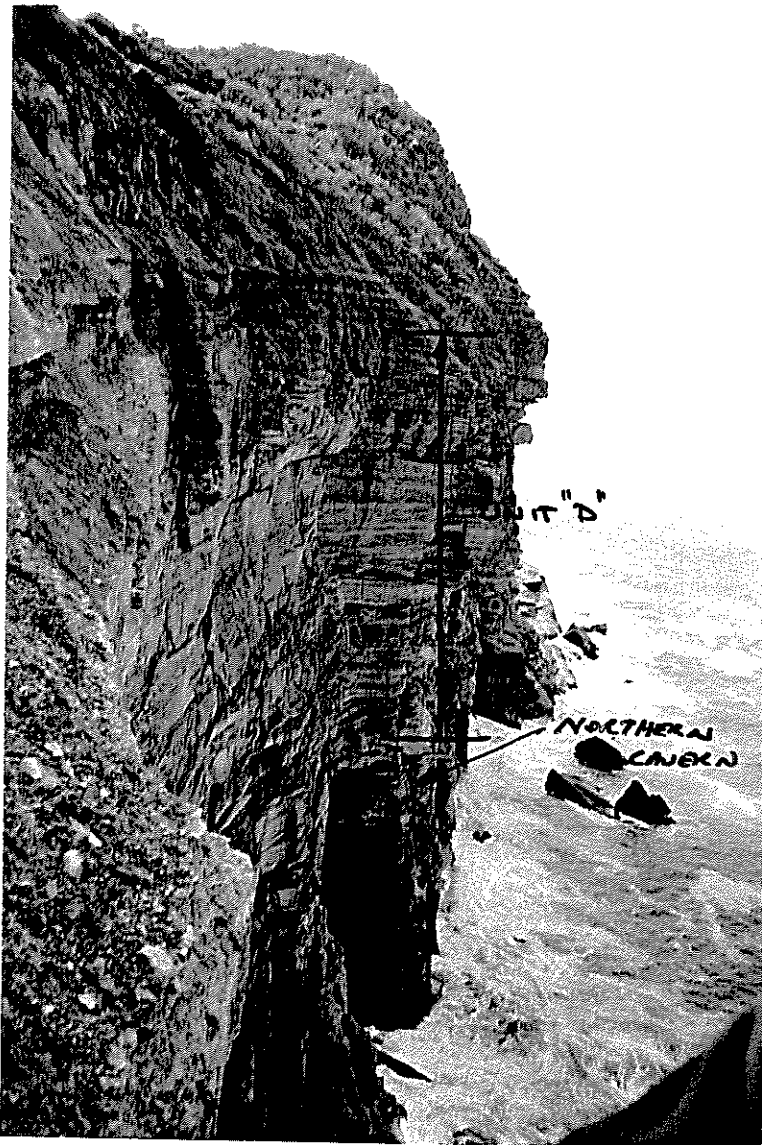
P.5.

VIEW OF MAIN SANDSTONE
UNIT "D" & NORTHERN
CAVERN FROM SECTION 2.

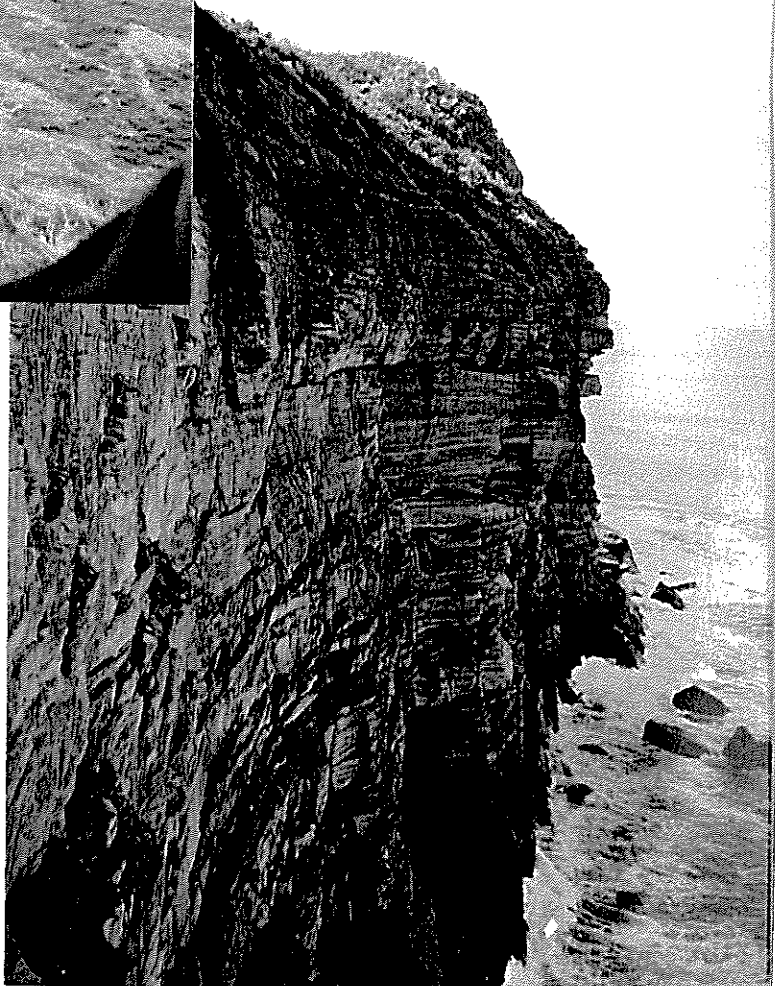
P.6.

VIEW OF MAIN SANDSTONE
UNIT "D" FROM SECTION 2.

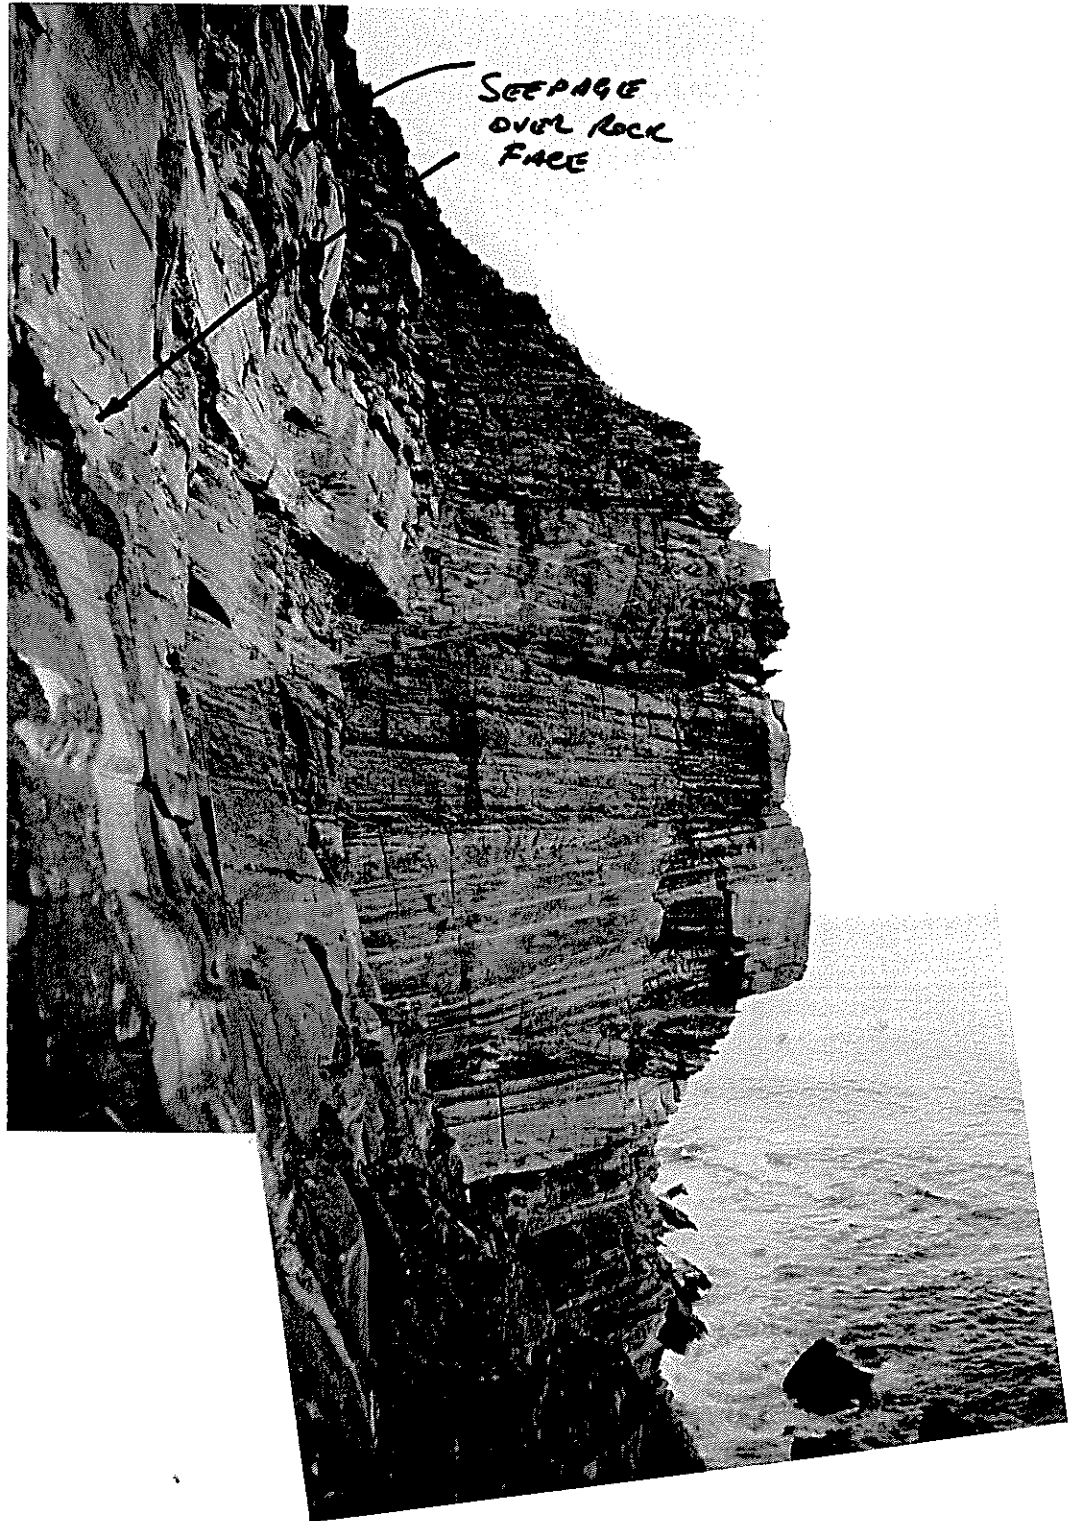
P.7. - VIEW OF MAIN SANDSTONE UNIT "D" & SEEPAGE
OVER CLIFF FACE NEAR SECTION 3.

NOTE: CLIFF UNDERCUT AREA NORTH
OF SECTION 3.

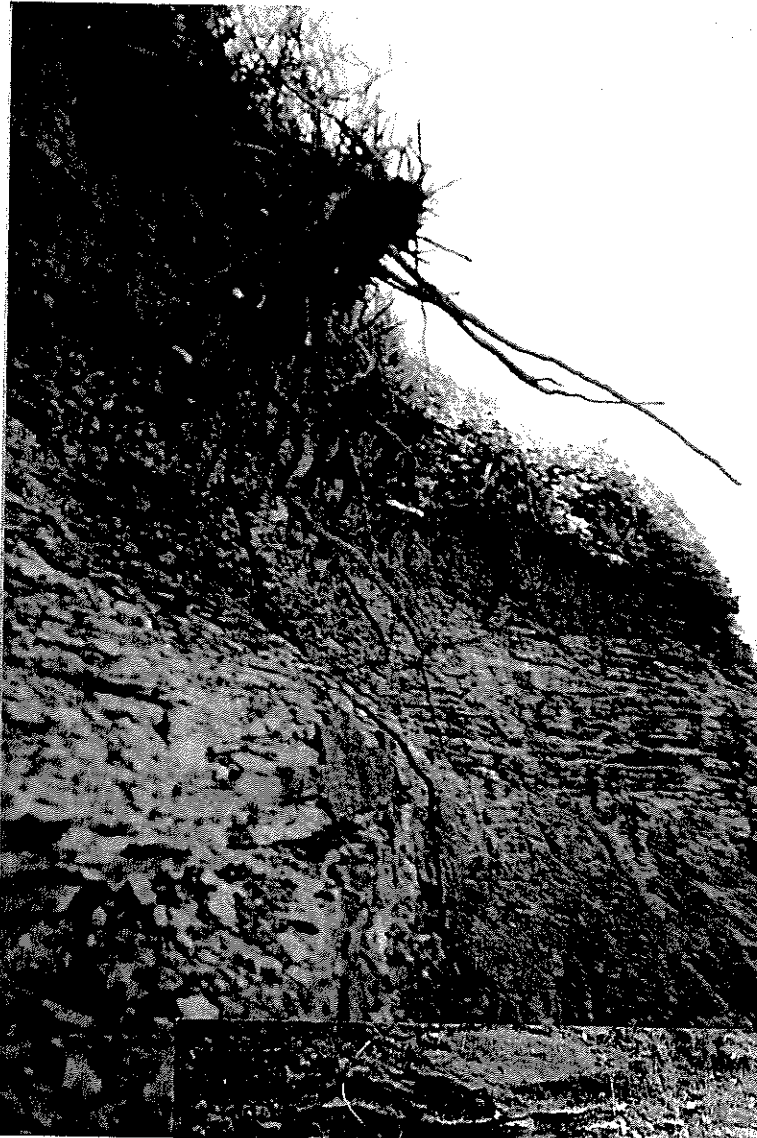
P.16.

SECTION 1. - VIEW OF SURFICIAL
SOIL UNDERCUT BY SOFT ROCK
WEATHERING.

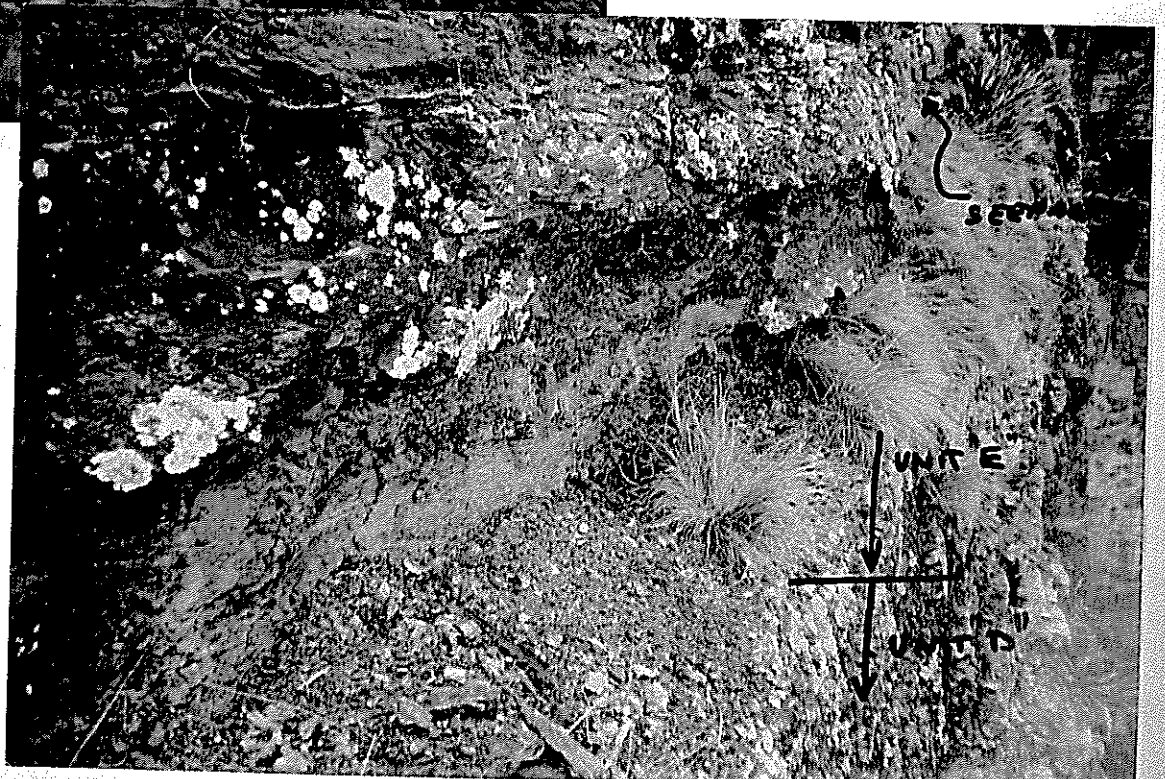
The faster weathering units undercut the sandstone units and eventually, when a vertical or near vertical joint plane is encountered, the sandstone blocks break off in a line which is roughly parallel to the existing cliff face. Also, the unfavourable orientation of joint lines can combine with the bedding plane orientations to form an unstable rock wedge which then results in blocks of material falling from the cliff face. Both of these mechanisms were observed at the site and Plates No. P10, P11, P17, P19, P20 & P21 are included in the Appendix to illustrate this process.

P.17. - SECTION 4. - VIEW OF SOFT CLAYSTONE WEATHERING
ABOVE UNIT "D".

NOTE: ALSO SEEPAGE.

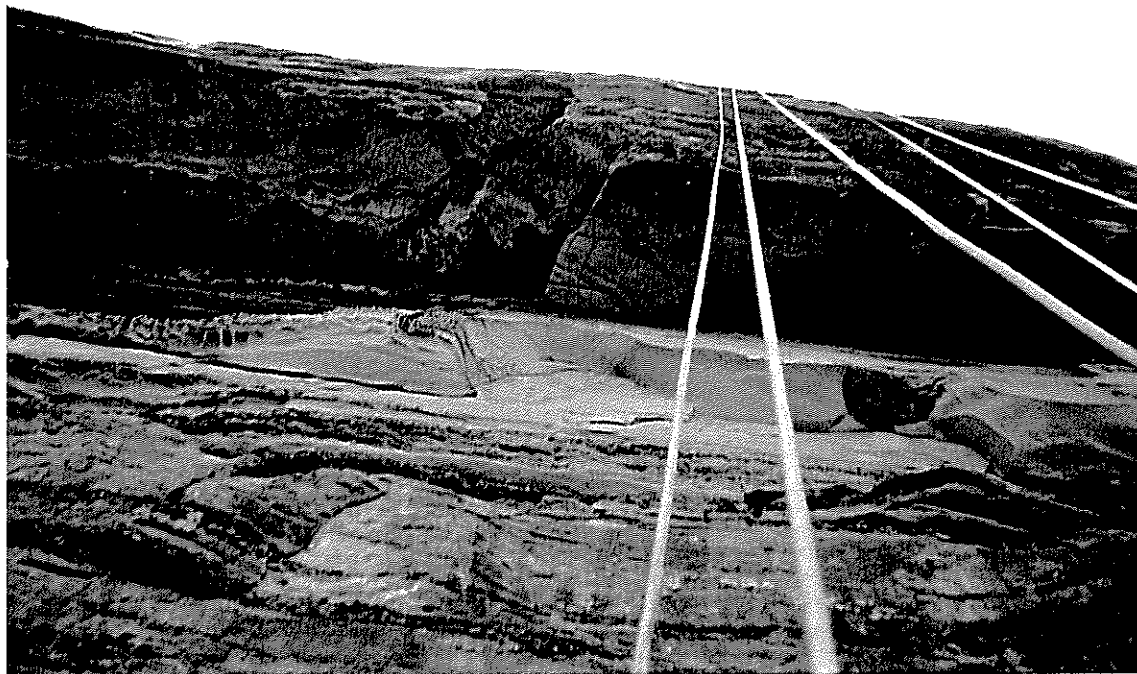
P.14. - SECTION 4. - UNDERCUTTING OF MAJOR SANDSTONE UNIT "D".

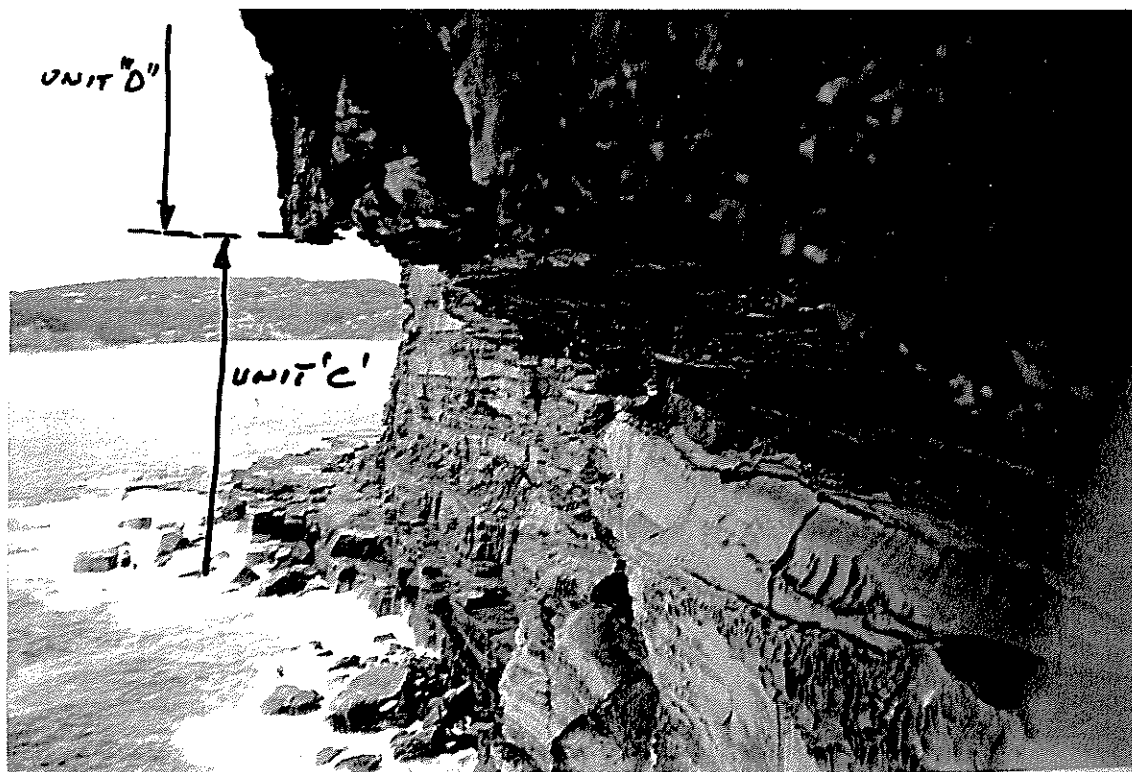
P.15. - SECTION 4. - UNDERCUTTING OF MAJOR SANDSTONE UNIT "D"
LOOKING SOUTH TO SECTION 3.

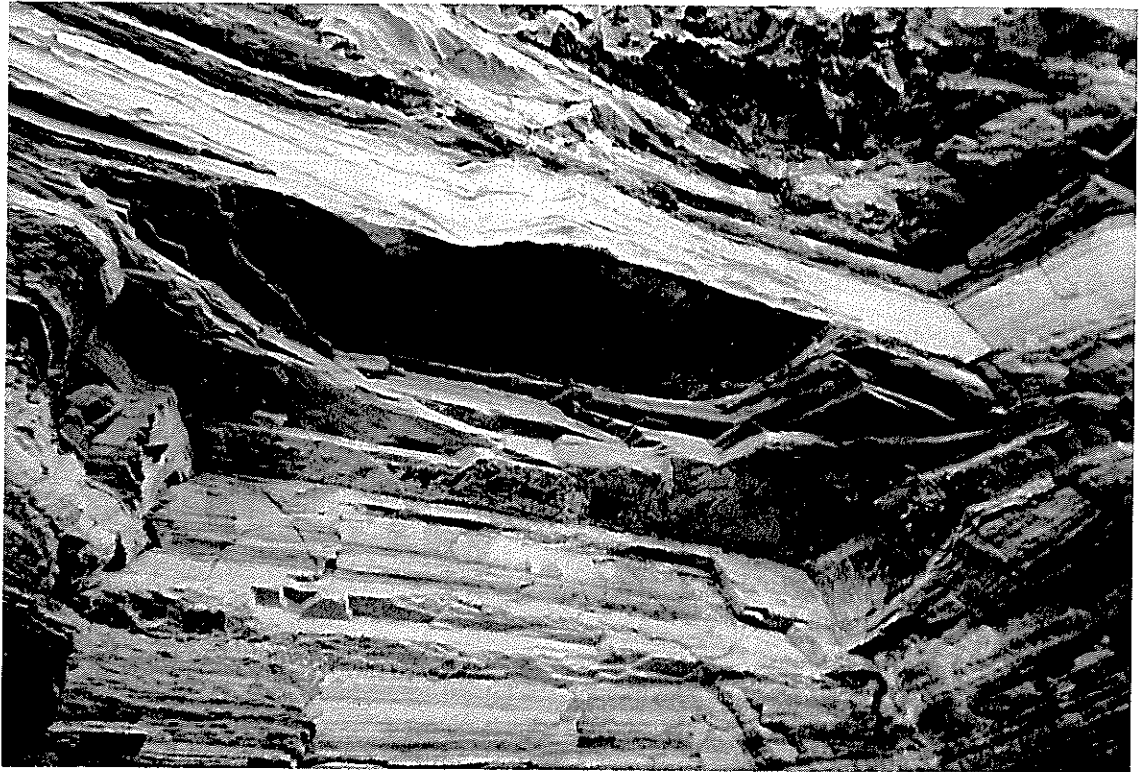
P.12. - STRESS RELIEF ROCK SPALLING IN ROOF OF SOUTHERN CAVERN.

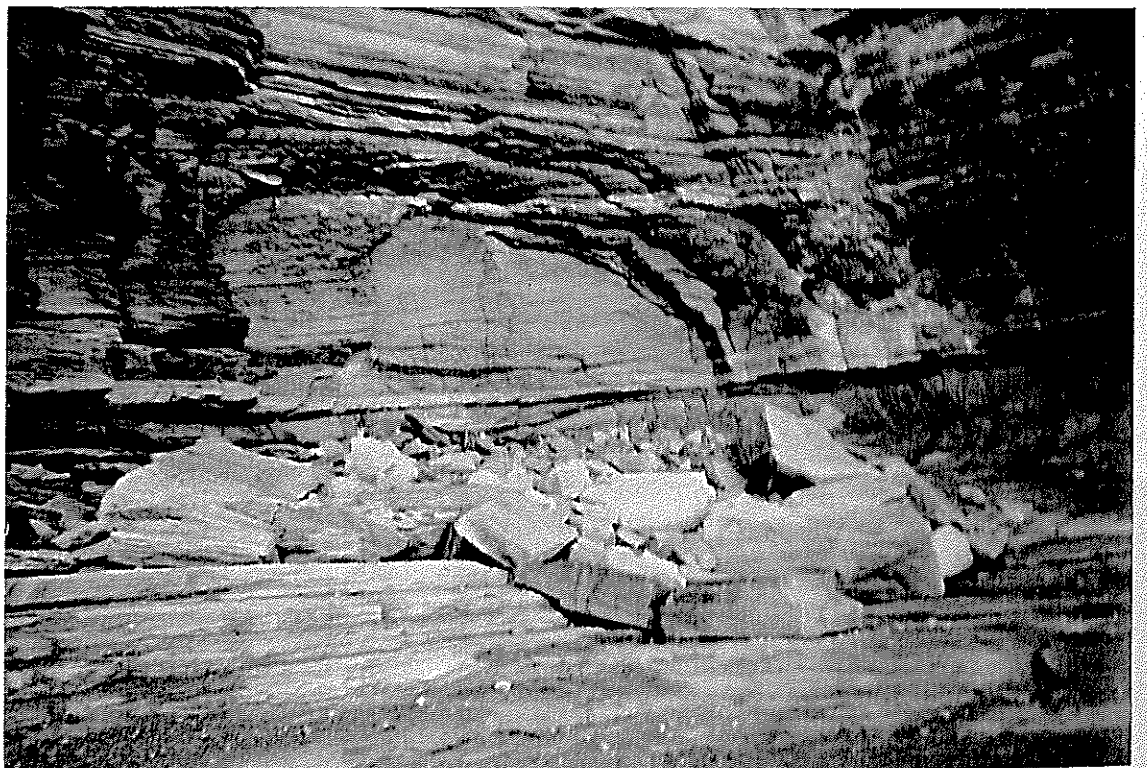
P.13. - ROCK DEBRIS ON FLOOR OF SOUTHERN CAVERN.

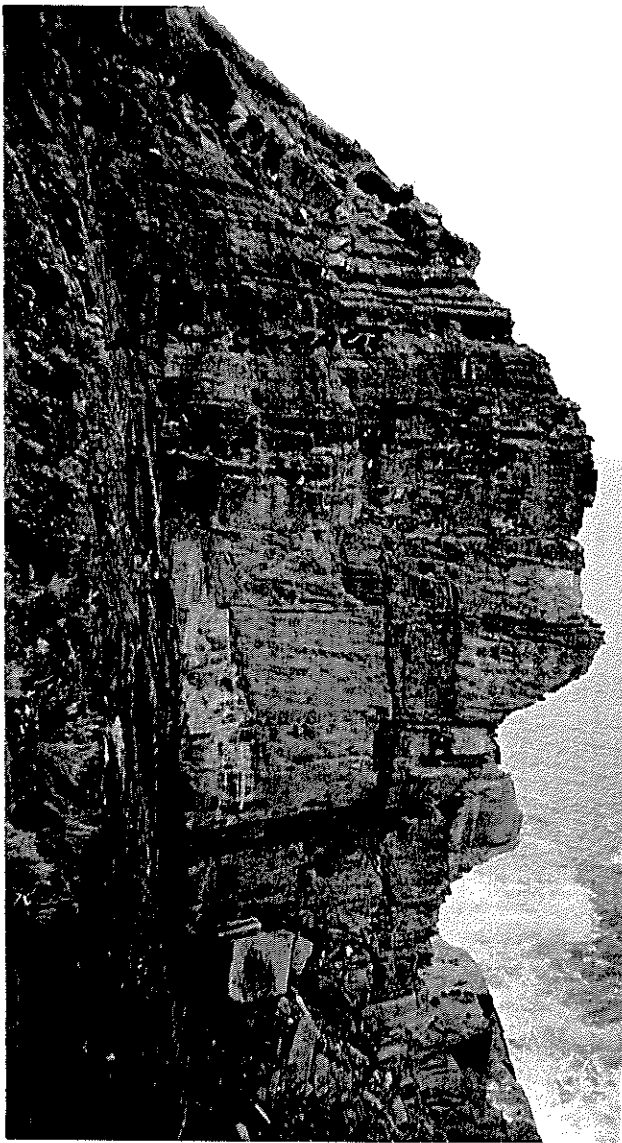
P.10.

VIEW OF MAJOR SANDSTONE
UNIT "D" & UNDERCUT CLIFF
AREA NORTH OF SECTION 4.

NOTE: SEEPAGE.

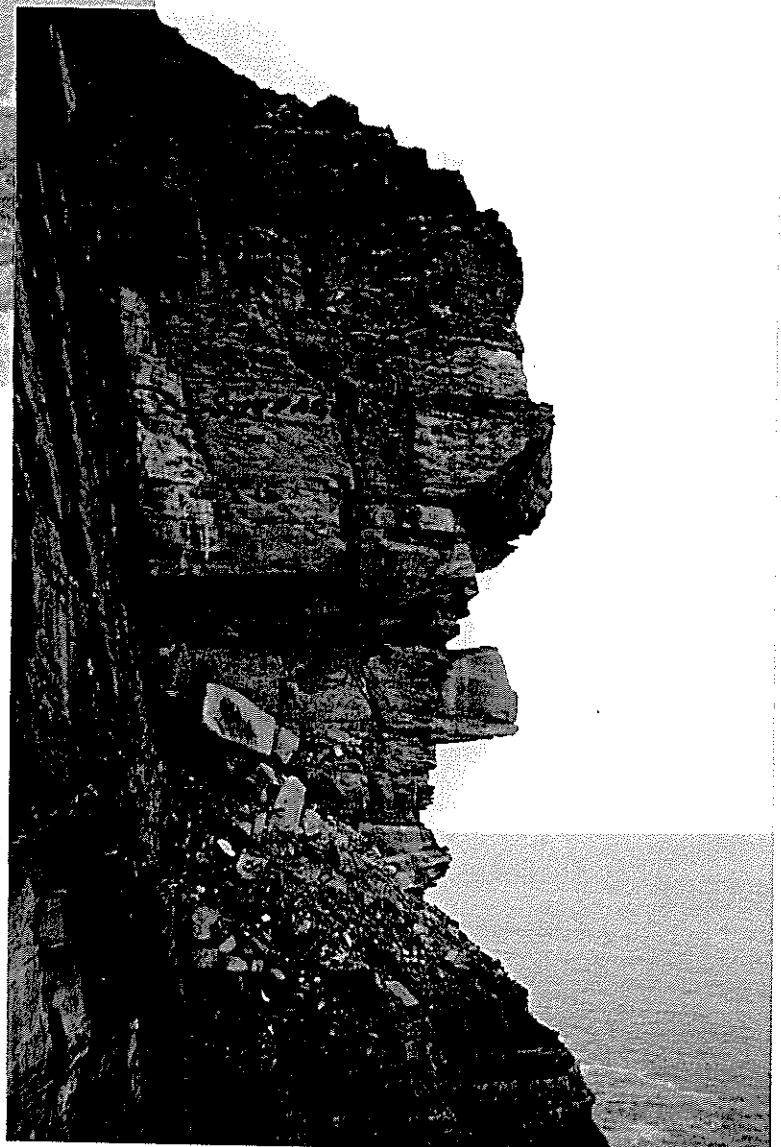
P.11.

VIEW OF UNDERCUT CLIFF
AREA NORTH OF SECTION 4.

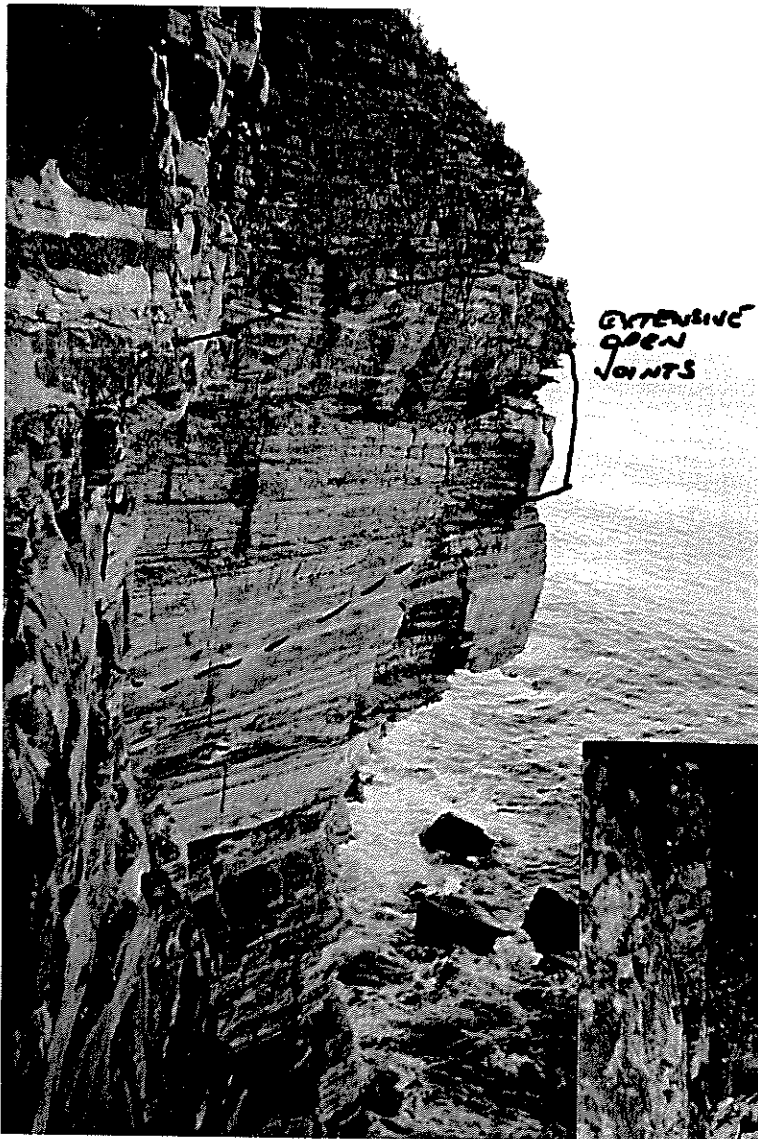
P.8.

VIEW OF EXTENSIVELY UNDERCUT
CLIFF AREA NORTH OF SECTION 3

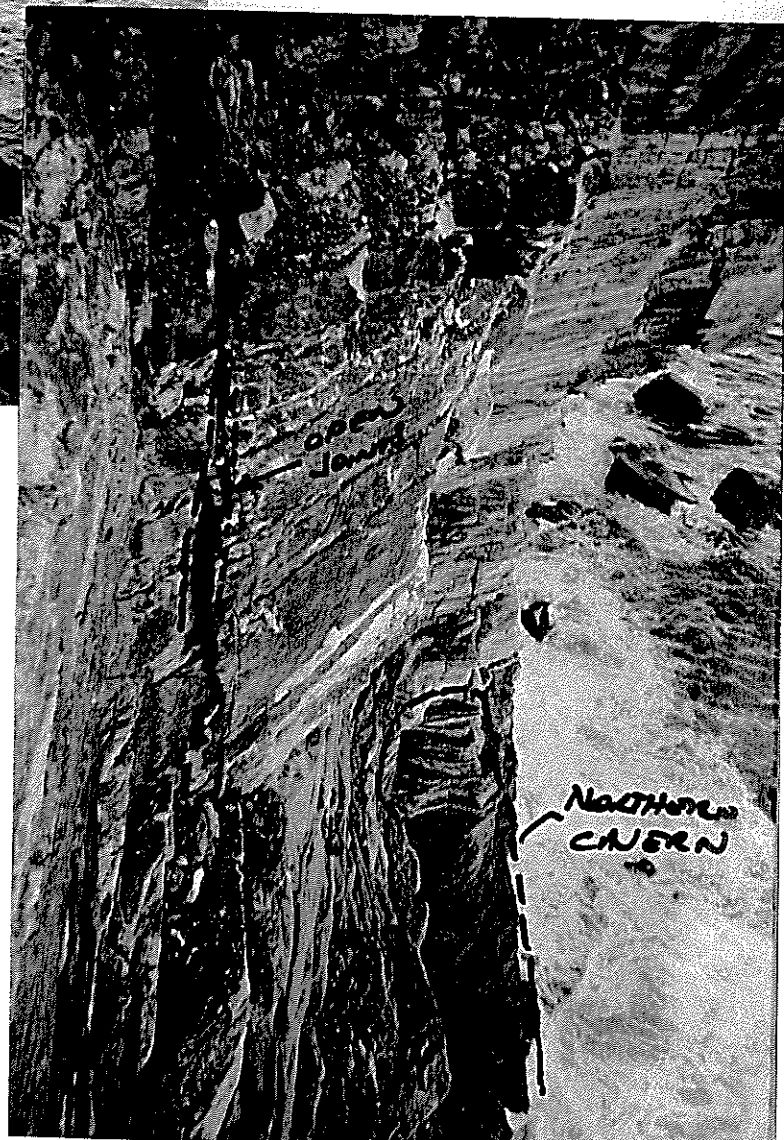
VIEW OF CLIFF UNDERCUT
& NORTHERN CAVERN FROM
SECTION 3.

NOTE: OPEN JOINTING
IN CLIFF.

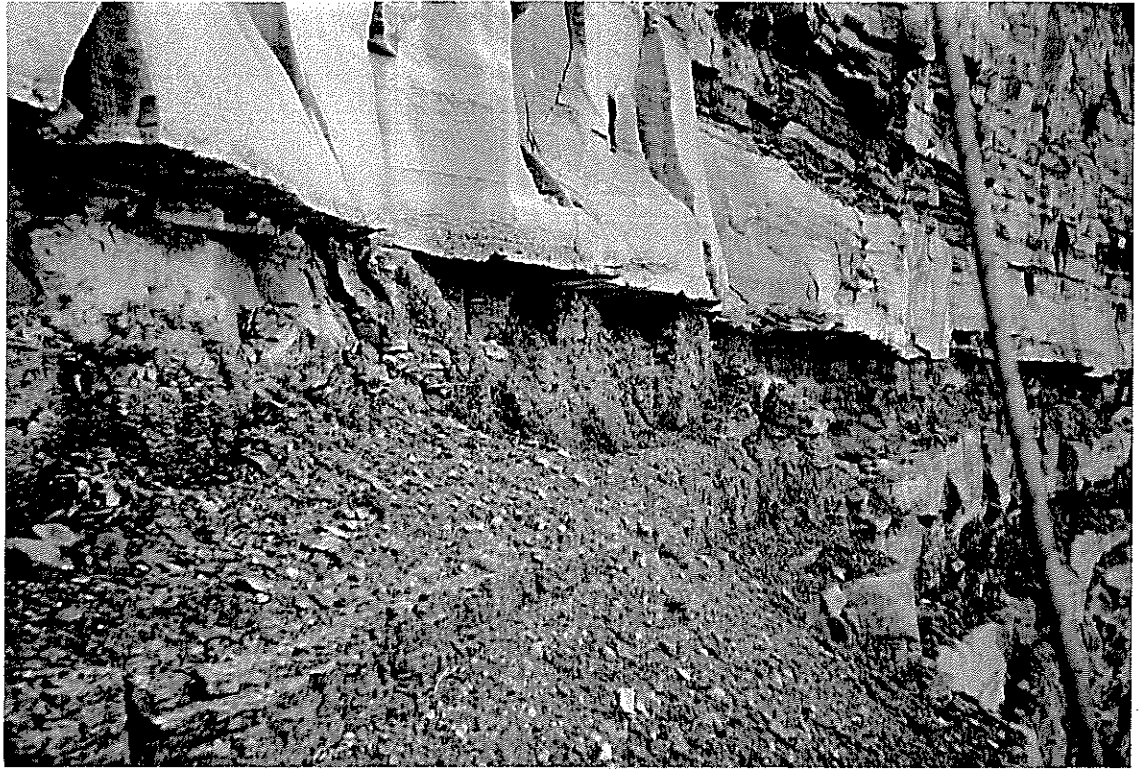
P.20. - SECTION 2. - WEATHERING OF UNIT D9 LOOKING NORTH.

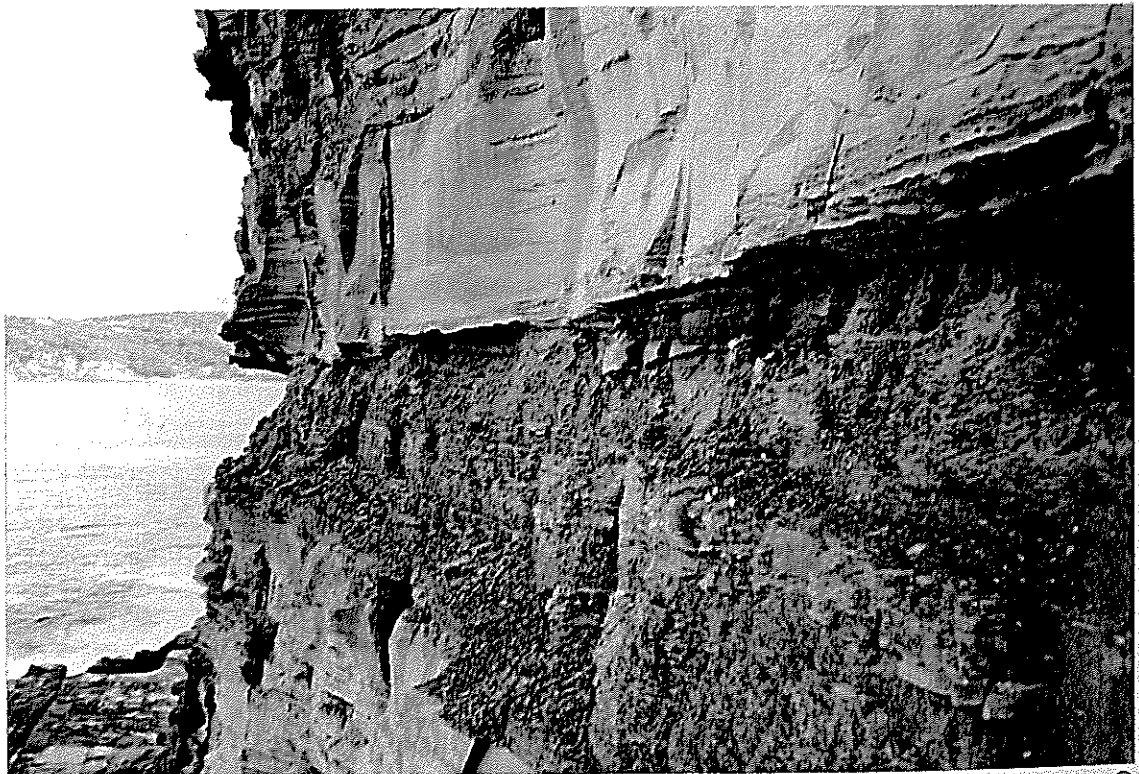
P.21. - SECTION 2. - WEATHERING OF UNIT D9
LOOKING SOUTH.

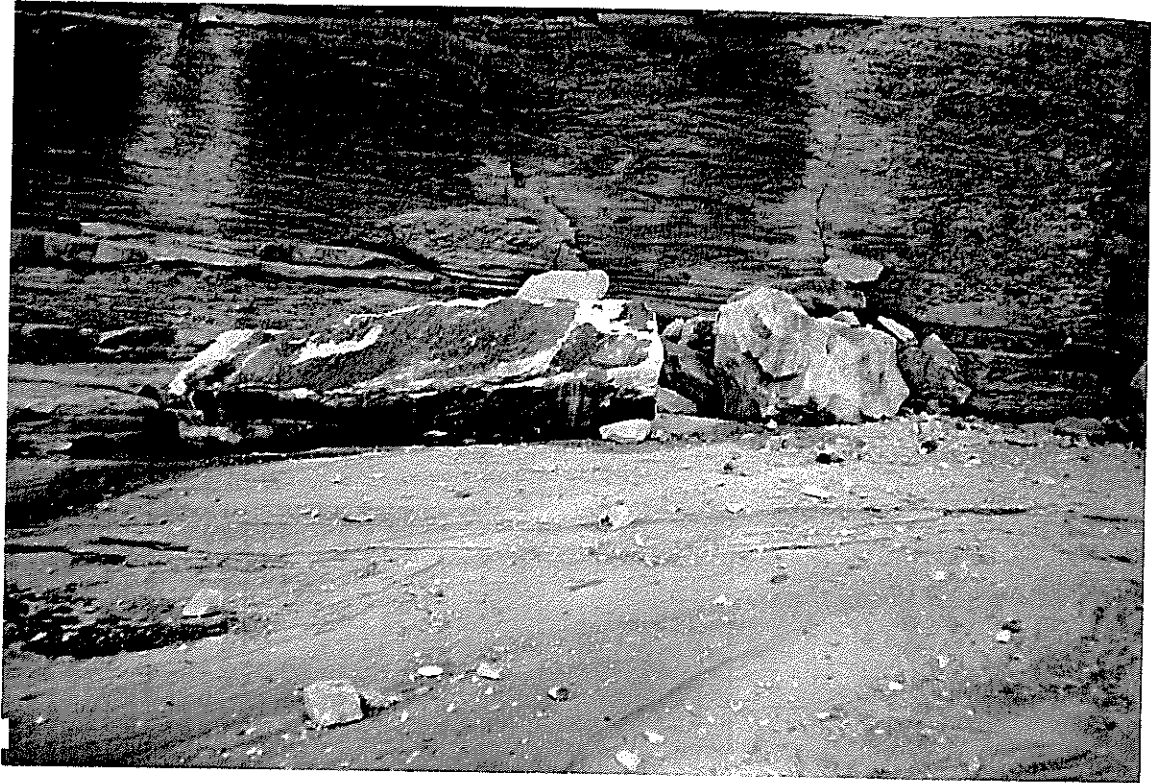
The combination of the near vertical joint sets [generally 80°] described above, local areas of high dip, the cliff line trend as dictated by the regional joint pattern, and horizontal undercutting through differential rates of weathering, has led to localised zones of instability. Observations of the cliff during the field inspections noted some areas with the potential for immediate failure; such a failure actually occurred during the course of the study [see Plate No. P18].

P.18. - VIEW OF ROCK DEBRIS FROM ROCK FALL NEAR LOT No. 876.

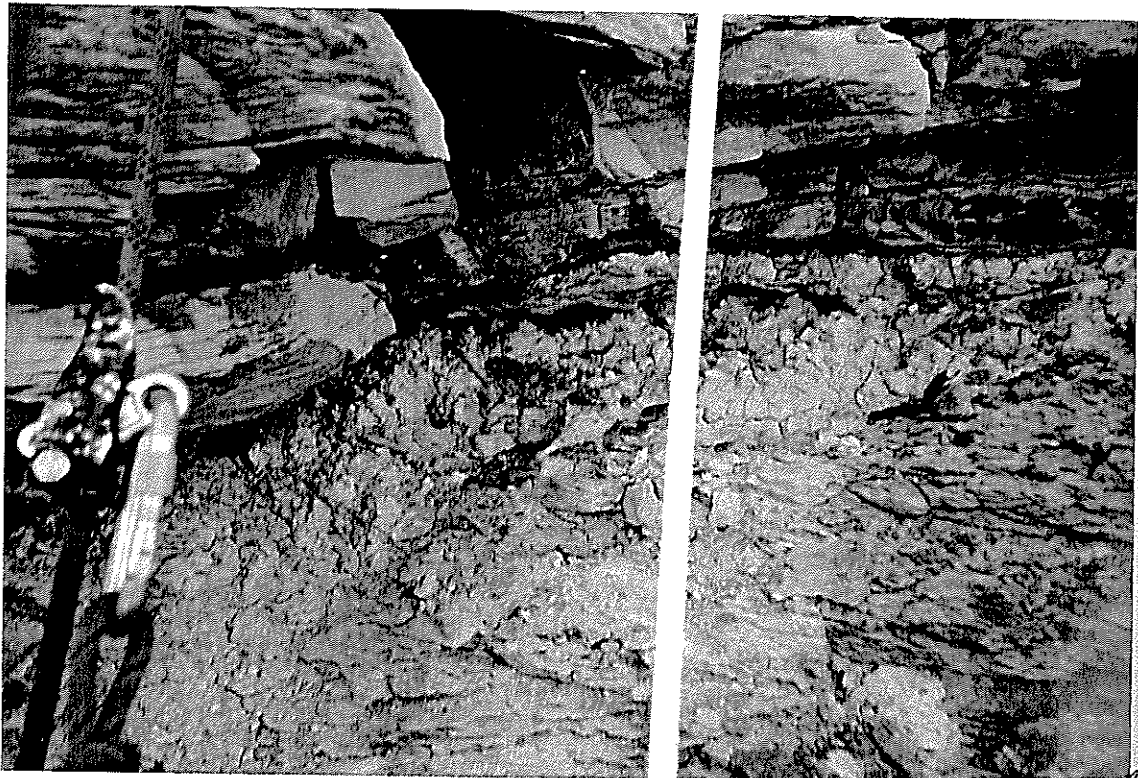
P.19. - SECTION 1. - WEATHERING OF SOFT CLAYSTONE
NEAR BOTTOM OF UNIT "E".

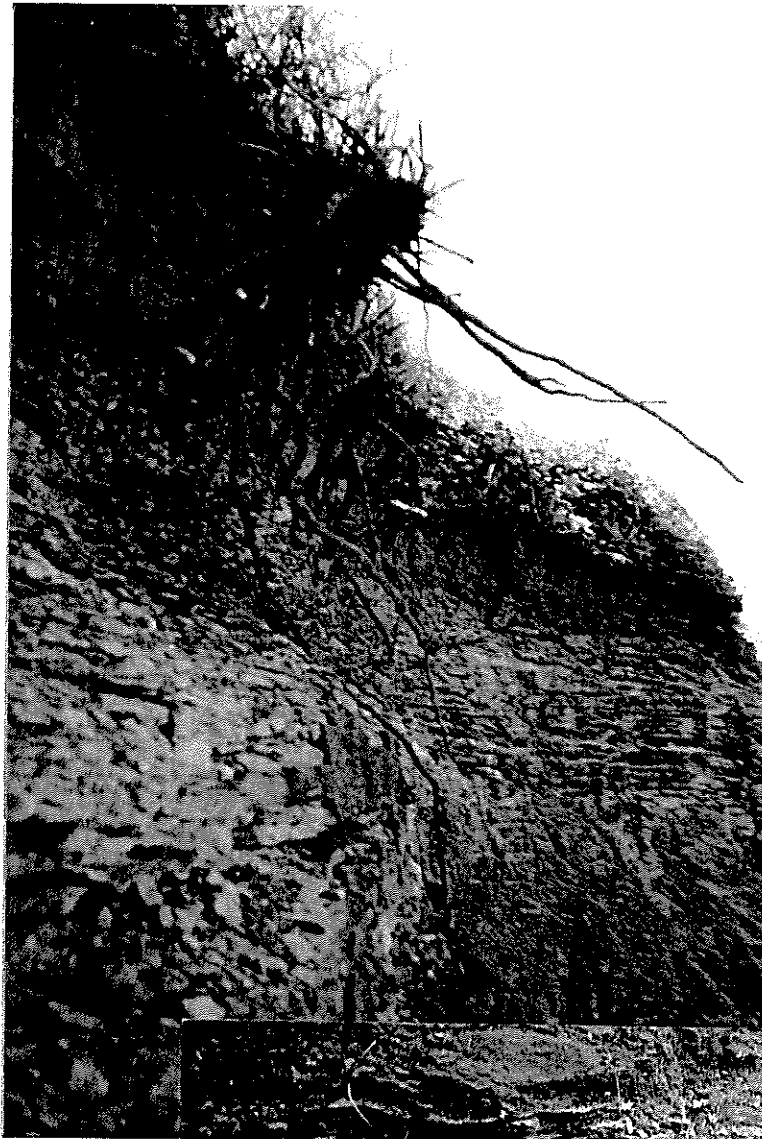
P.16.

SECTION 1. - VIEW OF SURFICIAL
SOIL UNDERCUT BY SOFT ROCK
WEATHERING.

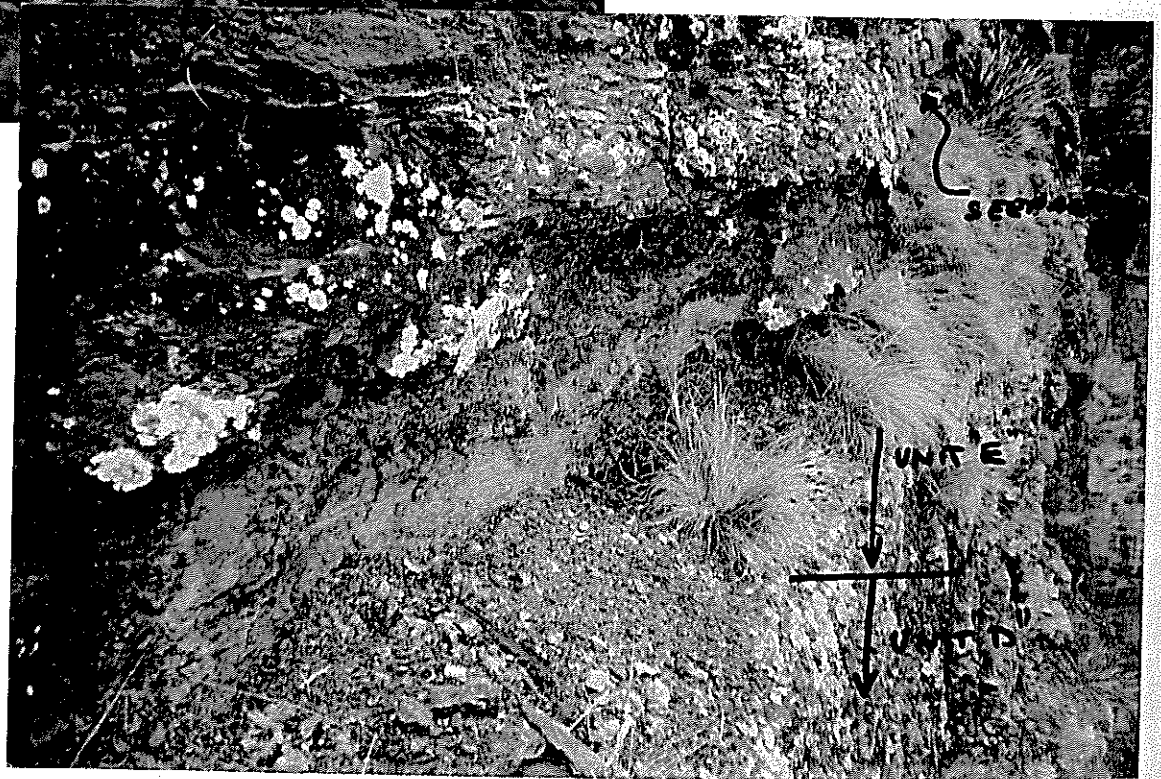
P.17. - SECTION 4. - VIEW OF SOFT CLAYSTONE WEATHERING
ABOVE UNIT "D".
NOTE: ALSO SEEPAGE.
