2.2 The Existing Building:

3.0 CONCLUSION & RECOMMENDATIONS

John Carr
Heritage Architect
(Reg. No. 4128)

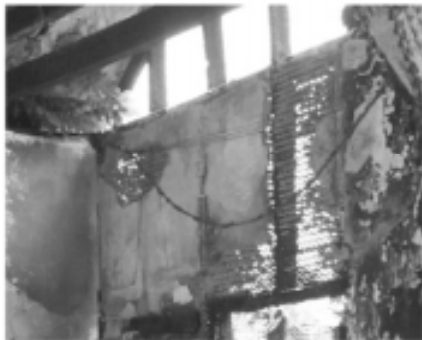
The remains of the Alison Homestead are interesting from technical aspect as the lath used on the walls and ceilings to allow the hard wall plaster to adhere, is expanded steel. This was available in the 1890's as it was used in the first floor additions to the Newcastle Police Station. Similarly, the roof to part of the building is clad in unglazed terracotta Marseilles Pattern tiles manufactured in France. The older section was galvanised iron which replaced earlier timber shingles.

Plate 9: The remains of metal lath used on walls.

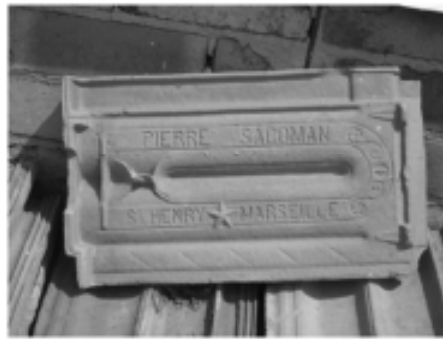
Plate 10: An original roof tile stored beside a shed.

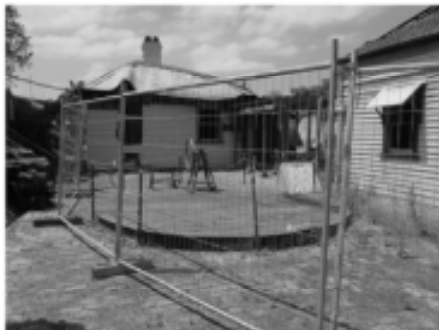
The well to the rear courtyard is abnormally large with most nineteenth century wells being nominally 1800mm to 2000mm in diameter. The well at the Alison Homestead may have only needed to be shallow to reach the water table, so therefore the diameter may have been expanded to provide a volume of water without requiring a great depth.

Plate 11: The large diameter well.

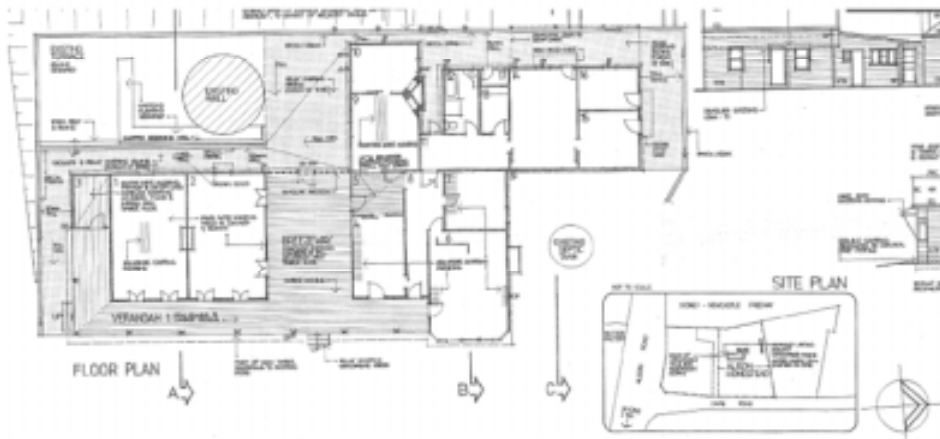
Plate 13: Part of the 1990 plans. (Suters Architects Snell)

The fire has extensively damaged the building with only a couple of rooms that potentially could be saved. The following diagram is taken from the 1990 plans by Suters Architects Snell when the Homestead was refurbished as a base for the Wyong Historical Society

Table of Estimated Room Damage

Room 1 - 10%	Room 2 - 90%	Room 3 - 5%	Room 4 - 100%
Room 5 - 100%	Room 6 - 100%	Room 7 - 80%	Room 8 - 100%
Room 9 - 70%	Room 10 - 60%	Room 11 - 100%	Room 12 - 60%
Room 13 - 90%	Room 14 - 70%	Room 15 - 50%	Room 16 - 10%
Room 17 - 20%

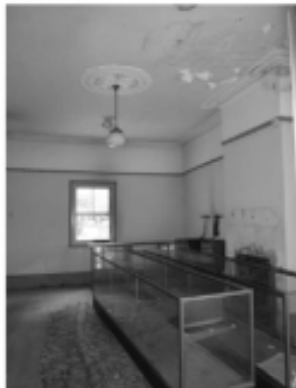
Plate 14: Room 1 showing signs of damage to the ceiling and the fire mantle and box removed.

Recommended Solution: Rooms 1 and 3 are the most in tact following the fire and these together with Room 2 could be restored and reconstructed to form the basis of a new building by preserving some of the significant fabric. Due to the extent of reconstruction required to Room 2 the use of modern materials such as timber lining boards or plasterboard on the internal walls instead of solid wall plaster could be justified due to the preservation of Room 1 and the possible use that Room 2 may serve as part of the re-development of the site. A budget of \$50,000 should be allowed to restore Room 1 and reconstruct Room 2 using modern materials such as treated softwood frames and trusses with plasterboard or timber linings. Clad the external walls in salvaged weatherboards and tile the roof with salvaged and stored tiles. The design and construction of a new building to add to the required space needed by the Wyong Historical Society, should take the form of a modern design, drawn from but not copying the original Homestead. The benefit from this mixture of work is the survival of original fabric from the Homestead and the opportunity to construct a purpose designed building for the Wyong Historical Society to conduct their meetings and tours of the remaining Homestead, outbuildings and display the now extended story of the site.

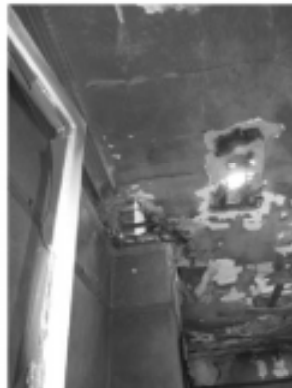
Plate 15: looking at the chimney above the ceiling line in Room 2

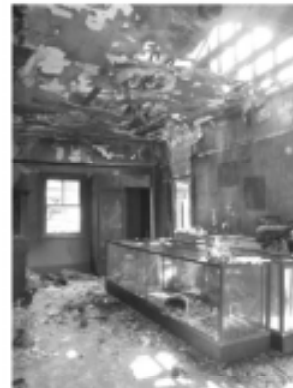
The fire was most vigorous between and including rooms 2 to 7. The verandah deck survives on the eastern and southern sides of rooms 1 & 2. The hardwood wall, ceiling and roof frames have allowed the structure to remain standing where it has not completely burnt out.

Plate 16: The extensive damage to Room 2, with hardwood framed walls still standing.

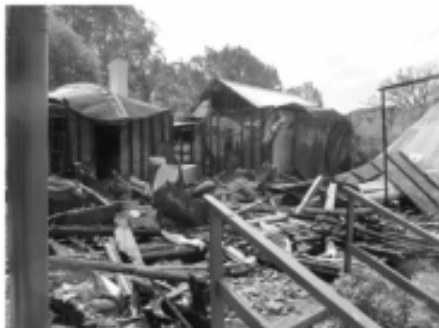
Plate 17: View across the deck towards Room 4

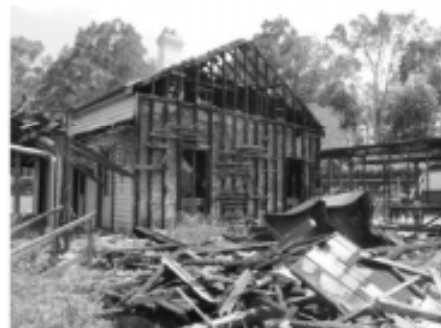
Plate 18: View back to Room 2. Note; hardwood weatherboards slowed the fire damage

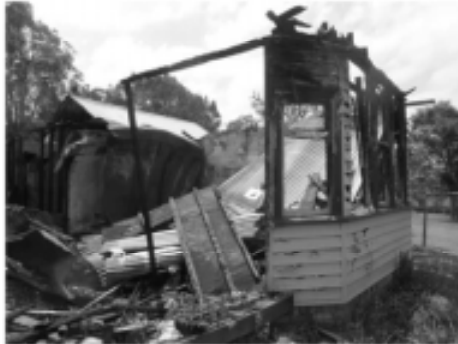
Plate 19: The remains of the bay window to Room 6.

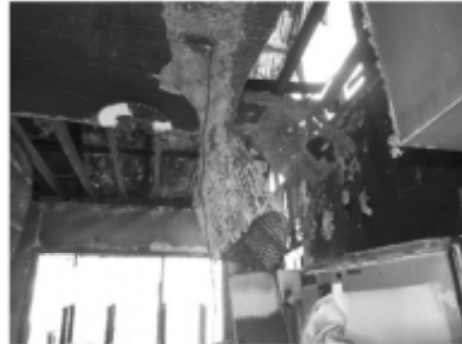
Plate 20: The remains of the decorative ceiling rose to Room 14.

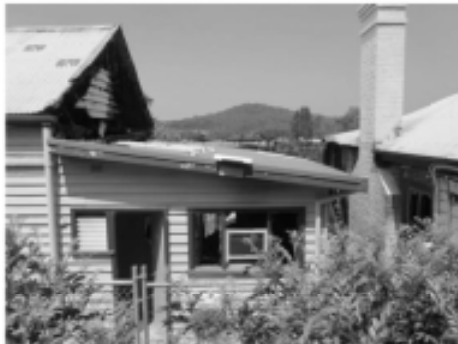
Plate 21: Burnt out gable over Room 14.

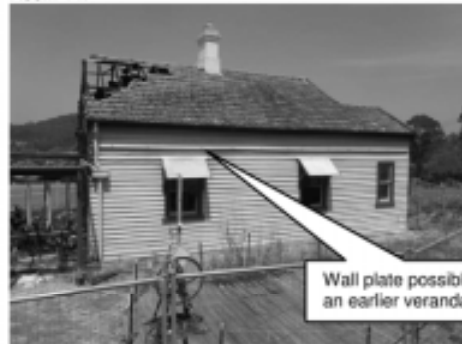
Plate 22: Burnt northern wall to Room 3 from the west.

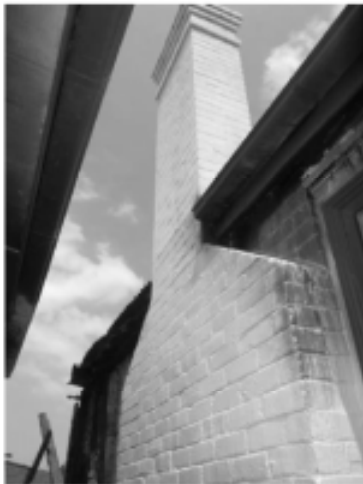
Plate 23: Chimney to Rooms 8 & 9.

Both of the above materials will be valuable assets in the reconstruction of Room 2 and the restoration of the roof covering to Rooms 1 & 2. Consideration should also be given to retaining the remaining chimney serving Rooms 8 & 9, possibly as a free standing element forming part of the landscaping.

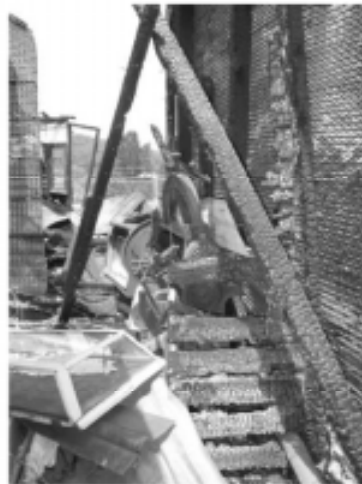
Plate 24: Salvage artefacts such as this Mangle.

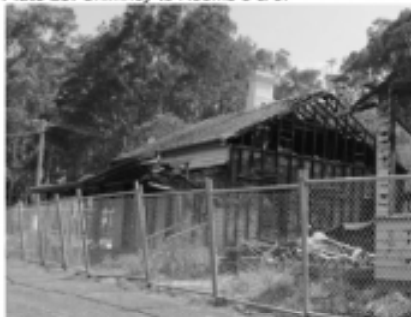
Plate 25: Salvage tiles from roof for re-use.

- the terracotta roof tiles and
- the hardwood splay timber weatherboards.

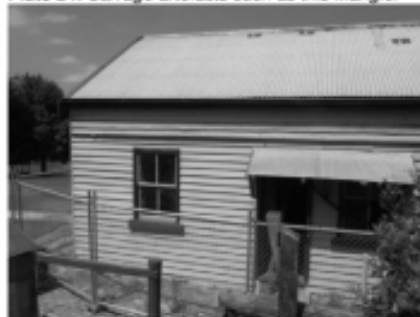
Plate 26: Salvage weatherboards for re-use.

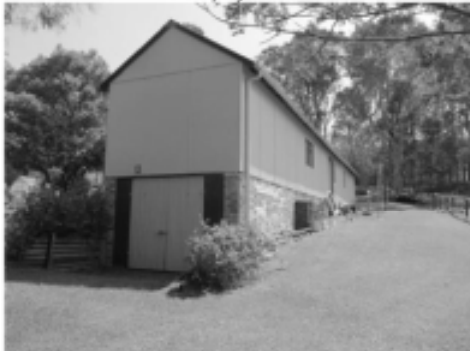
Plate 34: Storage shed for artefacts has a number of terracotta tiles from the roof for re-use.
