Wyong Shire Council

**3.1 TA 126/2011 - Removal of Three Trees at 58A Gordon Avenue,
Summerland Point**

Attachment 1: Arborist Report and Site Plan..... 3

Dear Mr & Mrs Fisk,
This report has been prepared on the three eucalyptus in your front yard.

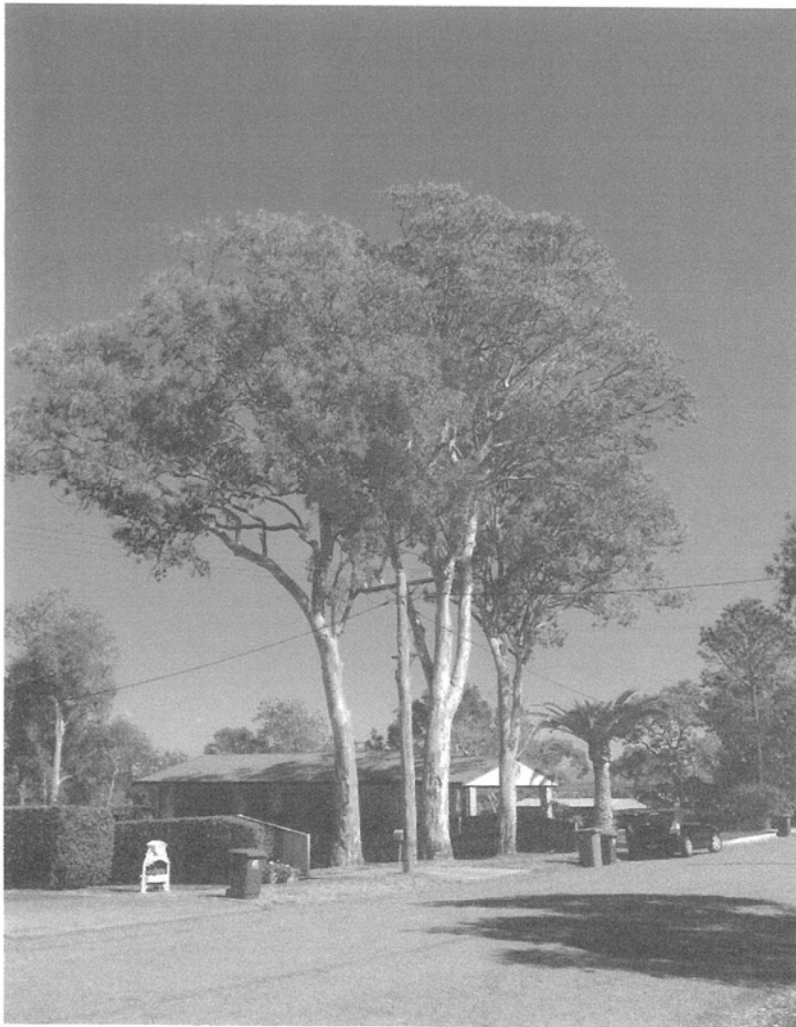
Photo.1 Trees 1, 2 & 3 in front of residence. Please note the location of the above ground electricity services.

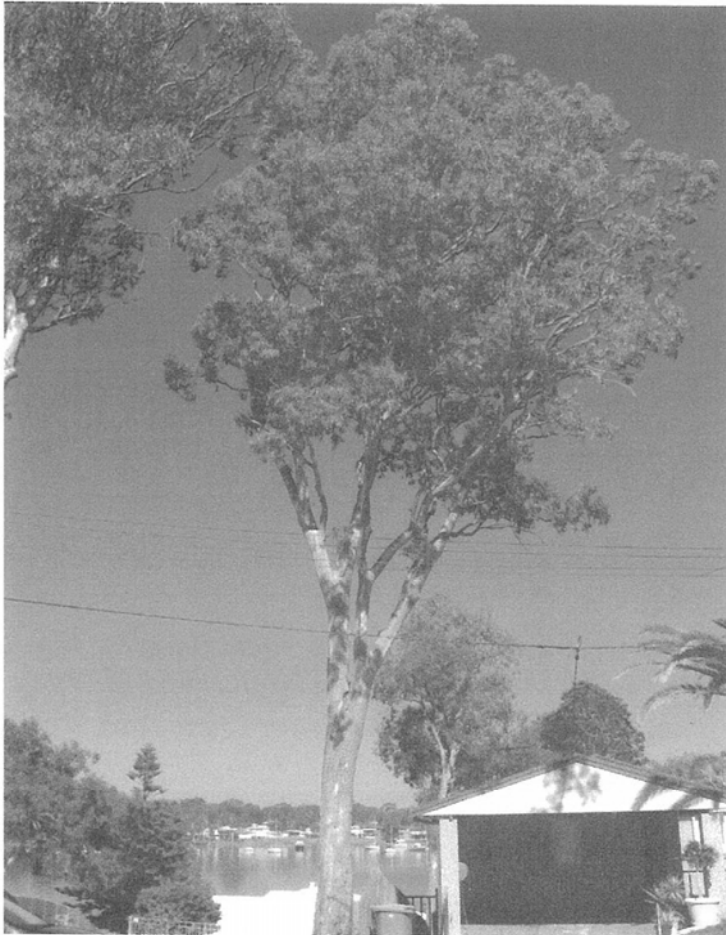
- **Height** 26.5m
- **Radius of foliage** Please refer to layout included
- **Diameter (1m)** 0.71m
- **Age class** Maturing
- **Description** The tree has a relatively short bole to 7m and extended crown that has been slightly suppressed by the grey gum to the south-east. (See photo.2) The tree's natural form and crown weight distribution has been altered due to the surrounding trees with a weight bias towards the adjoining property. This small fruited grey gum's bole is 3m from the roof of the adjoining residence (See photo.2) and overhangs this roofline. Please note the position of the water meter in relation the tree's trunk. (See photo.4)

Photo.2 The small fruited grey gum, *Eucalyptus propinqua* var. *propinqua*, tree.3. Please note the location of the trunk and canopy overhang in relation to the residence

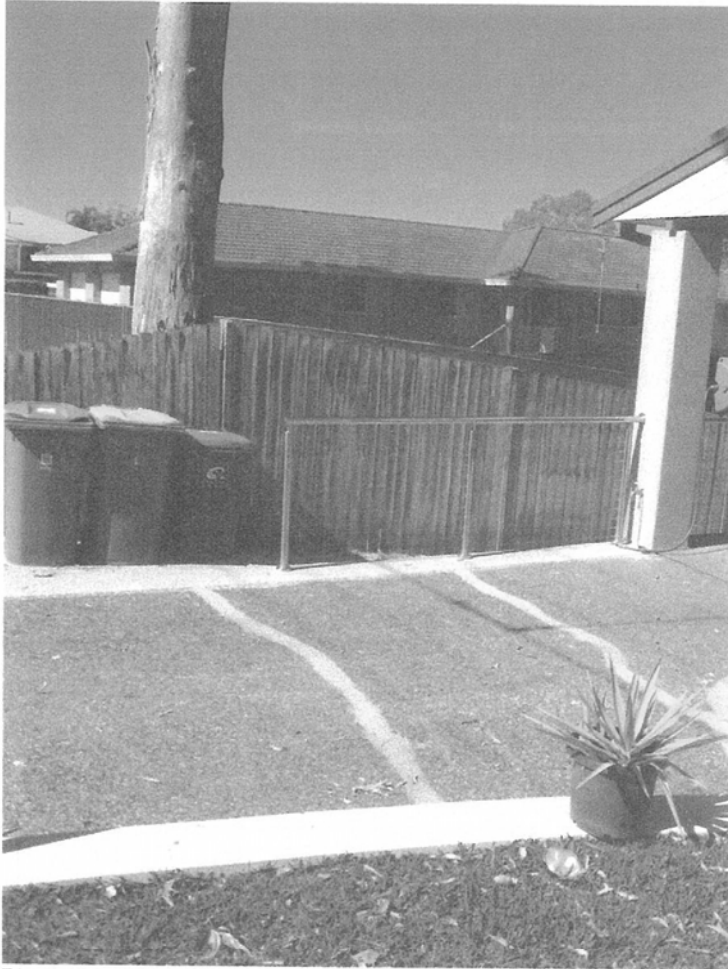
Photo. 3 The trunk of the small fruited grey gum and the driveway of number 60 Gordon Avenue. Please note the damage to the driveway and the boundary fence.

The small fruited grey gum beside the property of number 60 Gordon Avenue does overhang the carport and the residence, and is damaging the driveway and boundary fence; please refer to photos 2, 3 & 4. Pruning of this tree to Australian Standards will not alleviate the ongoing damage to the driveway and potential for branches to fall onto the residence of number 60 Gordon Avenue. This trees' bole is only three metres from the carport as previously mentioned.

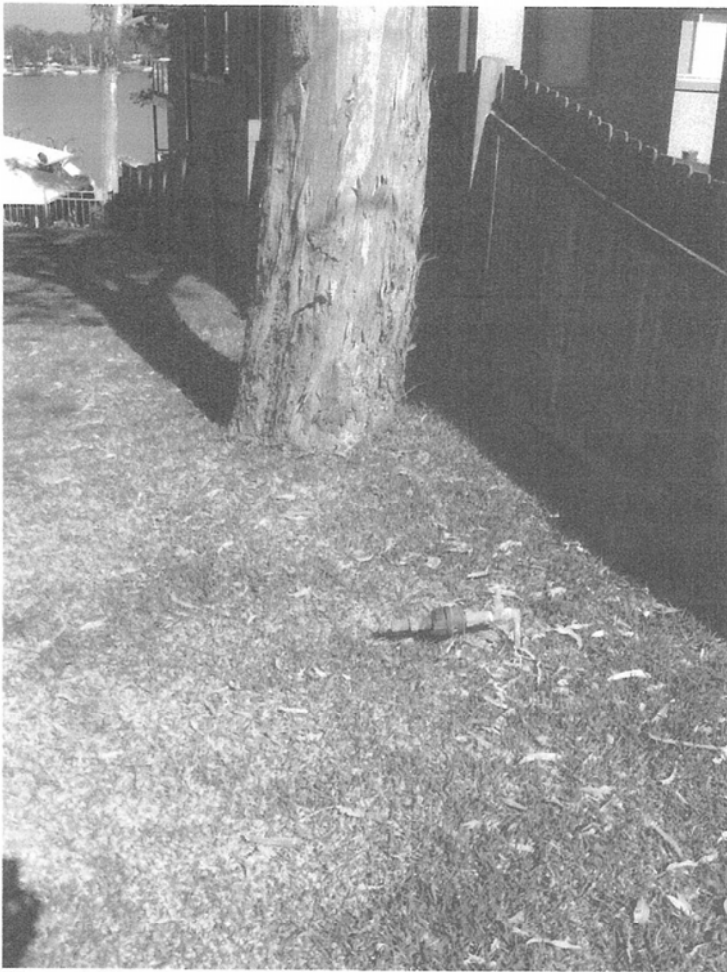
Photo.4 Showing location of the base of tree three. Note the location of water meter and the lean of the boundary fence.

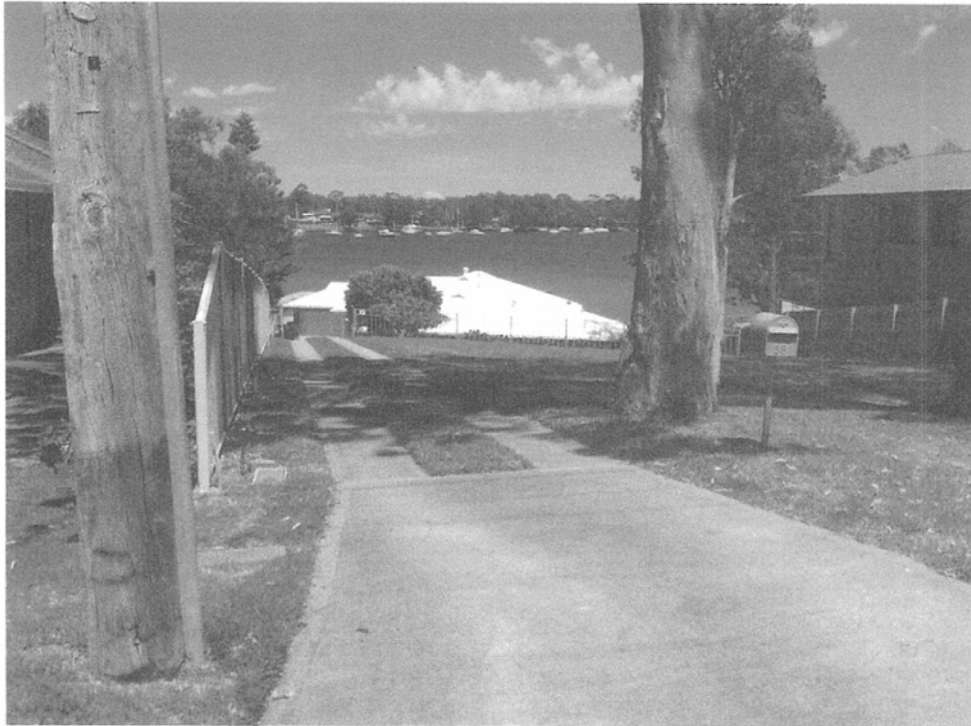
- **Height** 26m
- **Radius of foliage** Please refer to layout included
- **Diameter (1m)** 0.78m
- **Age class** Maturing
- **Description** The tree has a single trunk to 11m. The tree's natural form and crown weight distribution has been slightly altered due to the grey gum to the north-west and pruning for the electricity service to the north-east. The tree's crown has a weight bias towards the residence of number 56. The tree's main bole is only three metres from the boundary fence between numbers 56 and 58. Underground electricity services and domestic water services are located within one metre of this boundary. The driveway for the residence is also located between the boundary and the tree's trunk, limiting access to the residence. (See photo.5) This Small fruited grey gum is growing within the natural range of the genus.

Photo.5. Driveway of number 58. Please note location of trunk of Tree.1 in respect to property boundary fence, electricity services and the driveway.
