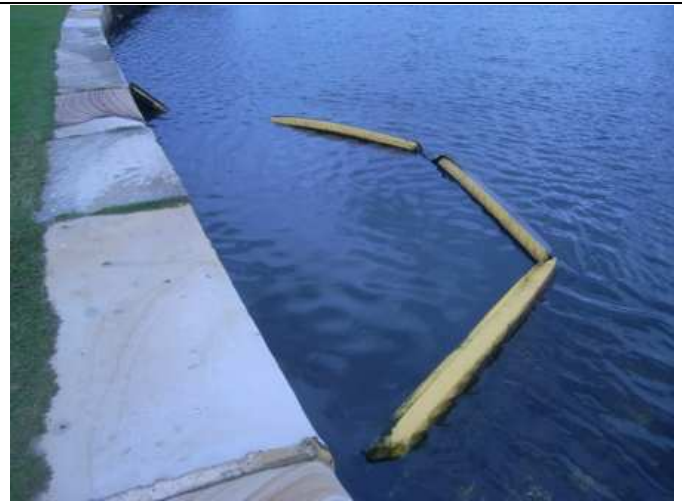
**Photo 4:** Stormwater traps along Gosford foreshore. (W27)

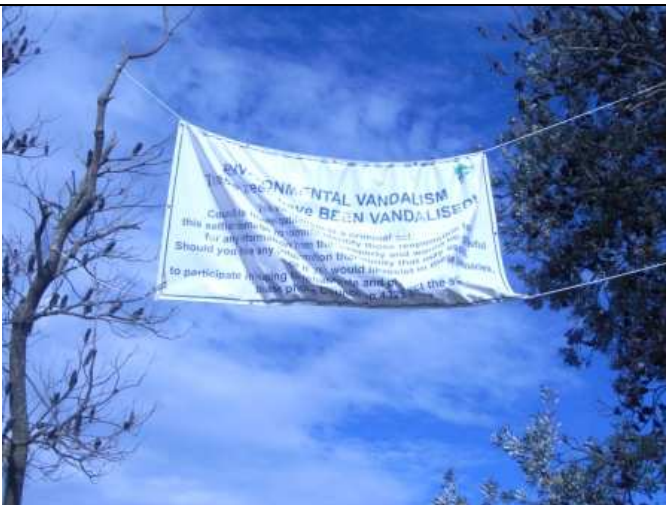
**Photo 11:** Tree vandalism sign along the Ettalong foreshore. (C05)

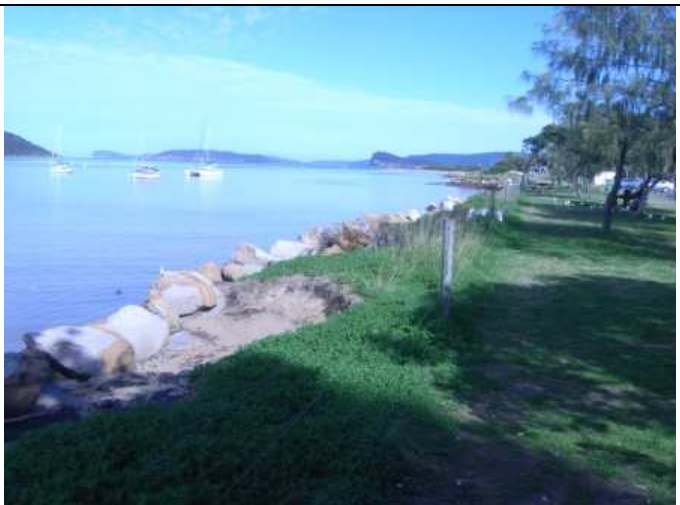
**Photo 12:** Looking south along Ettalong foreshore – seawall with adjacent recreational area. Lack of beach

access points along this stretch. (W112)

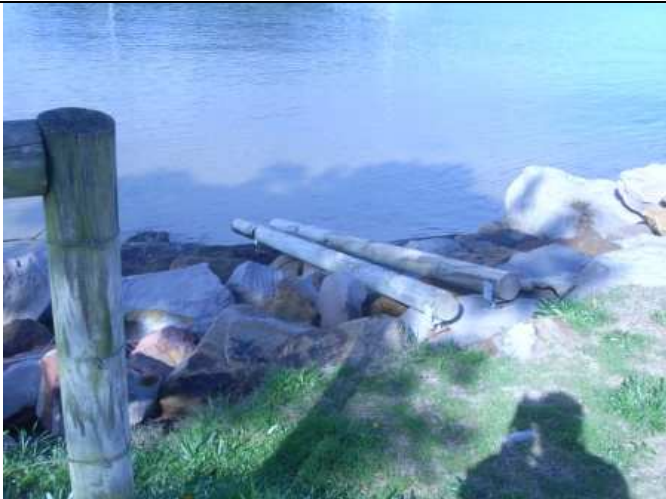
**Photo 13:** Informal vessel ramp along Ettalong foreshore. (P48, R31, C14)

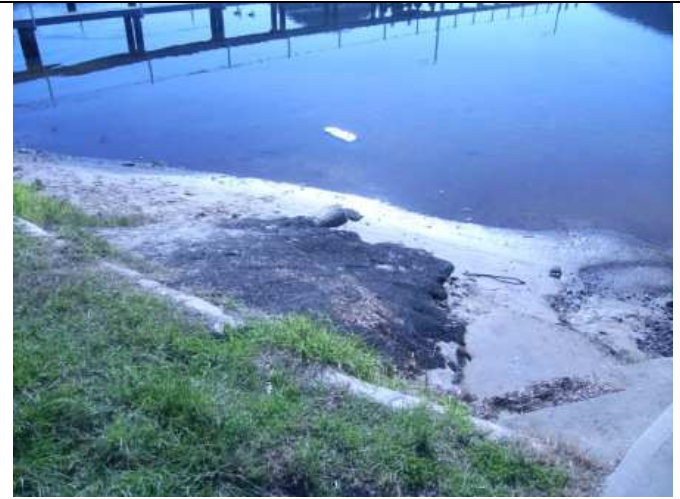
**Photo 14:** Informal boat ramp amidst numerous private jetties, at Woy Woy Bay. (P48, R31, C14)

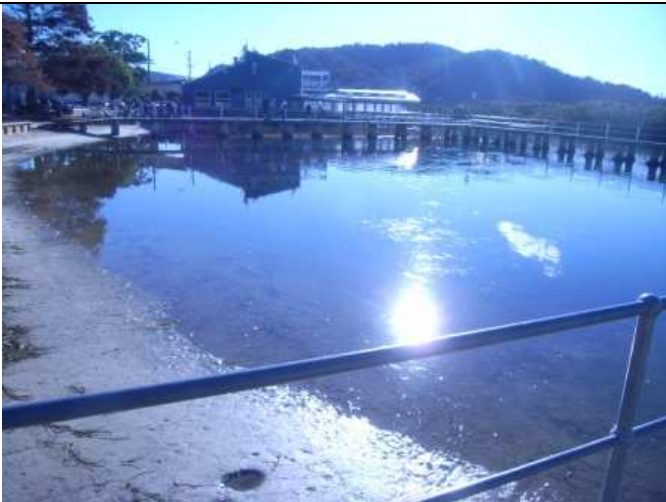
**Photo 17:** Public baths along the Woy Woy foreshore - visually poor water quality. (W108)

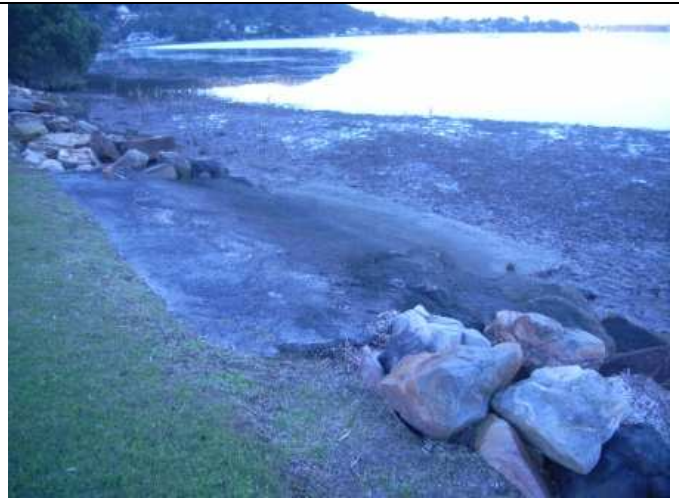
**Photo 22:** Informal boat ramp at Koolewong Foreshore Reserve. (C14)

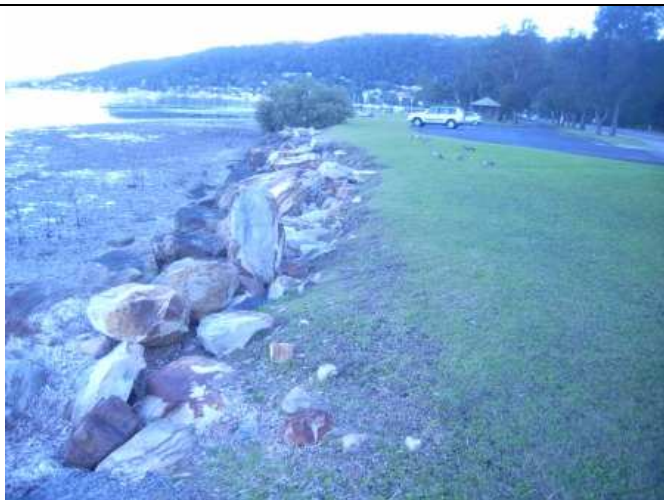
**Photo 23:** Erosion and rock armour along the Koolewong Foreshore. (W69)

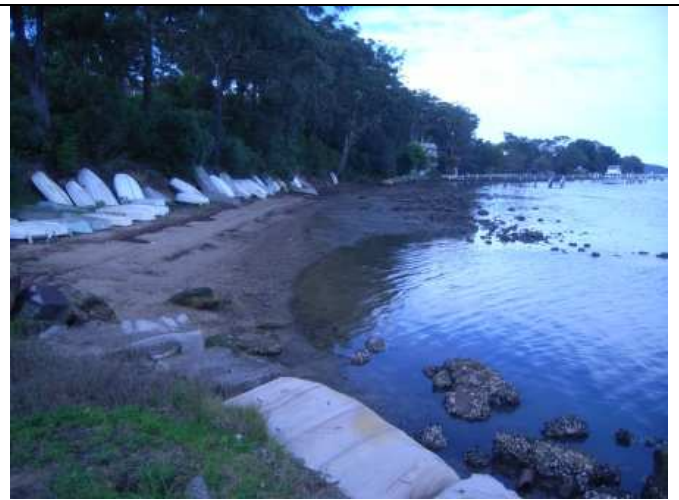
**Photo 24:** Informal dinghy storage along Masons Parade, Point Frederick (looking south). (W77, W86)

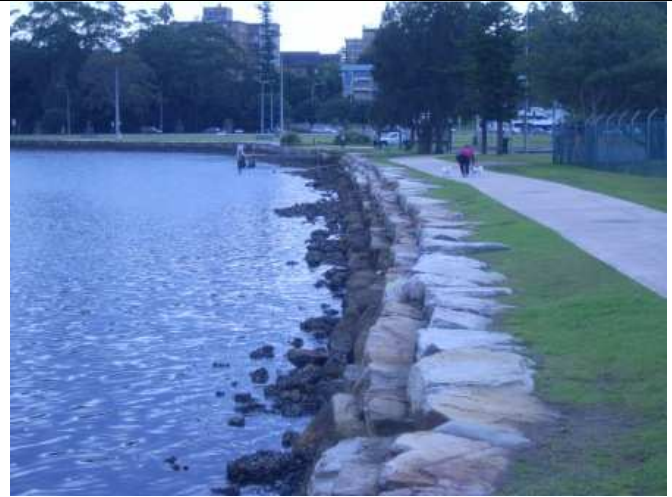
**Photo 26:** Point Frederick seawall looking north. (W69)

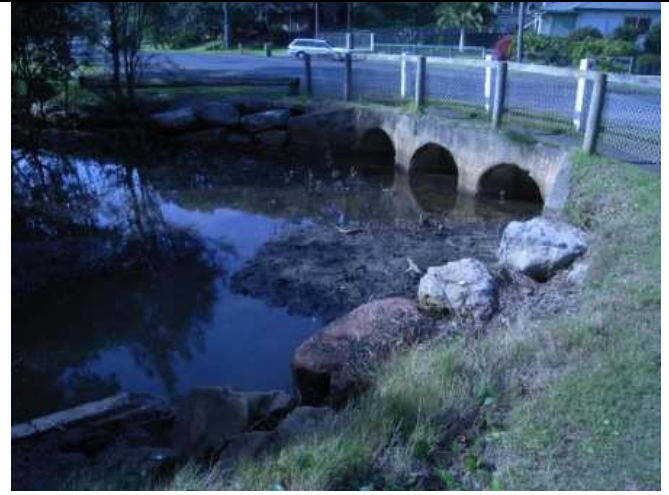
**Photo 34:** RSL Creek culvert into Hardys Bay. (W23)

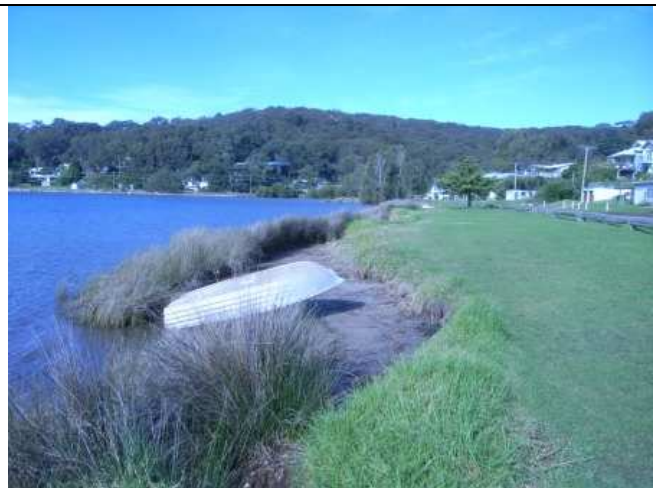
**Photo 35:** Foreshore erosion adjacent to Araluen Drive, Hardys Bay. (W39)

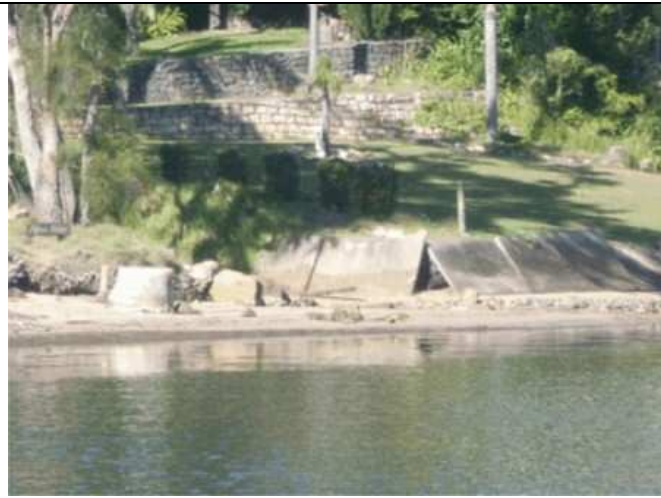
**Photo 39:** Informal sea wall (R13)

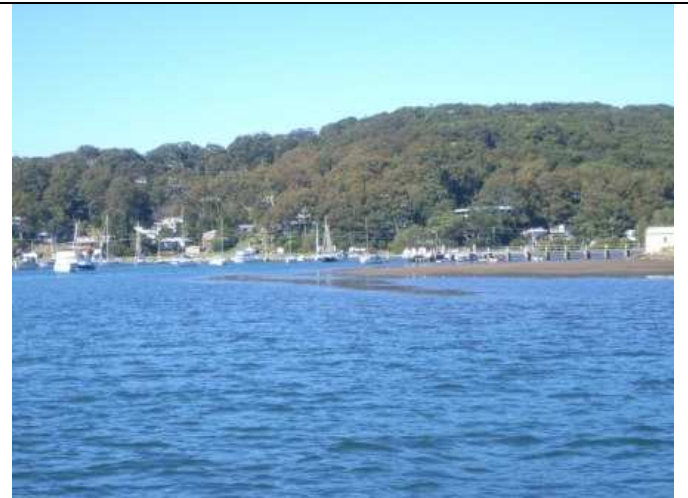
**Photo 40:** Sedimentation in Hardys Bay. (W24, W120)
