ECOLOGICAL ASSESSMENT OF THE SHORELINE AROUND THE BRISBANE WATER ESTUARY

Cardno Lawson Treloar Pty Ltd

August 2007

G. R. Sainty & D. E. Roberts

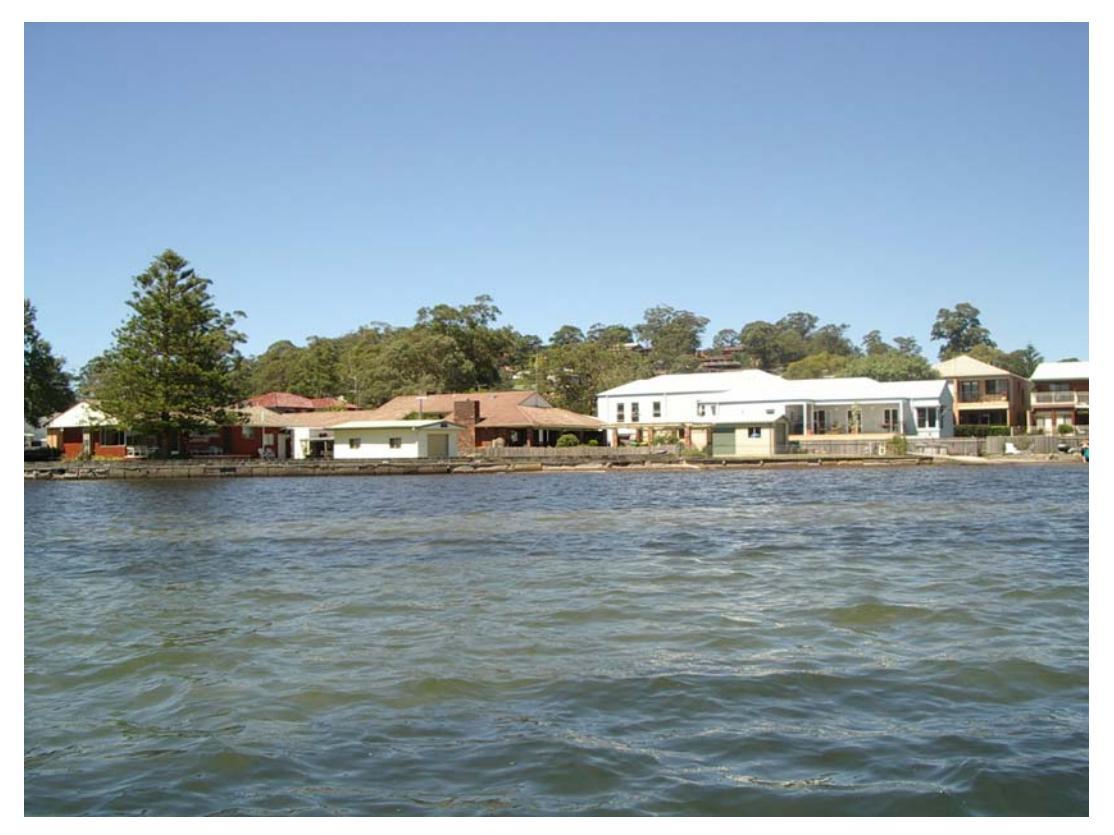
Figure 1. Highly disturbed and modified shoreline edge with seawalls and substantially developed catchment.

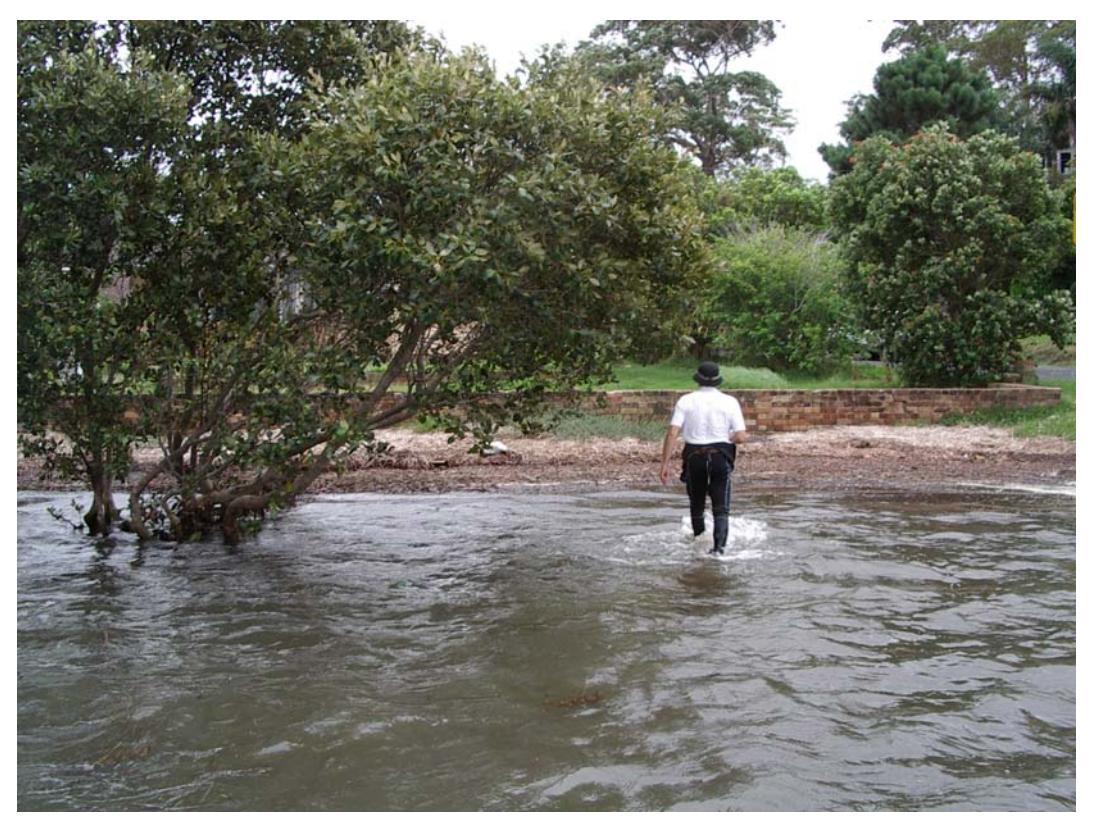
Figure 2. Disturbed/modified shoreline edge with seawall, limited saltmarsh and scattered mangroves.

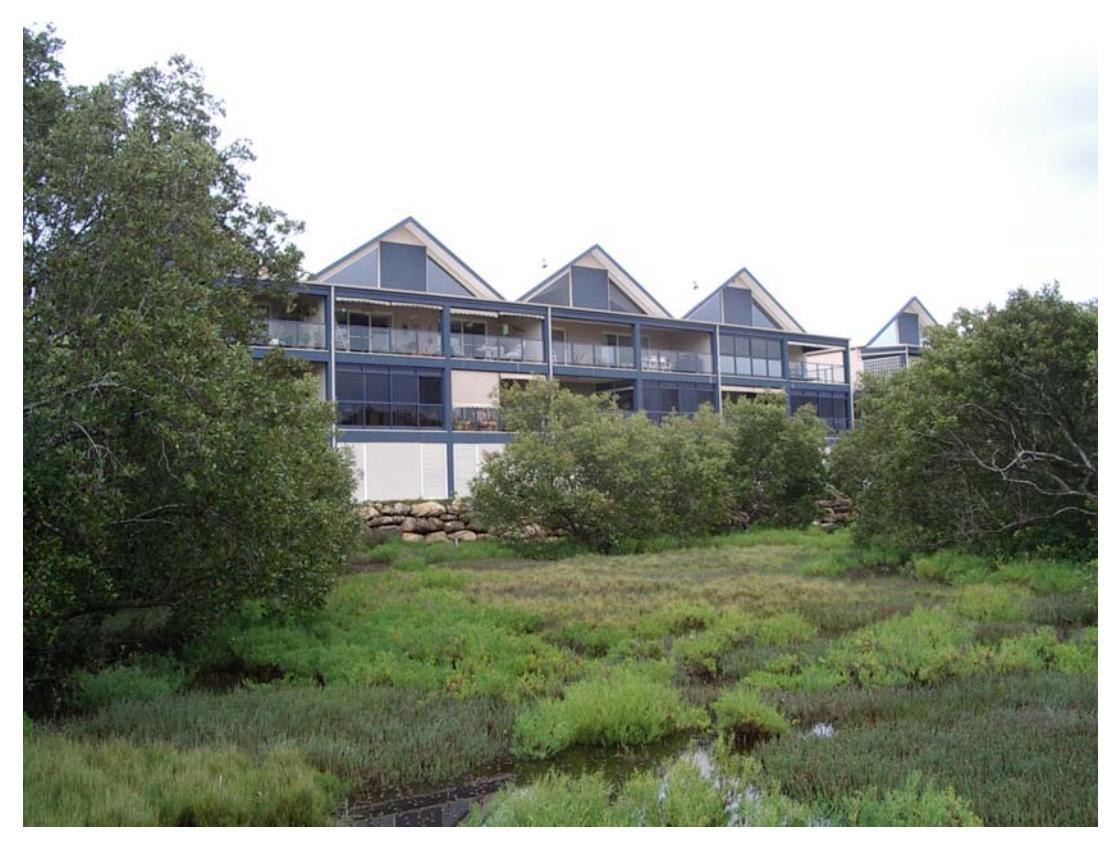
Figure 3. Saltmarsh and mangrove habitat with close development impacting on the ecological value of the foreshore.

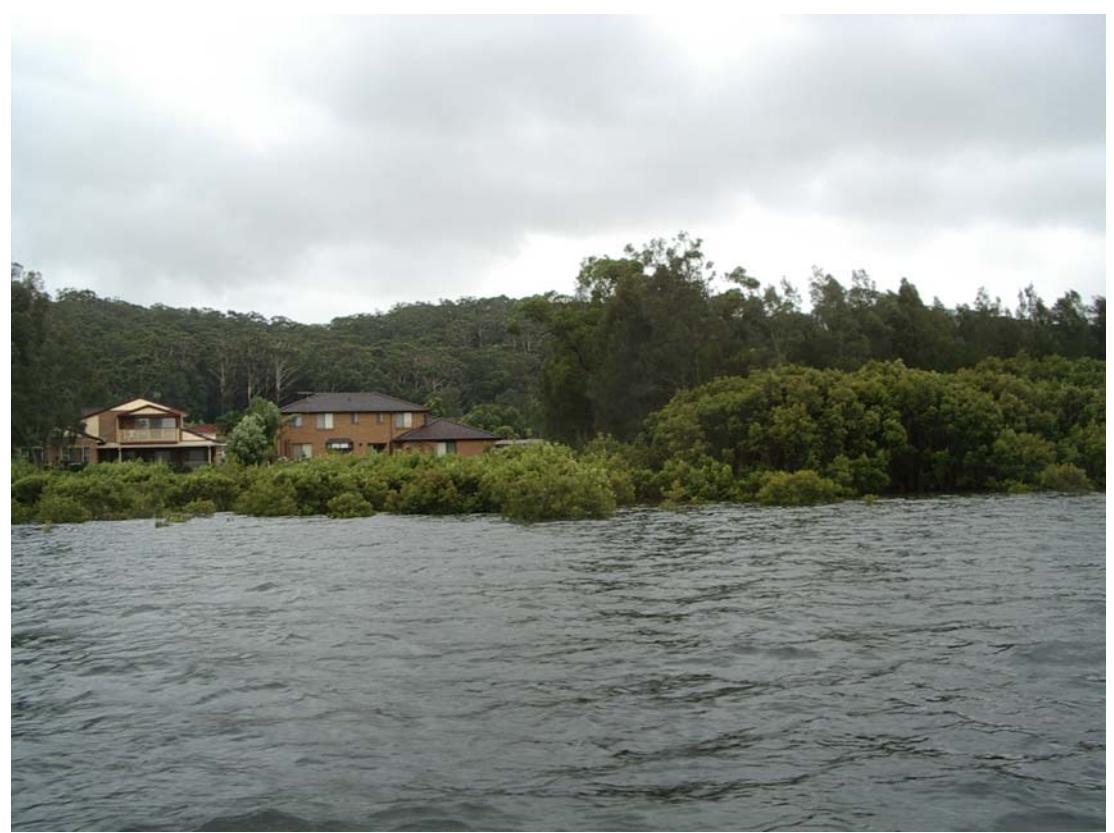
Figure 4. Unmodified foreshore with mangroves on waters edge, catchment partially developed.

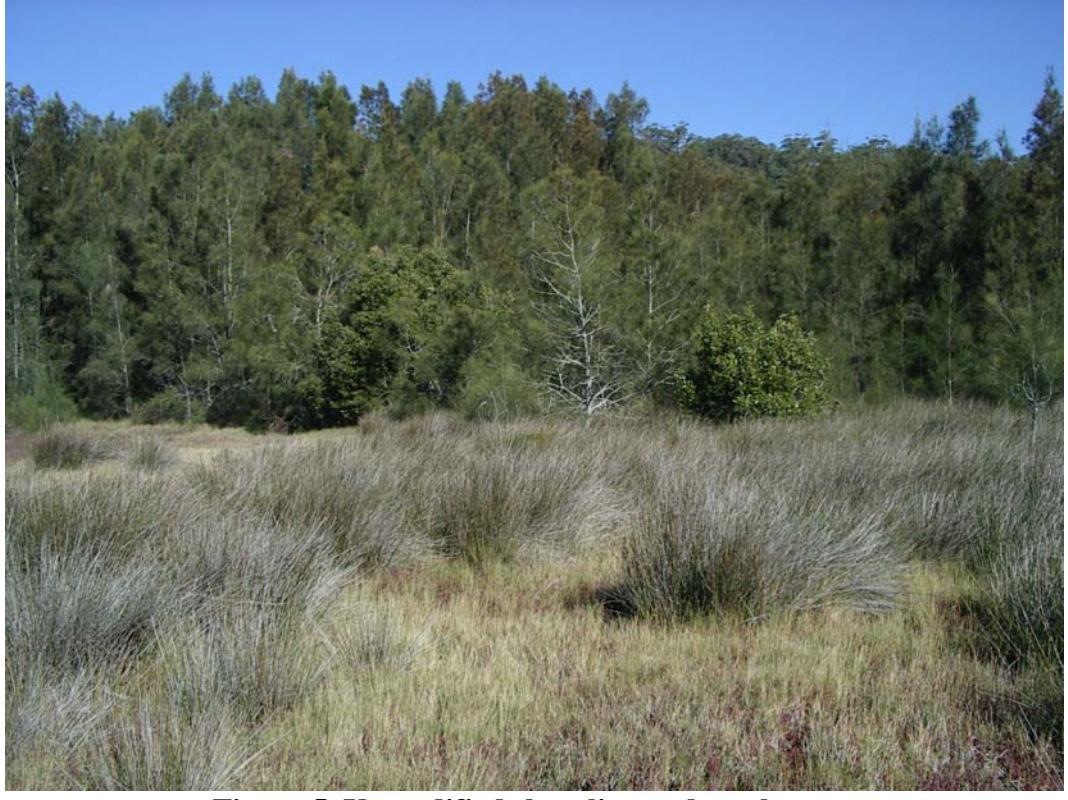
Figure 5. Unmodified shoreline and catchment.
