REPORT ON THE SAFETY OF NAVIGATION SHOULD TRAINING WALLS
BE ESTABLISHED AT THE BARWAY ENTRY TO THE ENTRANCE IN NEW
SOUTH WALES.

Prepared by Captain Charles Weston

24th April 2013

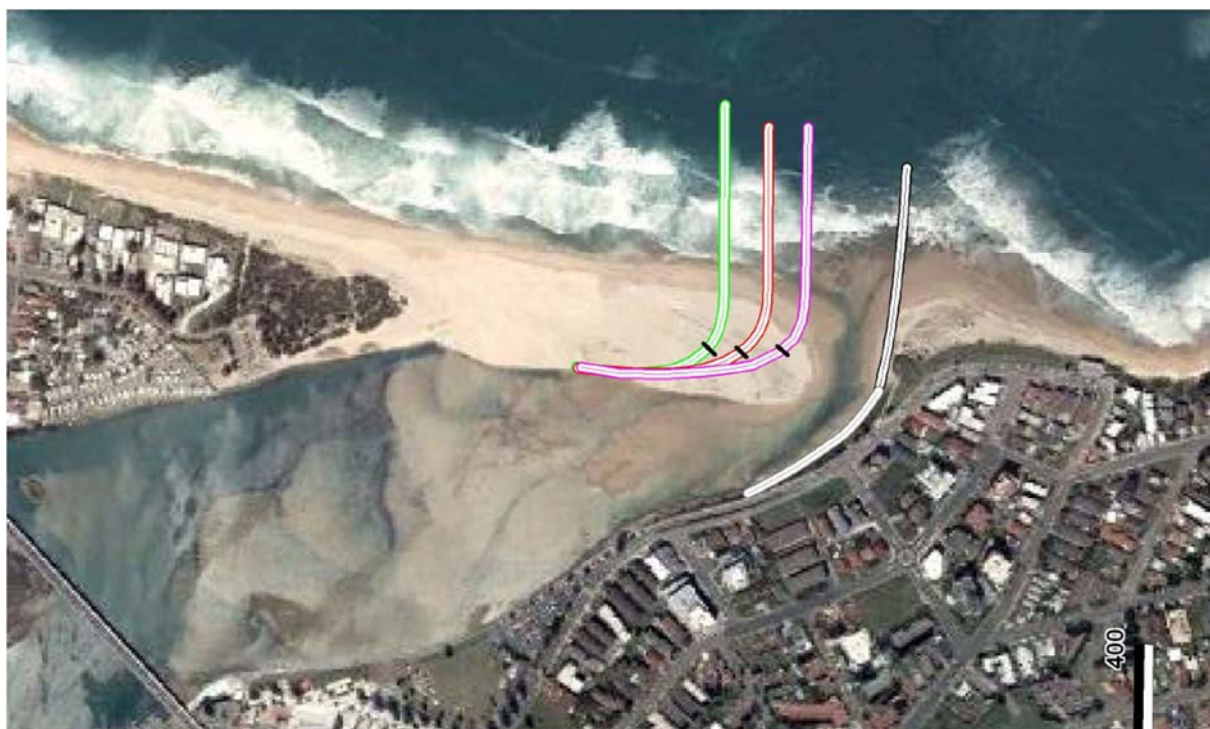
The proposed possible training walls superimposed in their approximate positions.

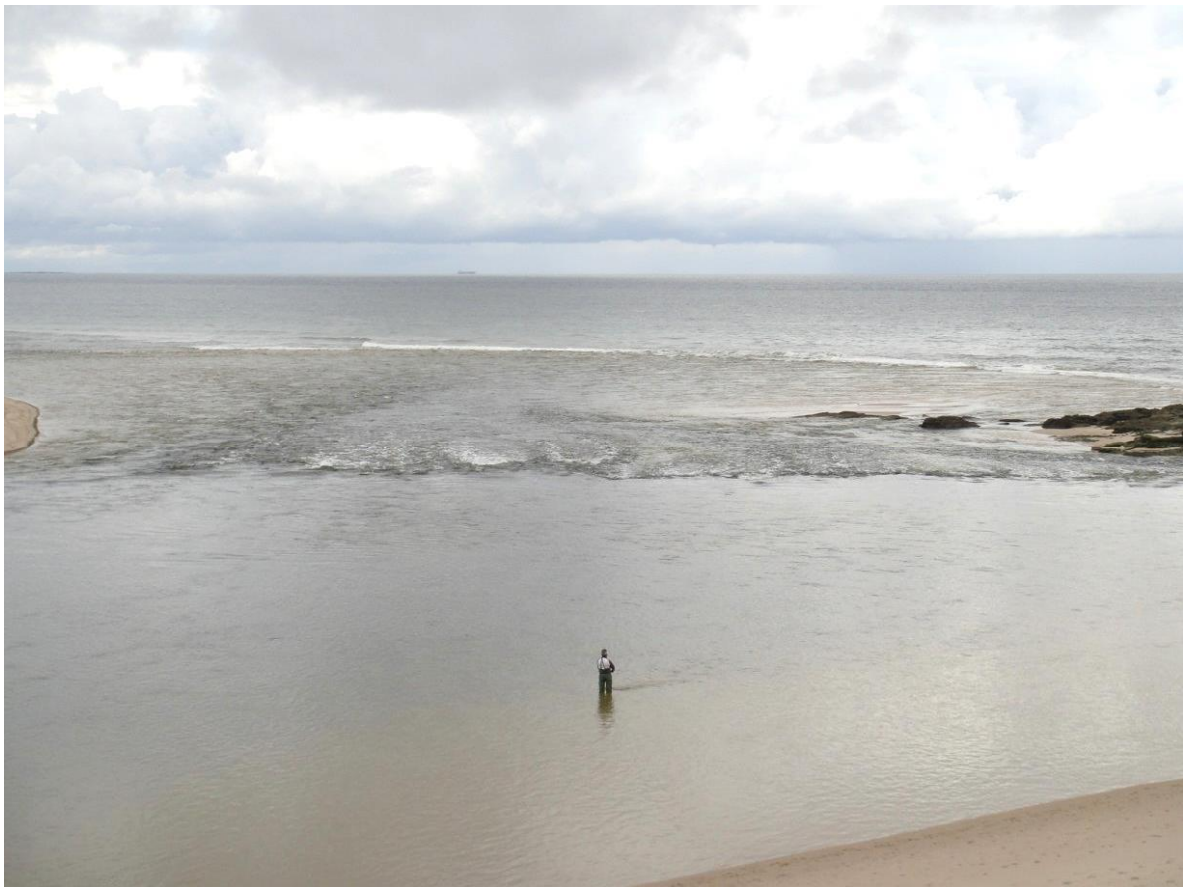
The rock shelf is evident in the foreground with the outgoing water breaking on it and the bar-way itself in the distance. This photo was taken just before low water and on an almost calm day. (Photo taken at 1415 on 9/4/13)

The base of the entry, inshore of the bar-way, is rock and at low tide has an approximate depth of 0.3m and is virtually non-navigable except by vessels such as jet skis and kayaks. The bar-way itself, the area where the outgoing water meets the sea, is also constantly

changing and shallow, and with even a moderate onshore wind and sea/swell, it would be considered dangerous should any attempt be made to navigate the entry.

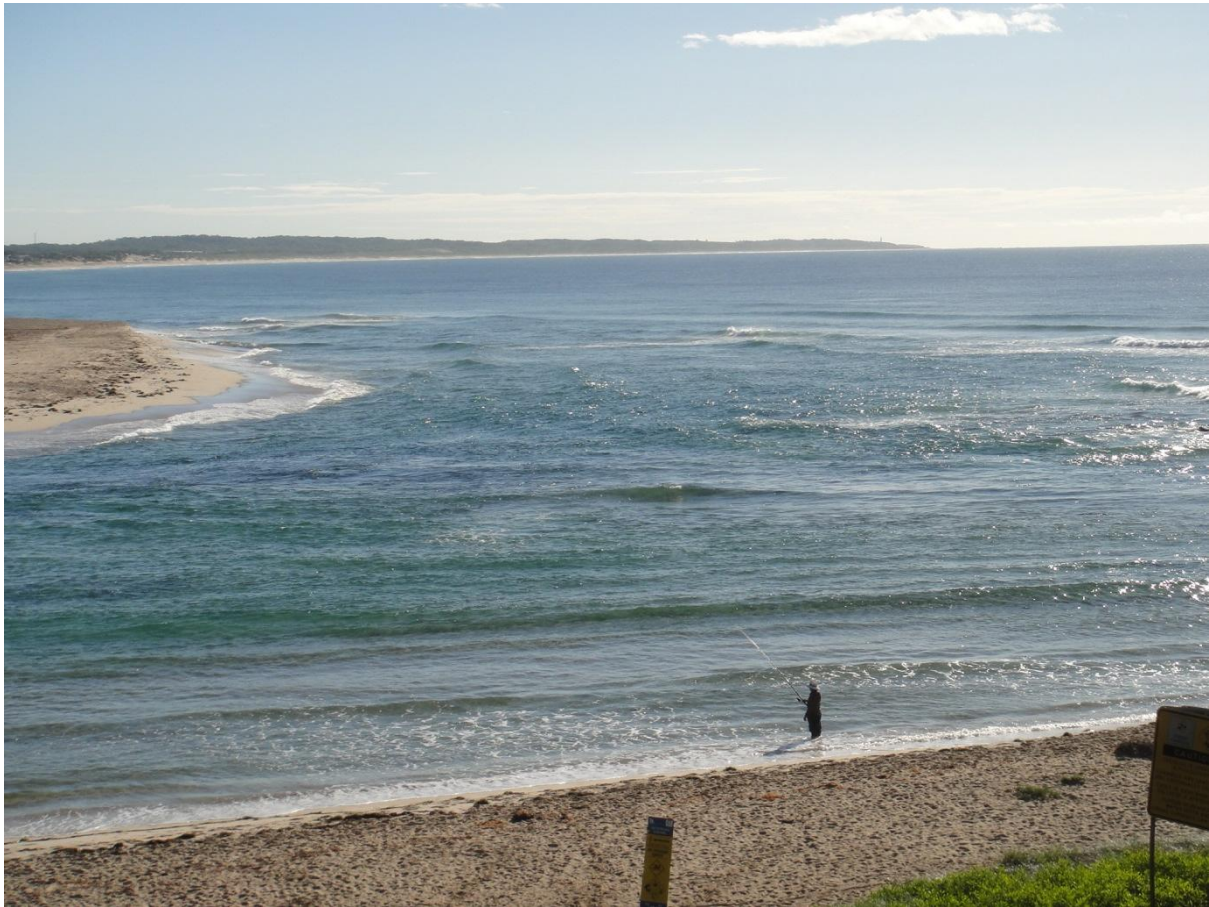
The same area at high tide. Note that the rock shelf is not evident due to the depth being approximately 1.0 to 1.5m. (Photo taken at 0815 on 10/4/13)
