Final Draft Report

# Wyong Coastal Hazard Study

October 2010

# **Wyong Coastal Hazard Study Main Report**

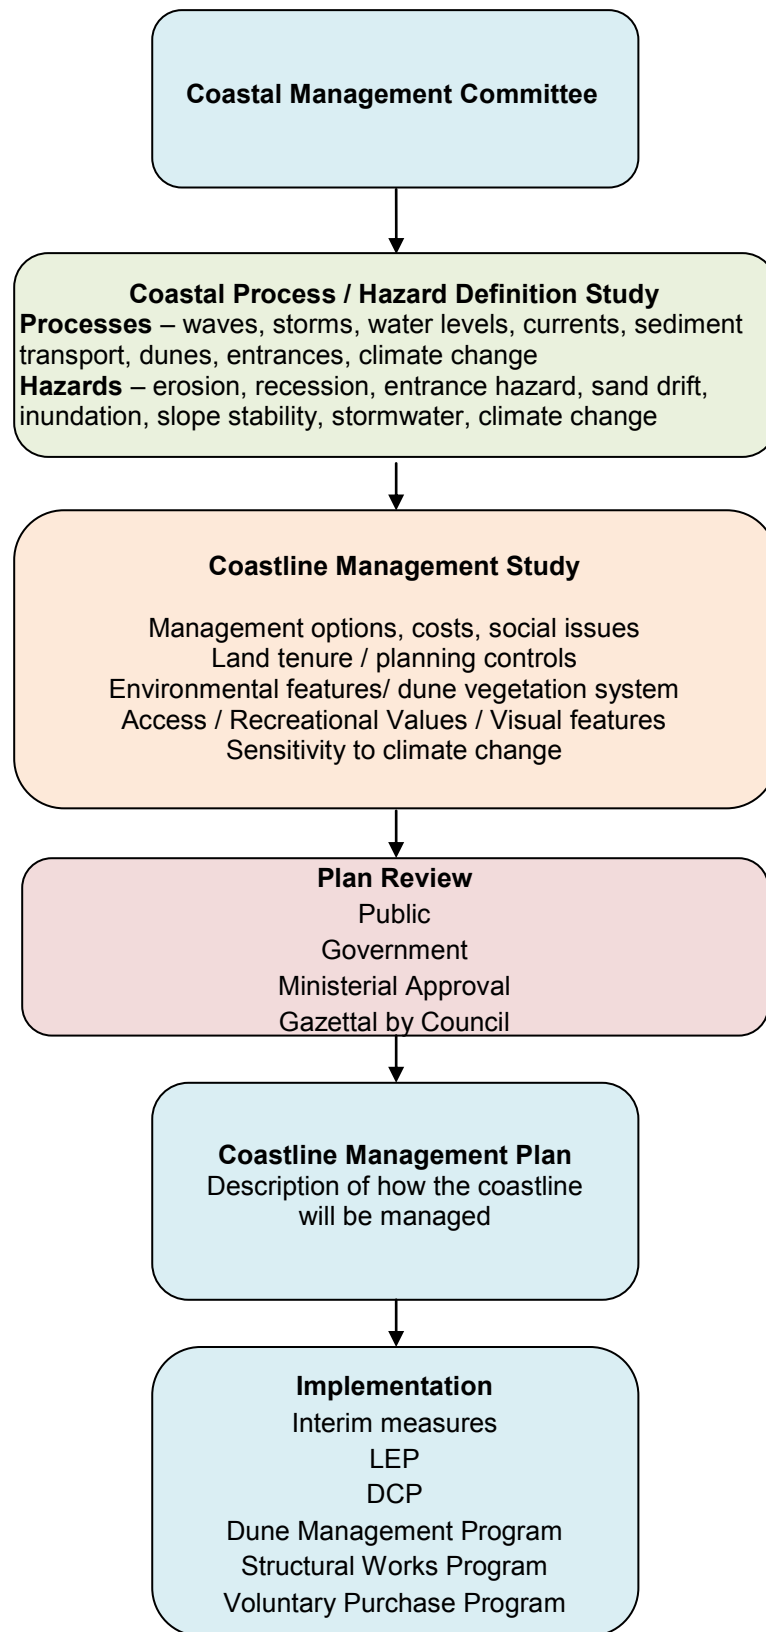
Figure 1 – The NSW Coastline Management process (NSW Government, 1990)

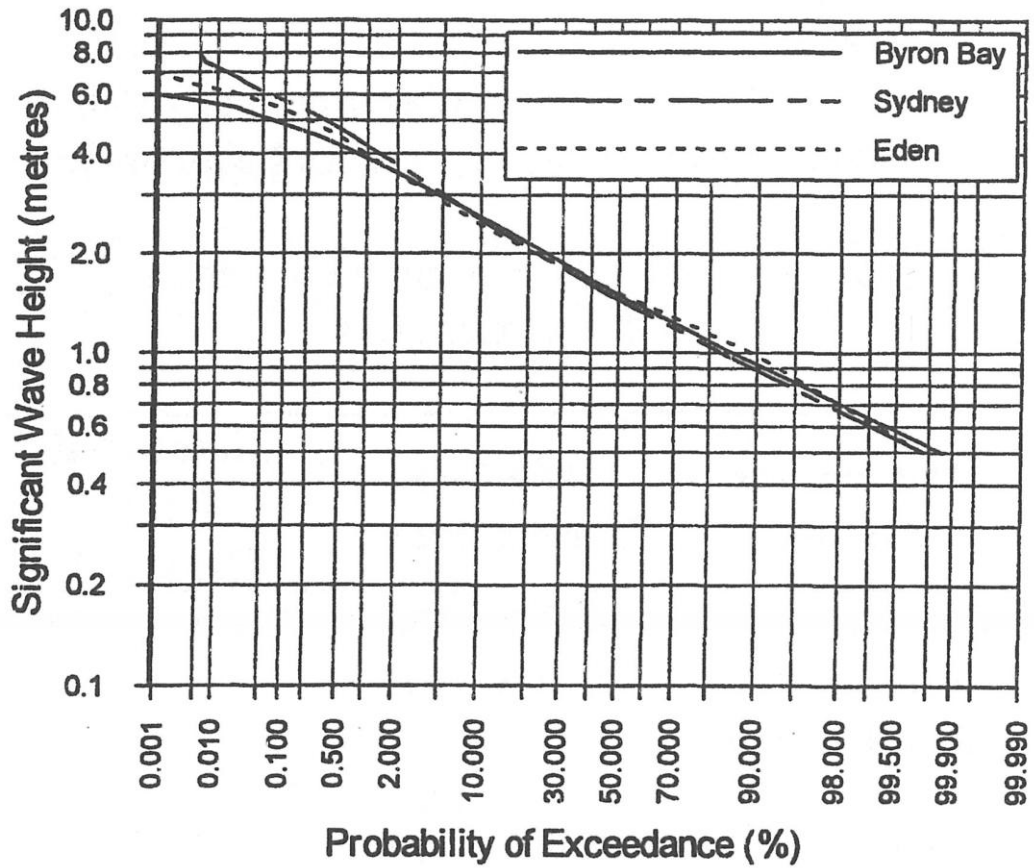
Figure 9 – Significant wave height exceedance for NSW coast (Kulmar et. al, 2005)

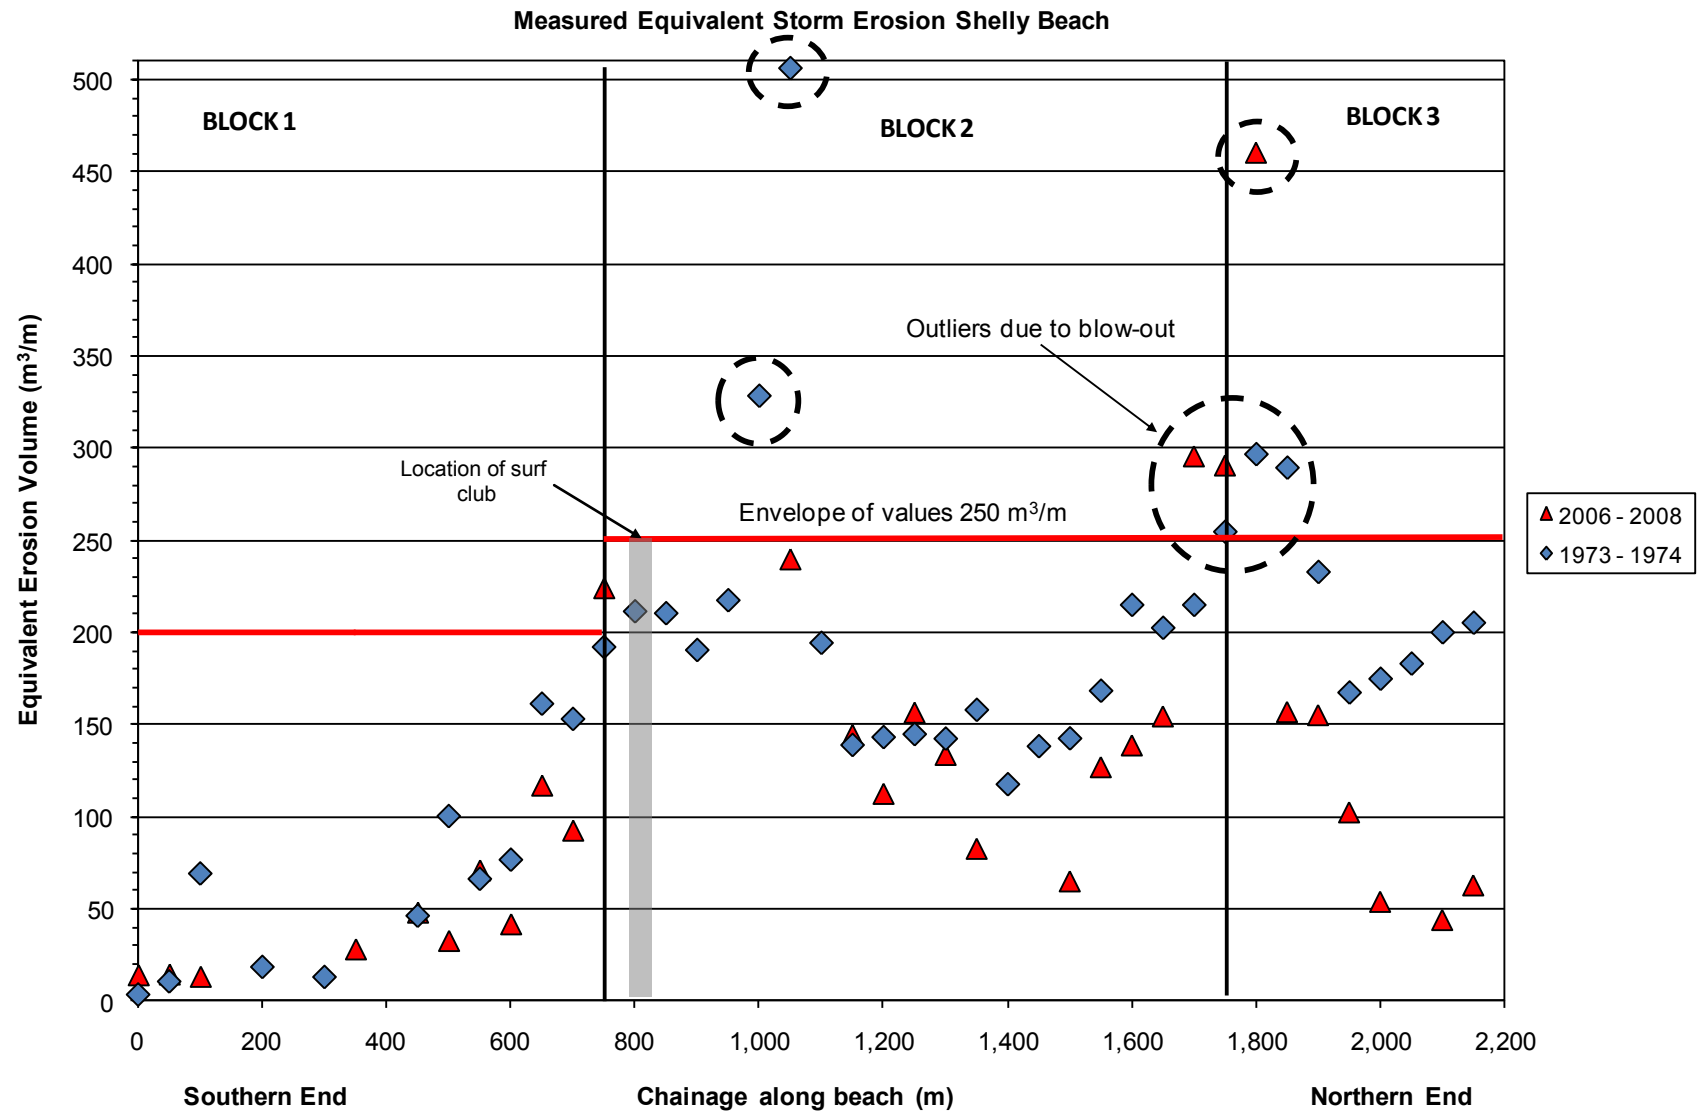
Figure 15 – Upper envelope for storm bite, Shelly Beach

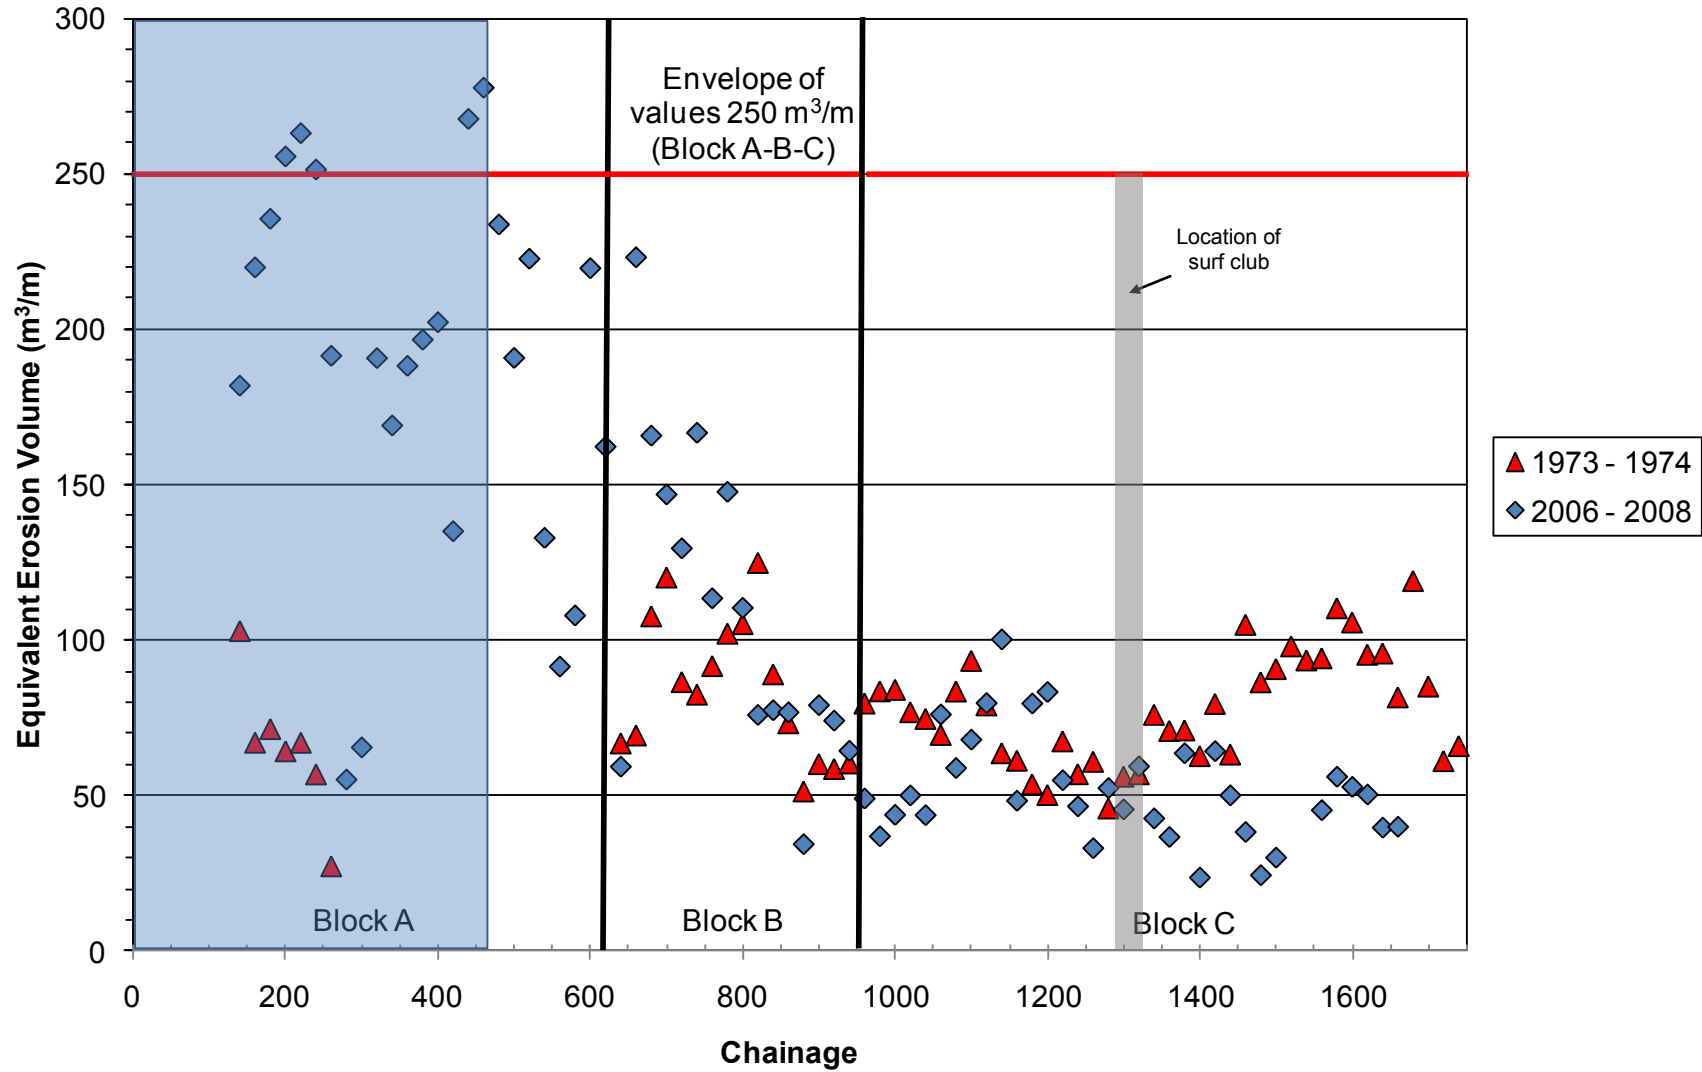
Figure 17 – Upper envelope for storm bite, North Entrance (Block A-C)

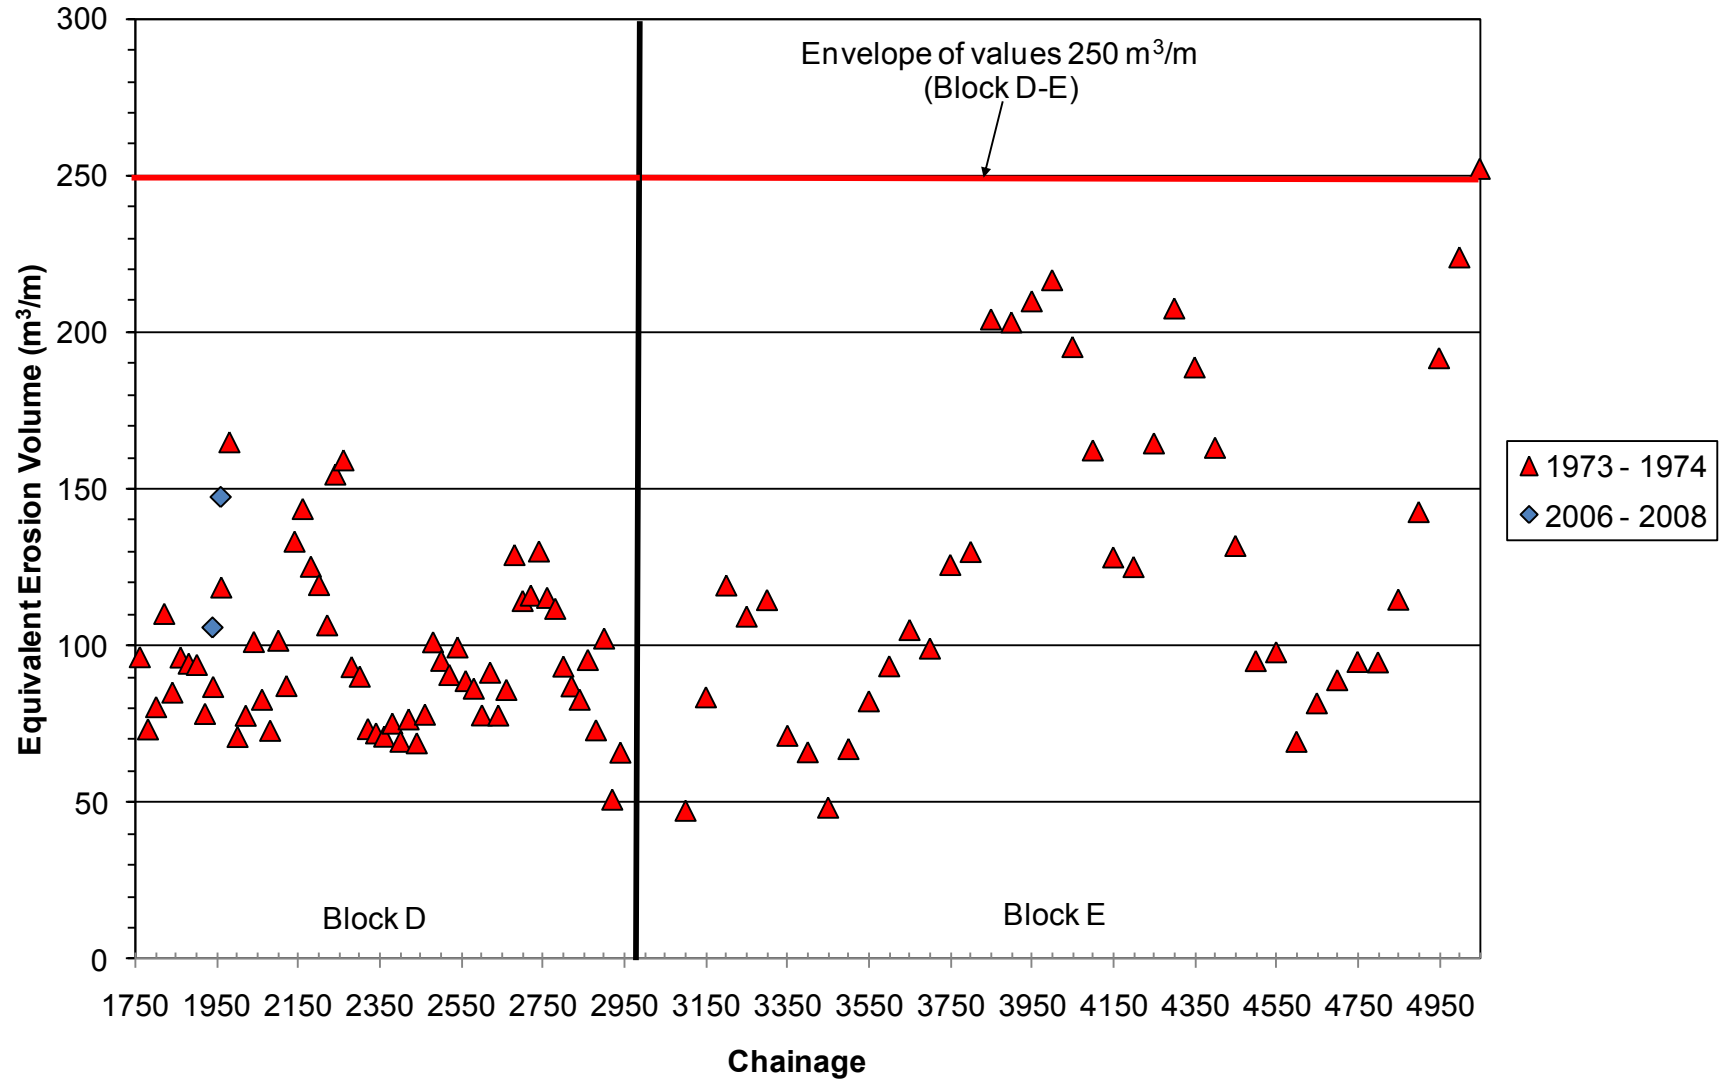
Figure 18 – Upper envelope for storm bite, North Entrance (Block D-E)

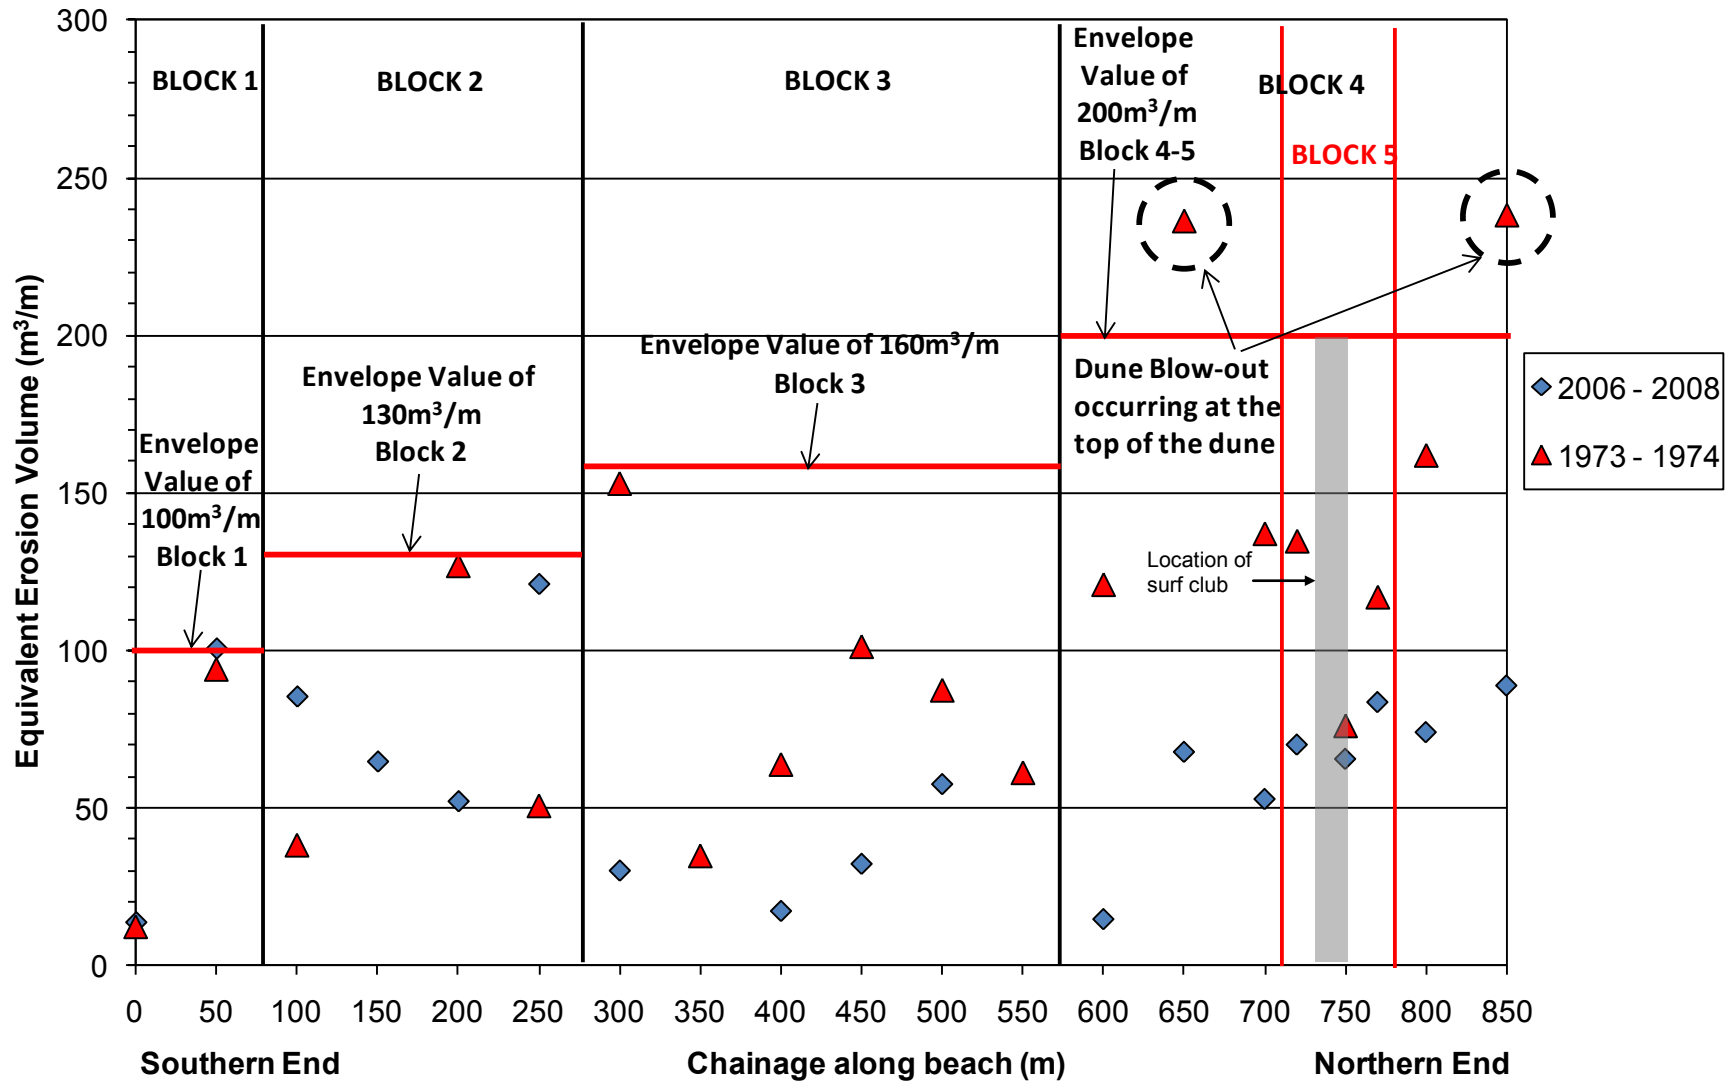
Figure 20 – Upper envelope for storm bite, Soldiers Beach

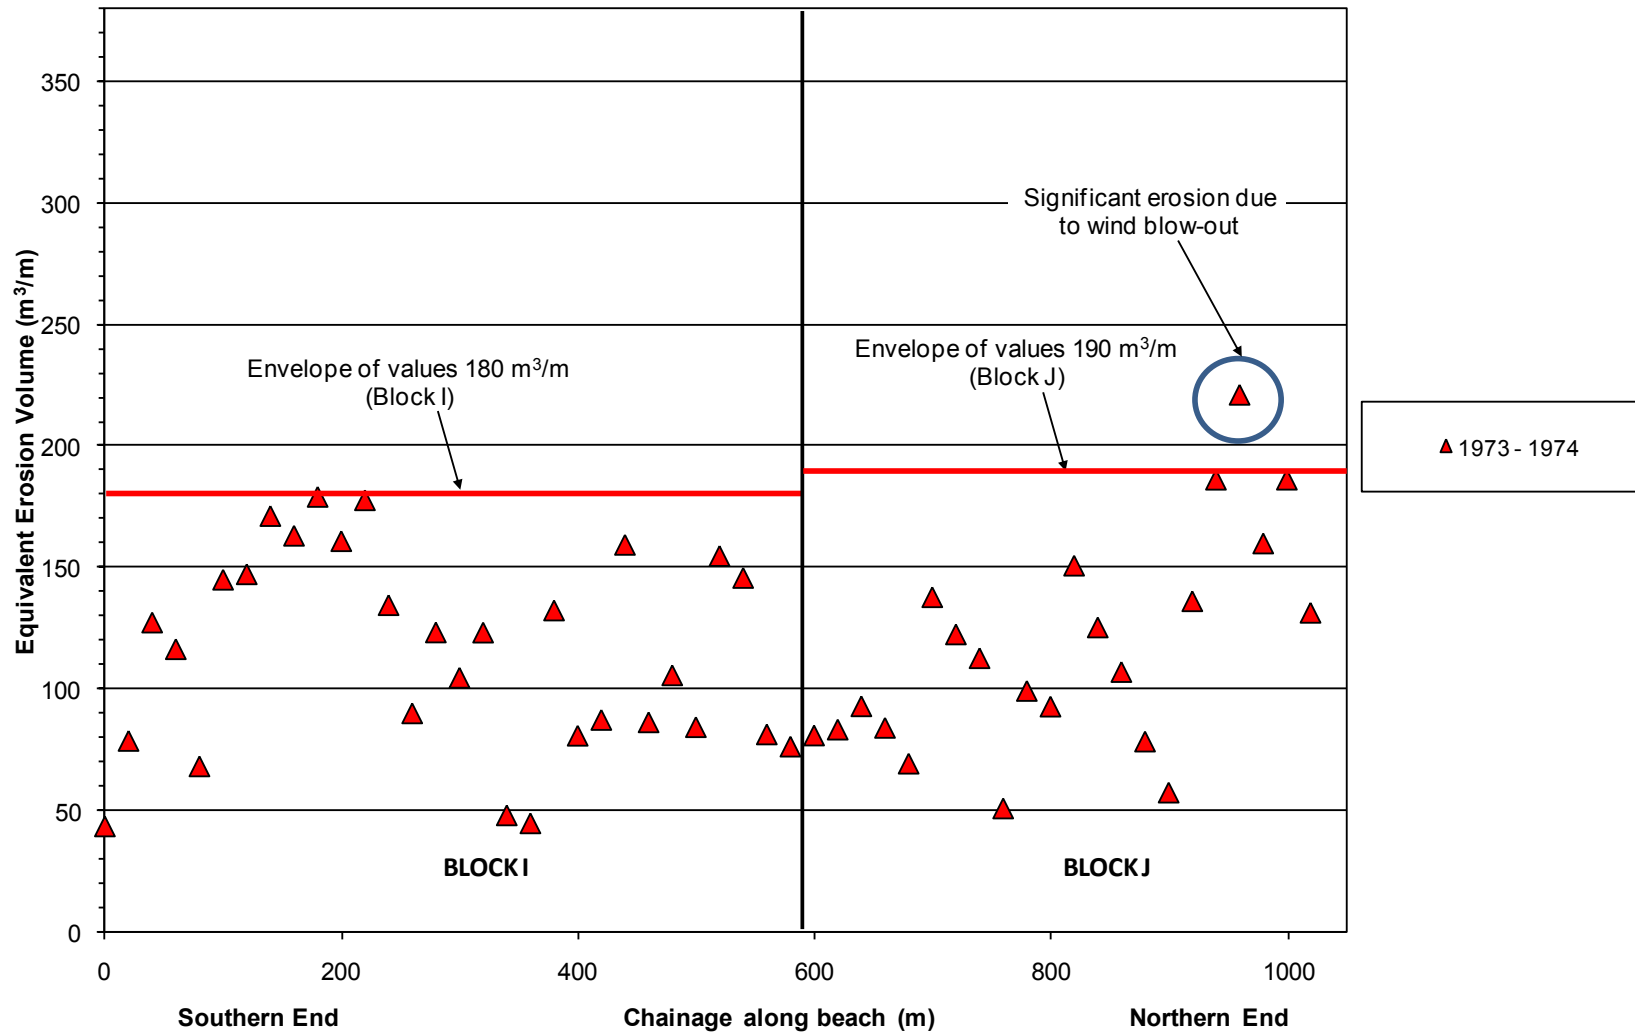
Figure 21 – Upper envelope for storm bite, Hargraves Beach

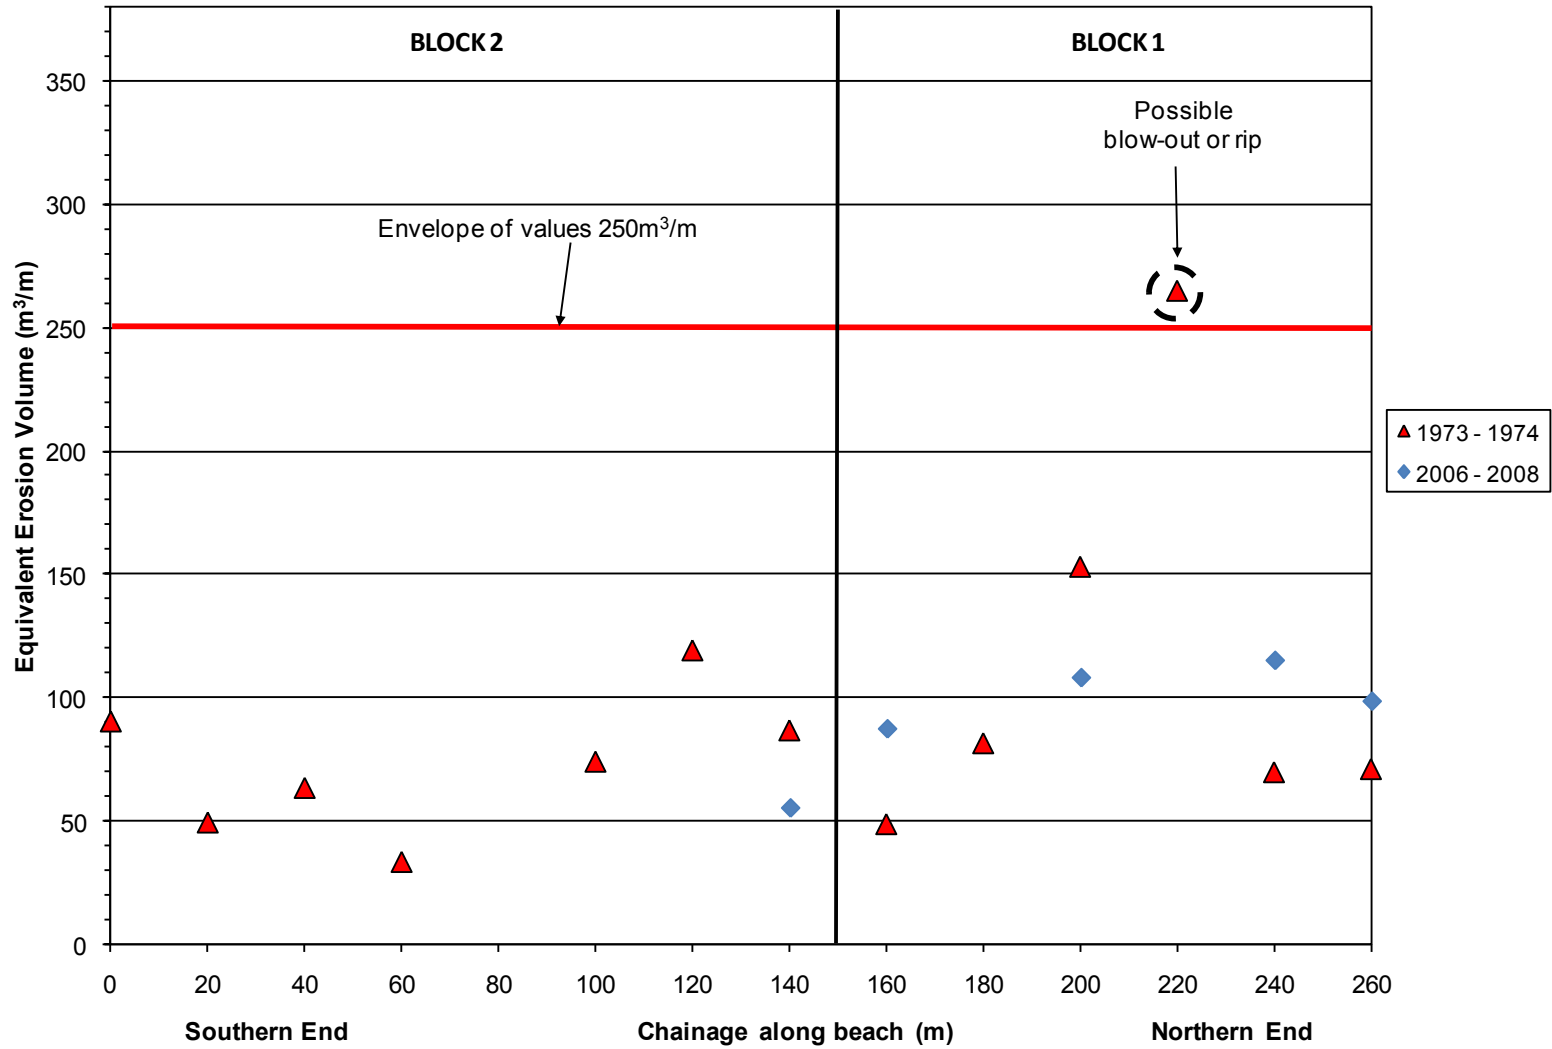
Figure 22 – Upper envelope for storm bite, Lakes Beach

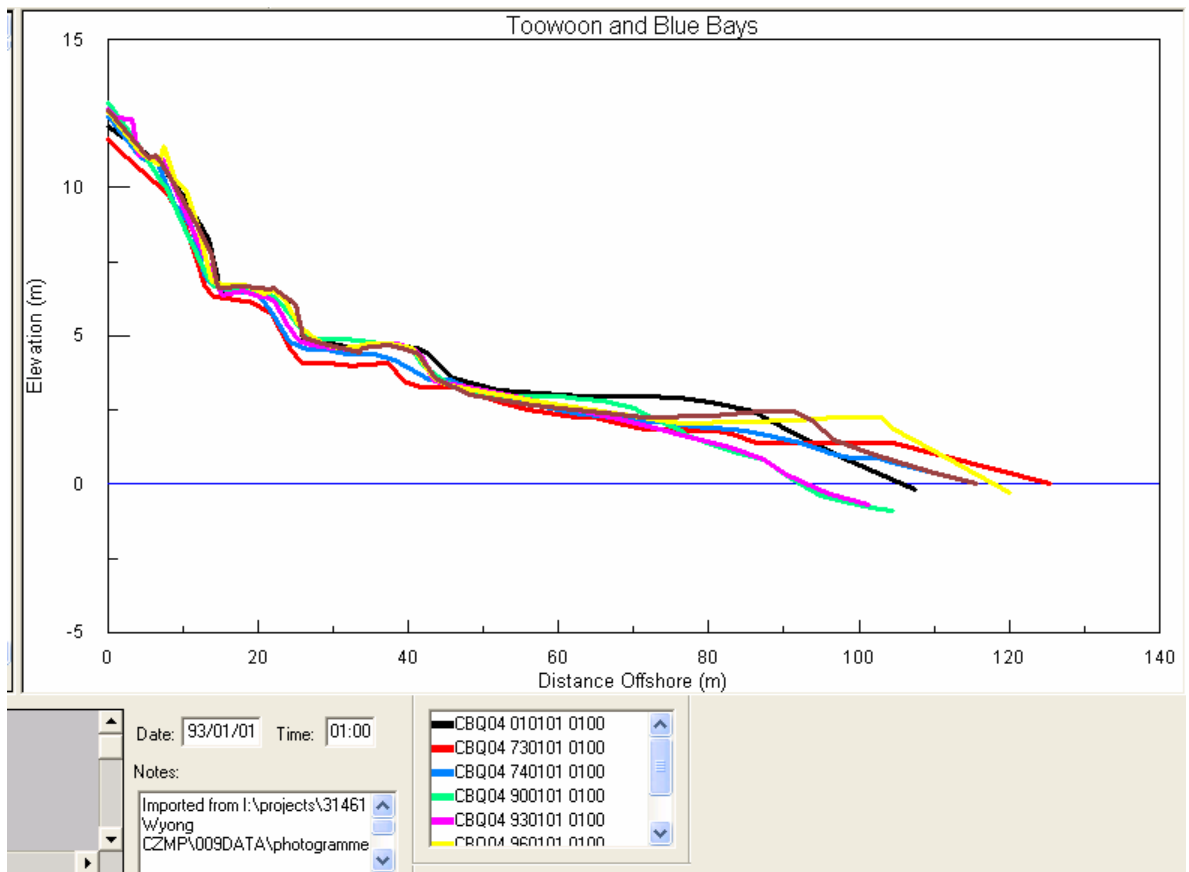
Figure B.27 – A set of profiles from Toowoon Bay, indicating datum error (red = 1973)

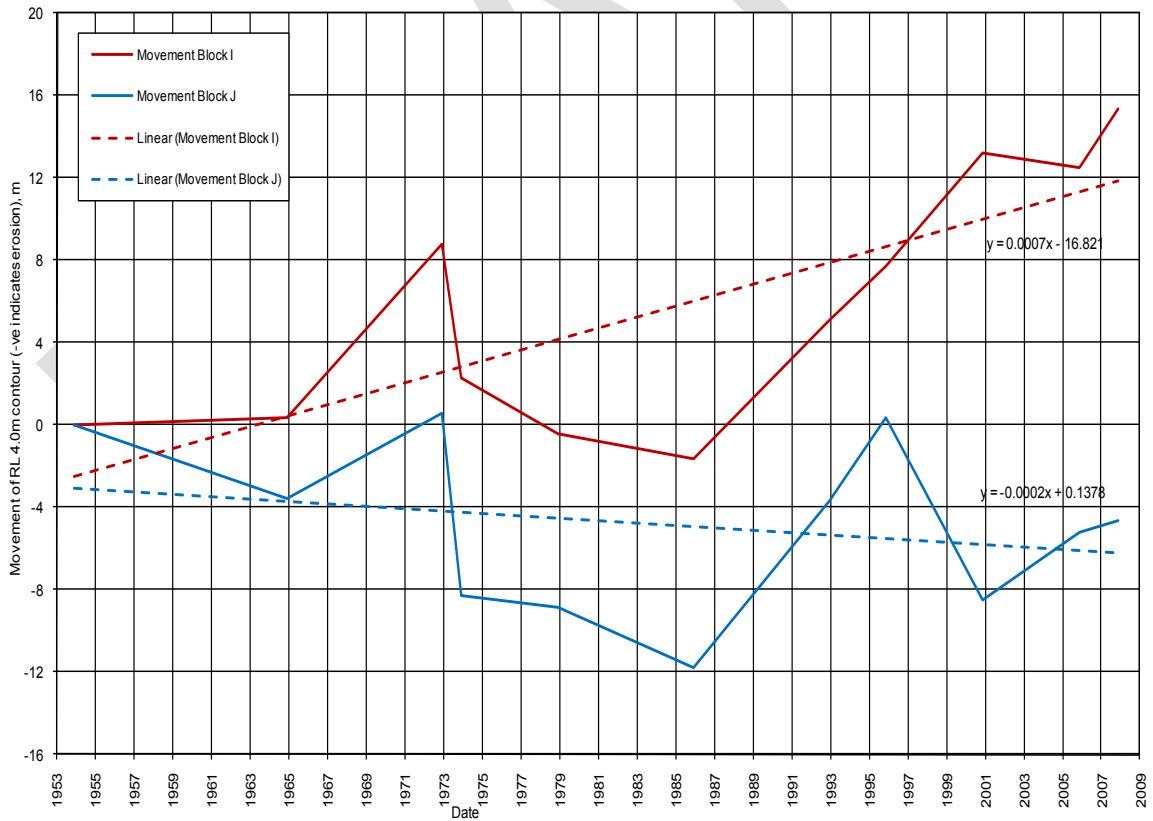
Figure B.54 – Average dune movement for, Hargraves Beach
