SITE PHOTOGRAPHS – 2004 to 2010

Wyong Coastline Study Area

C	31-05-2011	FINAL REPORT	AFS
B	21-05-2010	AMENDED NOTES, MECHANISM TITLE & IDENTIFIED SMEC STUDY AREA	AFS
A	11-05-2010	DRAFT ISSUE	AFS
REVISION	DATE	DETAILS	CHECKED
FIELDWORK:	DRAWN:	TITLE:	
SCE	WH	RECESSION MECHANISMS: INDURATED SANDS	
CHECKED:		COASTAL HAZARD MANAGEMENT STUDY	
DATE:		CLIENT:	
05-05-2010		WYONG SHIRE COUNCIL

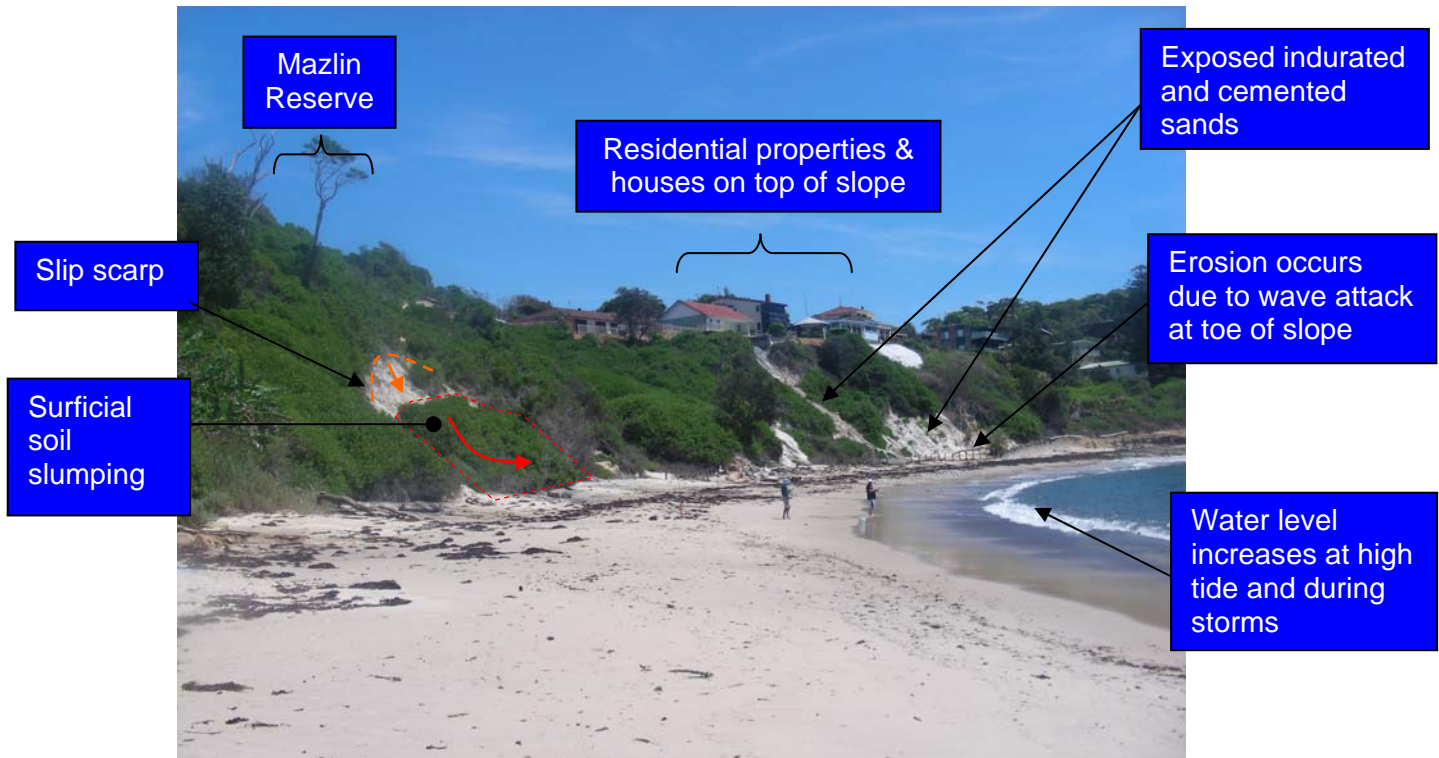
P1: Mechanism A – Indurated Sands.
Map Area G11: Toe erosion & progressive surficial soil slumping.

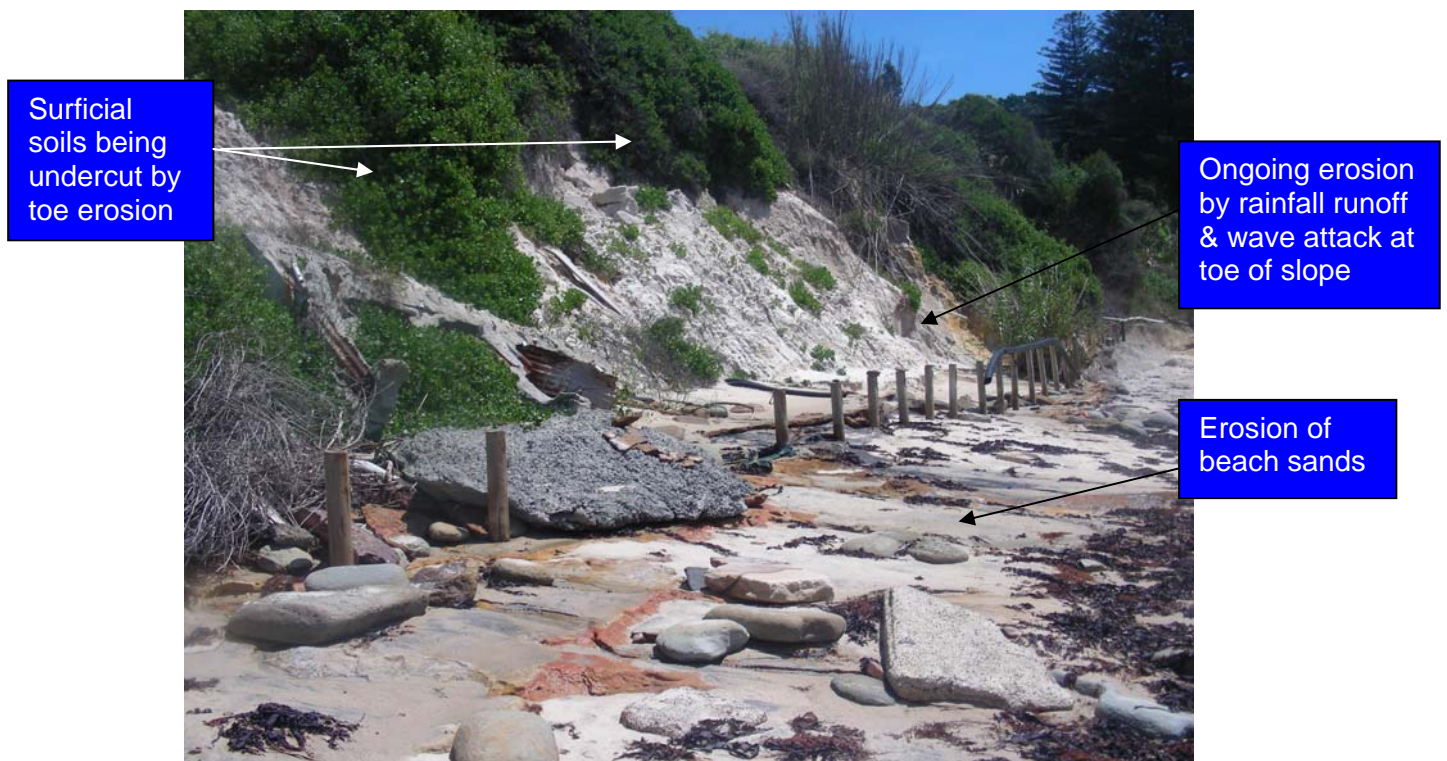
P2: Mechanism A – Indurated Sands.
Map Area G11: Toe erosion & progressive surficial soil slumping.

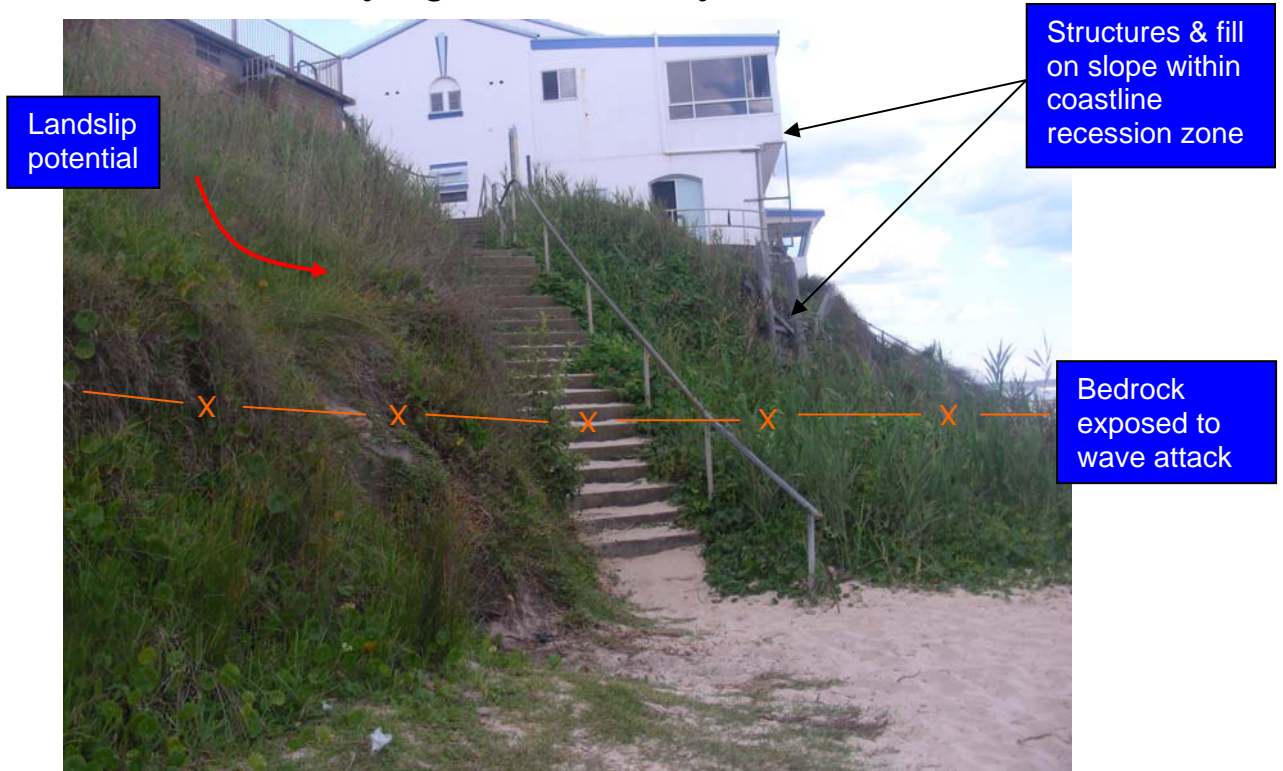
P3: Mechanism B – Soil & Fill Creep on Slopes.
Map Area G6: Land instability occurring in fill & soil slope above Patonga Claystone bedrock in coastline recession zone.

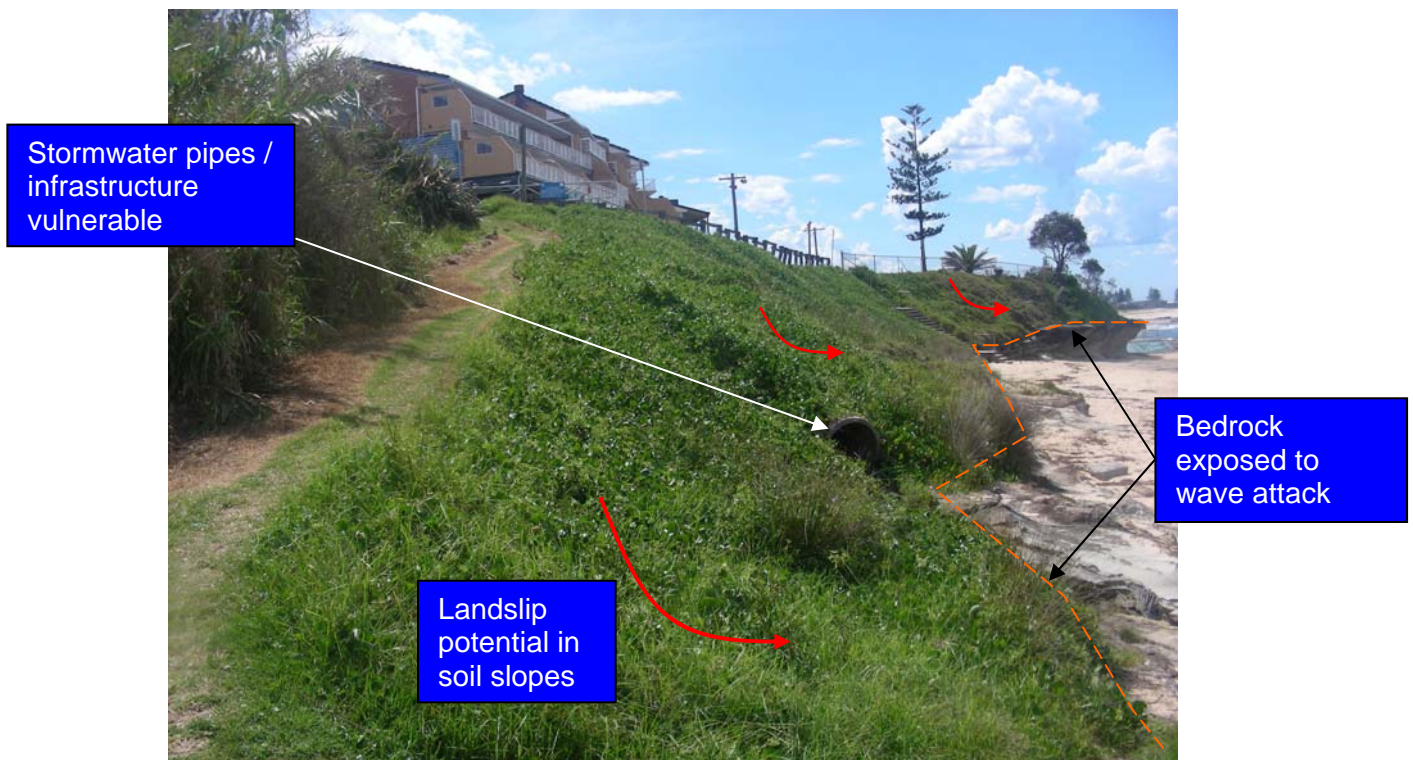
P4: Mechanism B – Soil & Fill Creep on Slopes.
Map Area G6: Land instability occurring in fill & soil slope above Patonga Claystone bedrock in coastline recession zone.

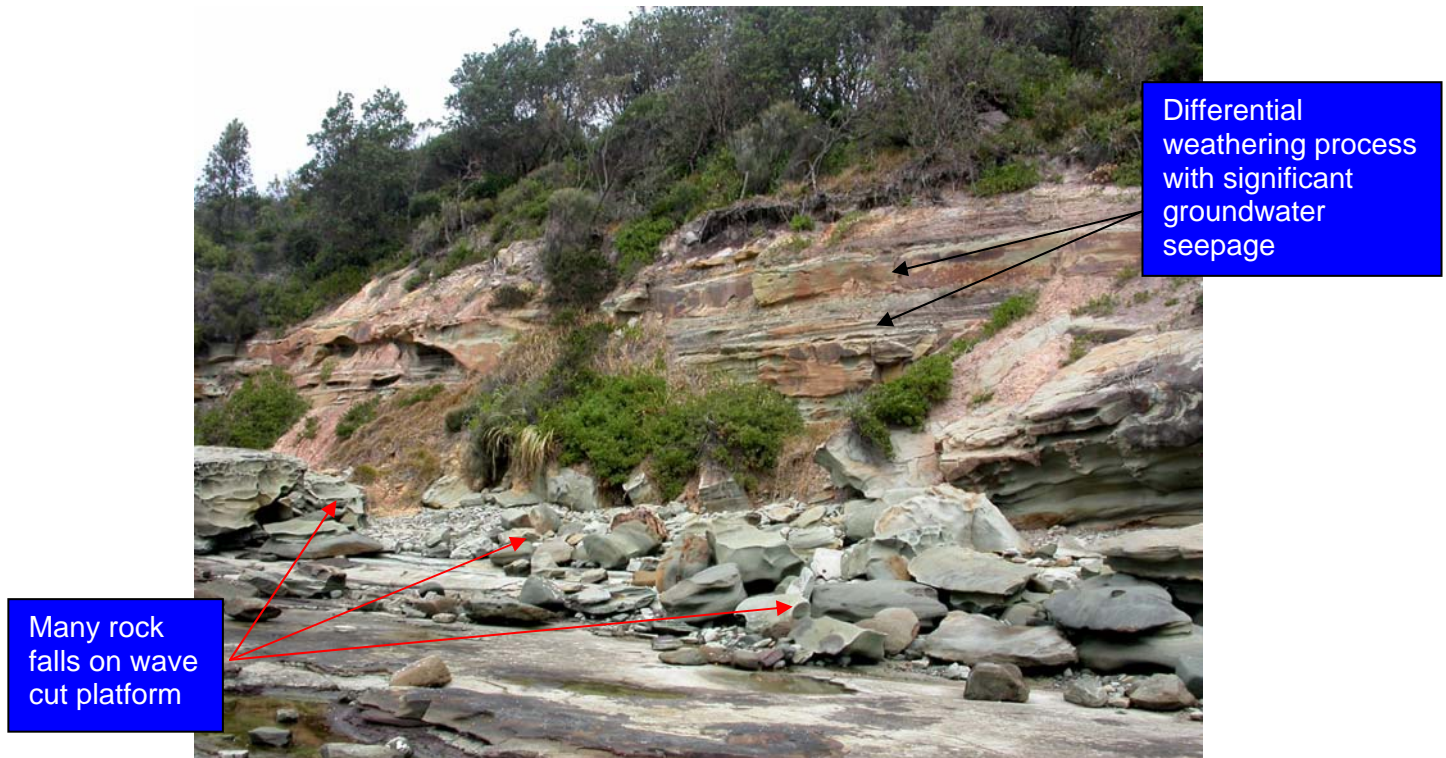
P5: Mechanism C – Rock Block / Differential Weathering.
Map Areas G2 / G3: Sandstone rock falls due to ongoing differential weathering of claystone / softer bands within Patonga Claystone.

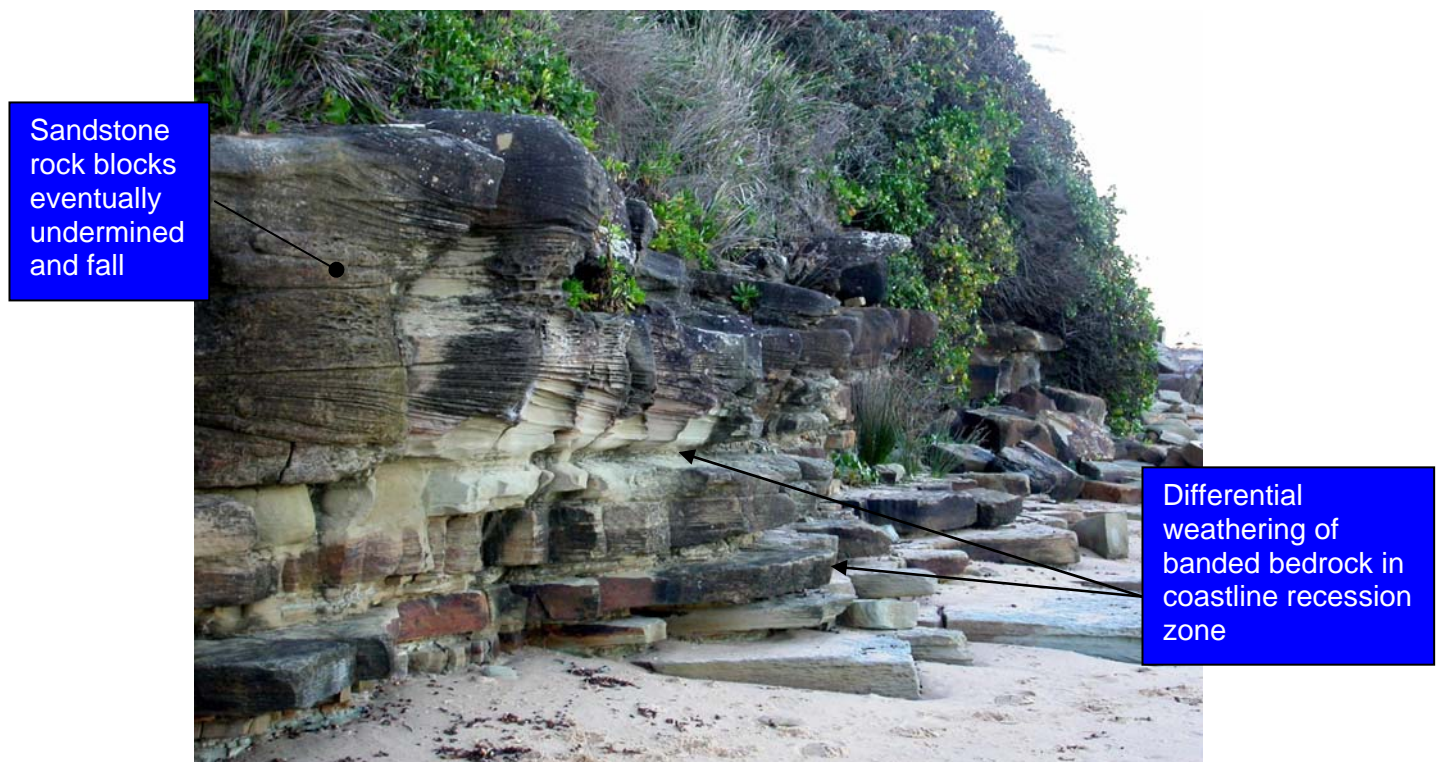
P6: Mechanism C – Rock Block / Differential Weathering.
Map Area G5: Sandstone rock falls due to ongoing differential weathering of claystone / softer bands within Patonga Claystone.

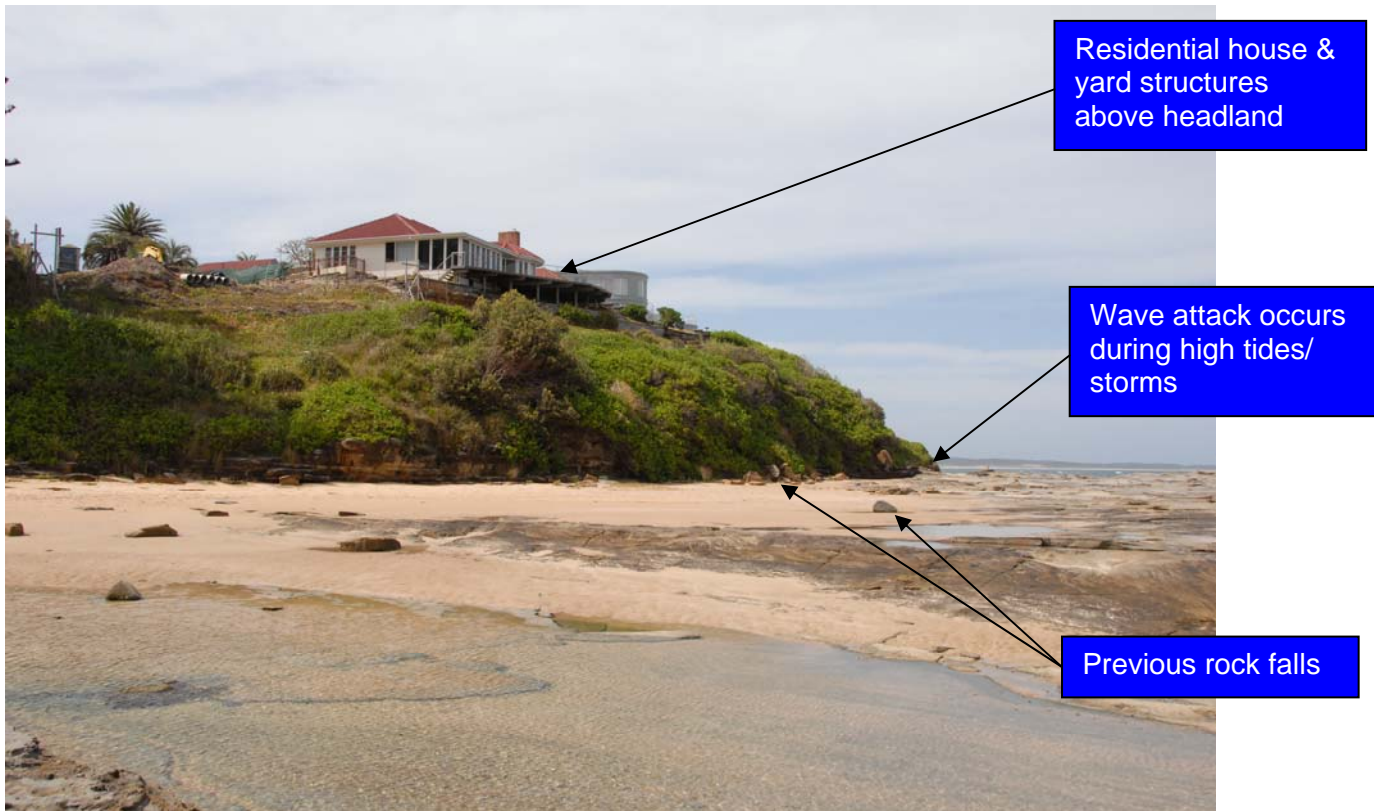
P7: Mechanism C – Rock Block / Differential Weathering.
Map Area G5: Sandstone rock falls due to ongoing differential weathering of claystone / softer bands within Patonga Claystone.

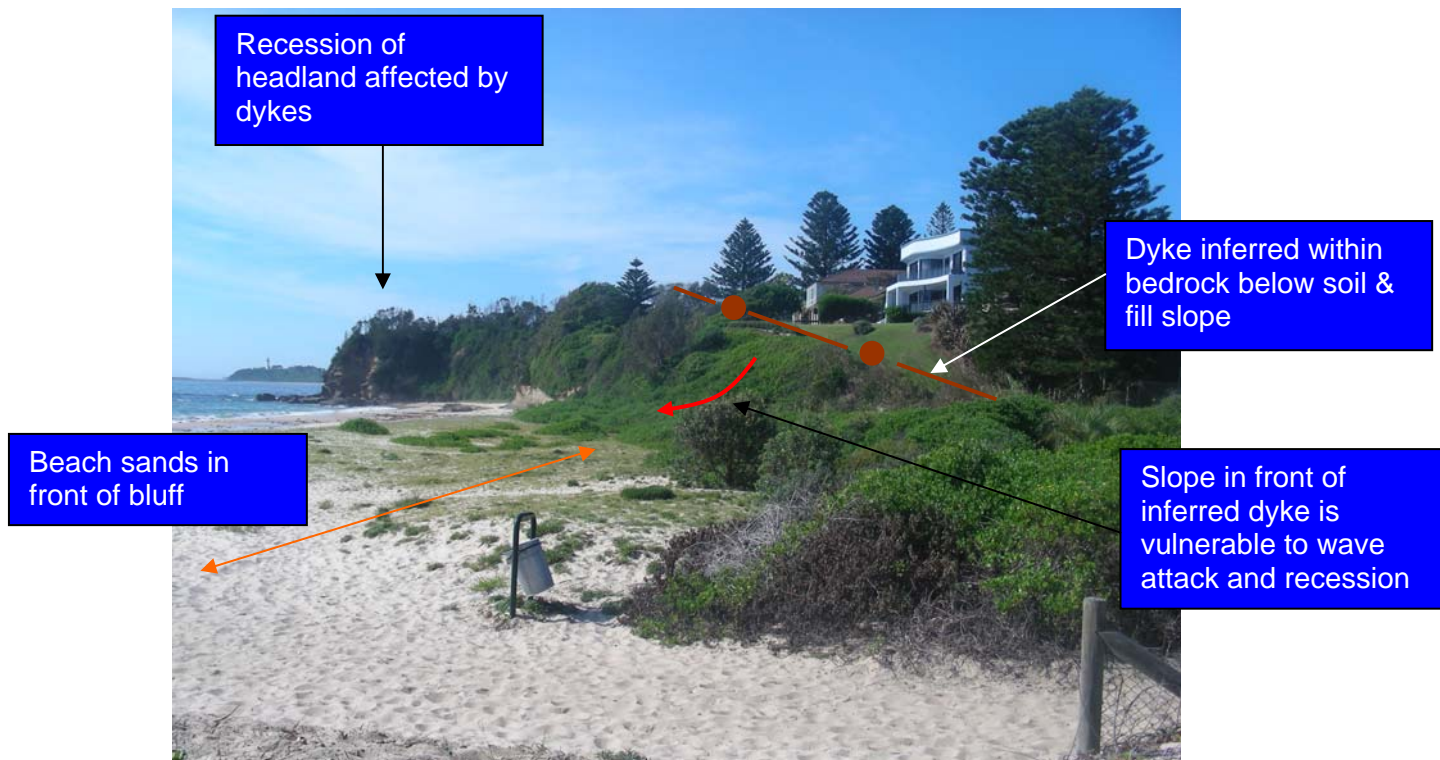
P11: Mechanism D – Dyke Influenced Rock Recession
Map Area G12: Sandstone bedrock undercut & rock falls near dyke.

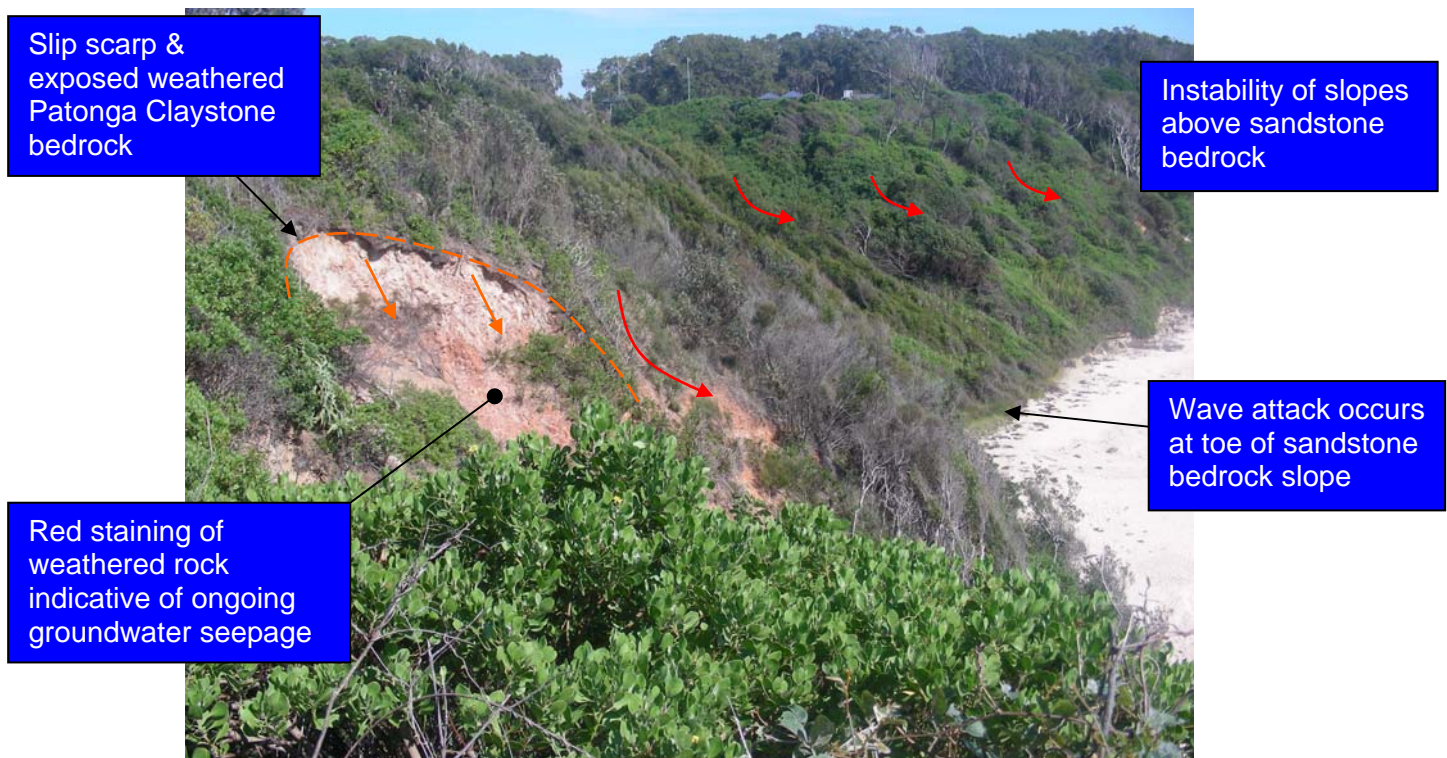
P14: Mechanism E – Instability of Weathered Rock / Soil Slope.
Map Area G12: Patonga Claystone weathered rock / residual soil slope instability, over Tuggerah Formation in coastline recession zone.

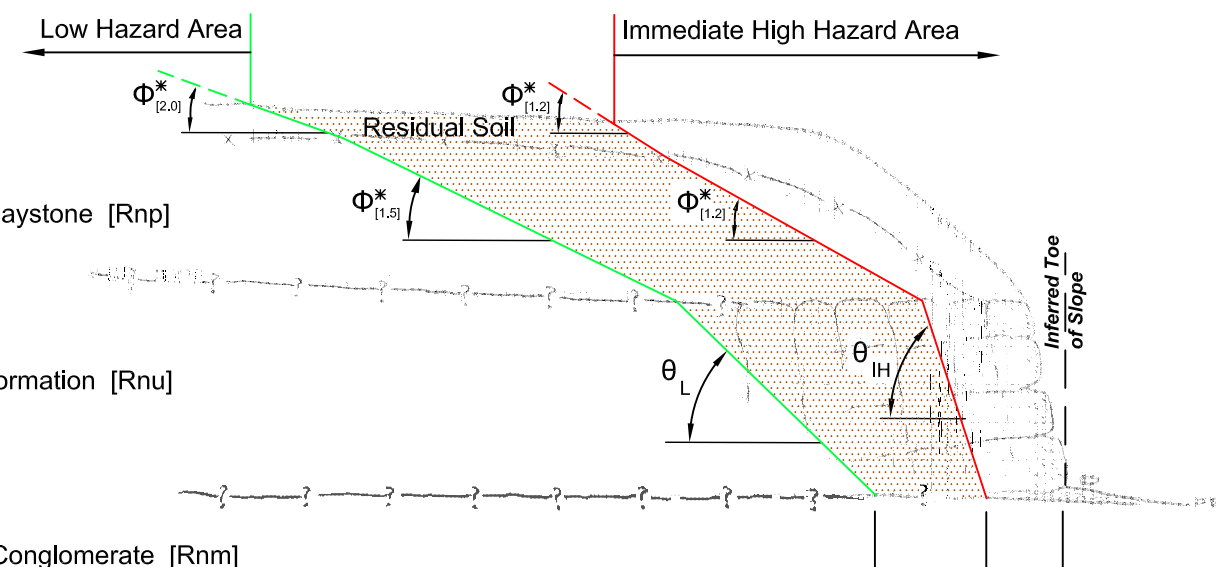
MECHANISM "E"

1.5 x Typical Joint
Spacing [i.e. 6 m]

1 x Typical Joint
Spacing [i.e. 4 m]

θ_L or θ_{IH} = The Angle of Influence of Coastline Recession Processes in the Tuggerah Formation. The Subscript Denotes the Low or Immediate High Hazard Line.
