Brisbane Water Estuary Management Study

J2717/R2471/V3 October 2010

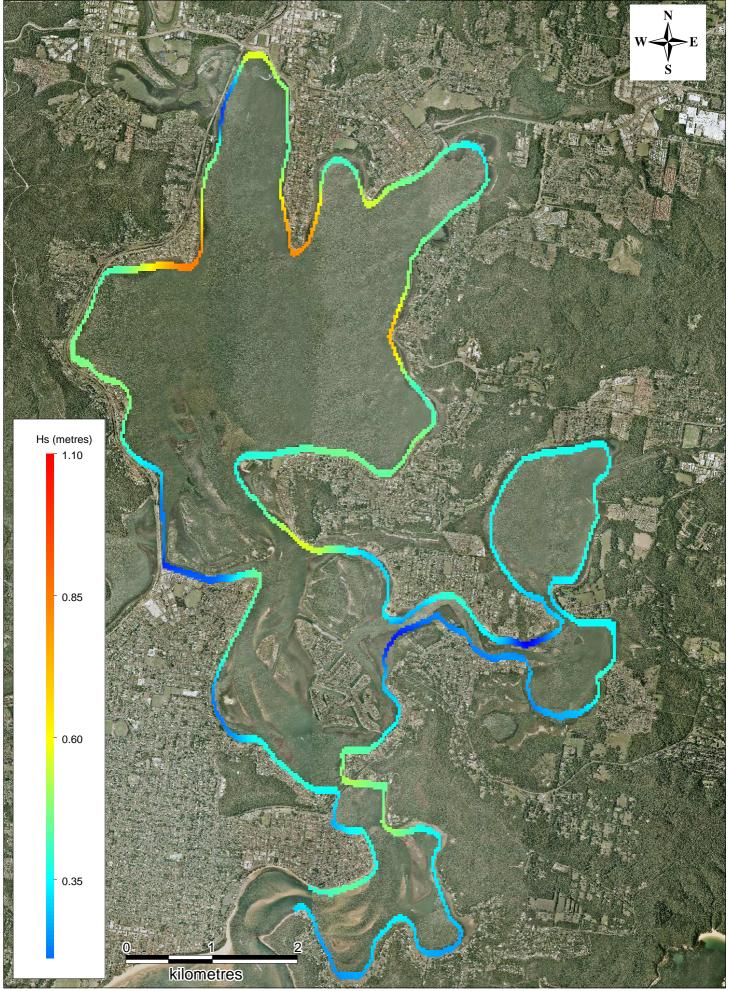
FIGURE 4.6 5YR ARI FORESHORE WAVE CONDITIONS LOCAL SEA DOMINATED AREAS

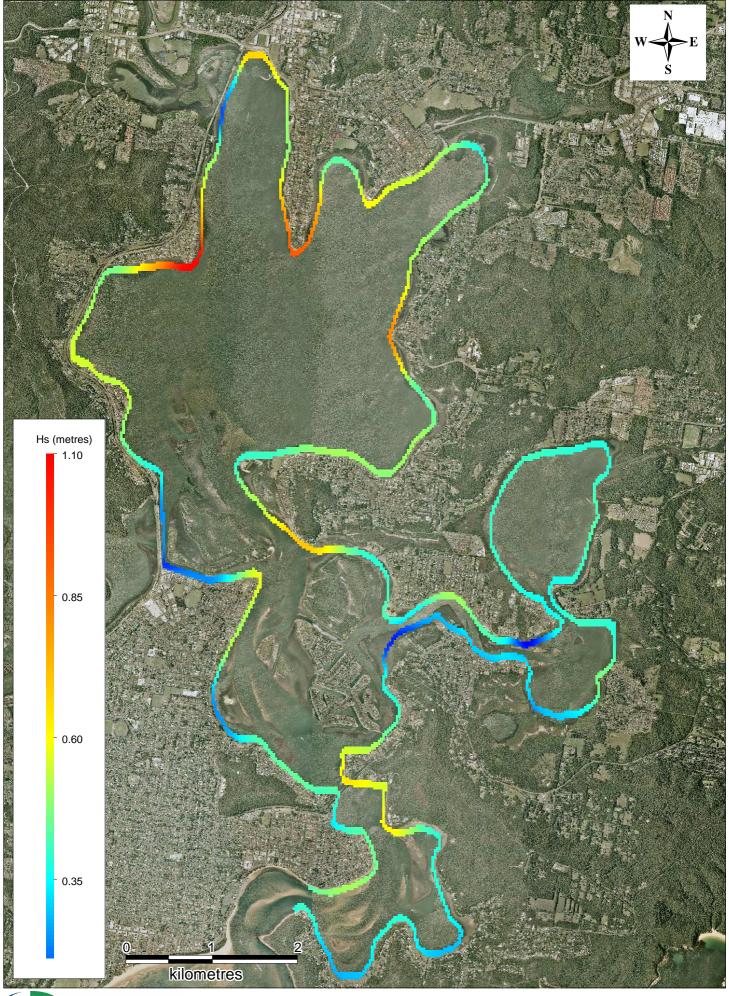
FIGURE 4.7 100YR ARI FORESHORE WAVE CONDITIONS LOCAL SEA DOMINATED AREAS

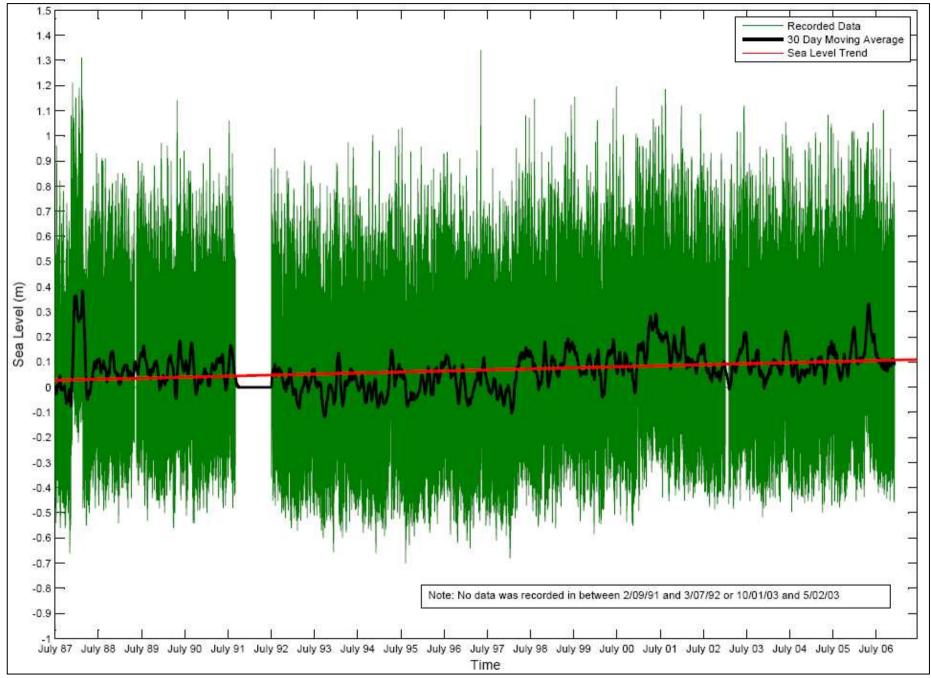
FIGURE 4.13 ETTALONG GAUGE HISTORIC WATER LEVEL ANALYSIS

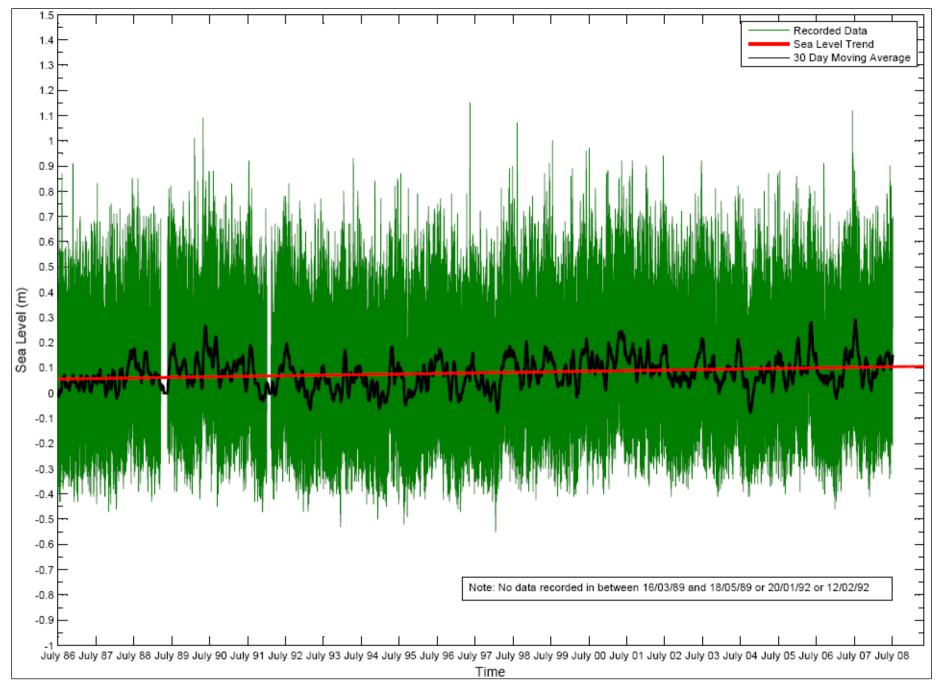
FIGURE 4.14 KOOLEWONG GAUGE HISTORIC WATER LEVEL ANALYSIS

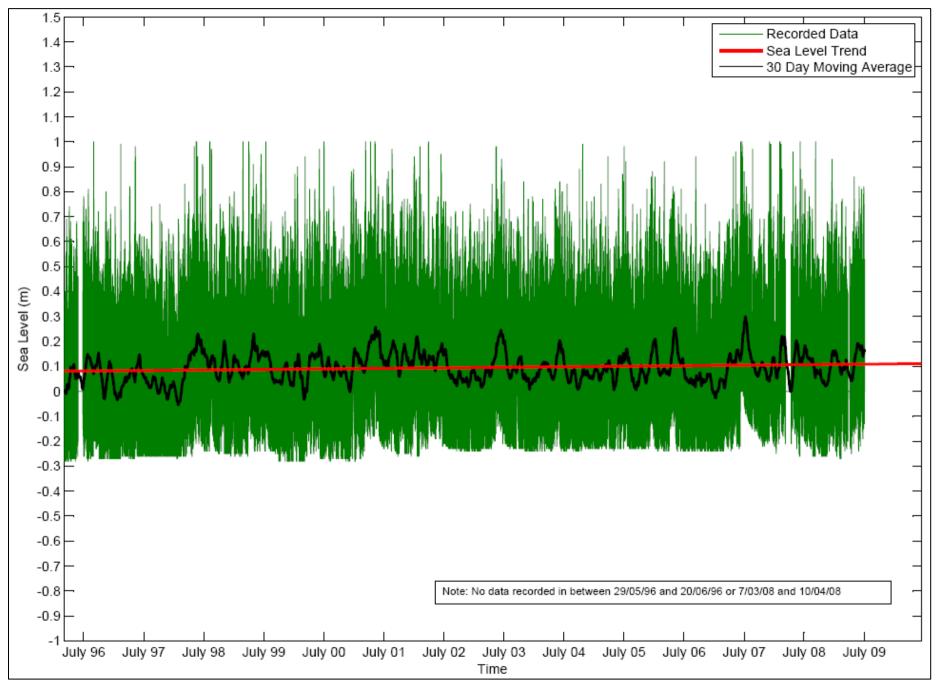
FIGURE 4.15 MANNS ROAD GAUGE HISTORIC WATER LEVEL ANALYSIS

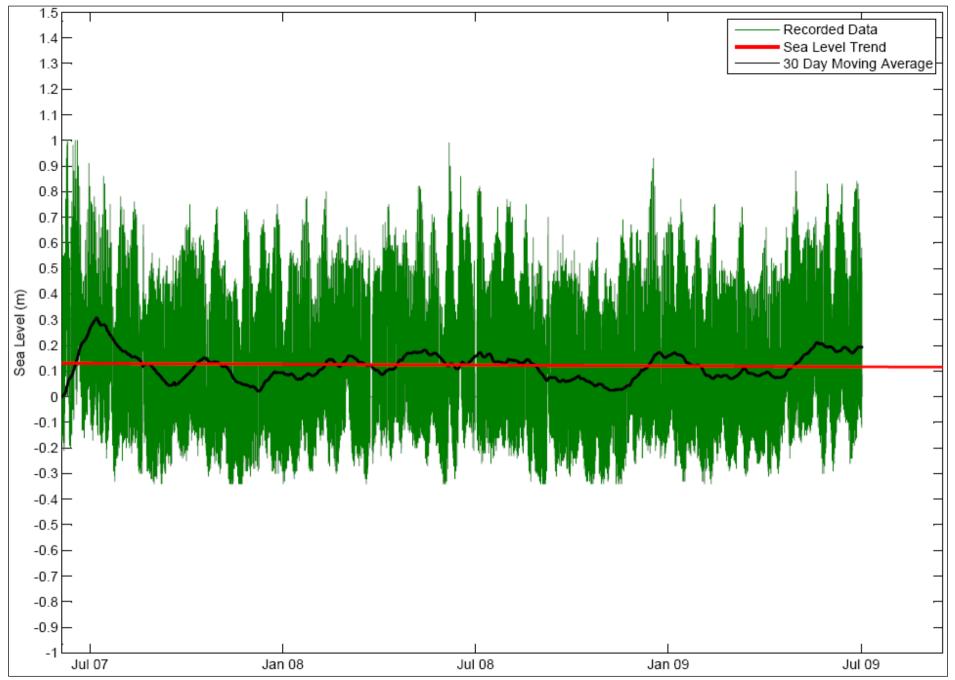
FIGURE 4.16 NEW BRIDGE, ERINA CREEK, GAUGE HISTORIC WATER LEVEL

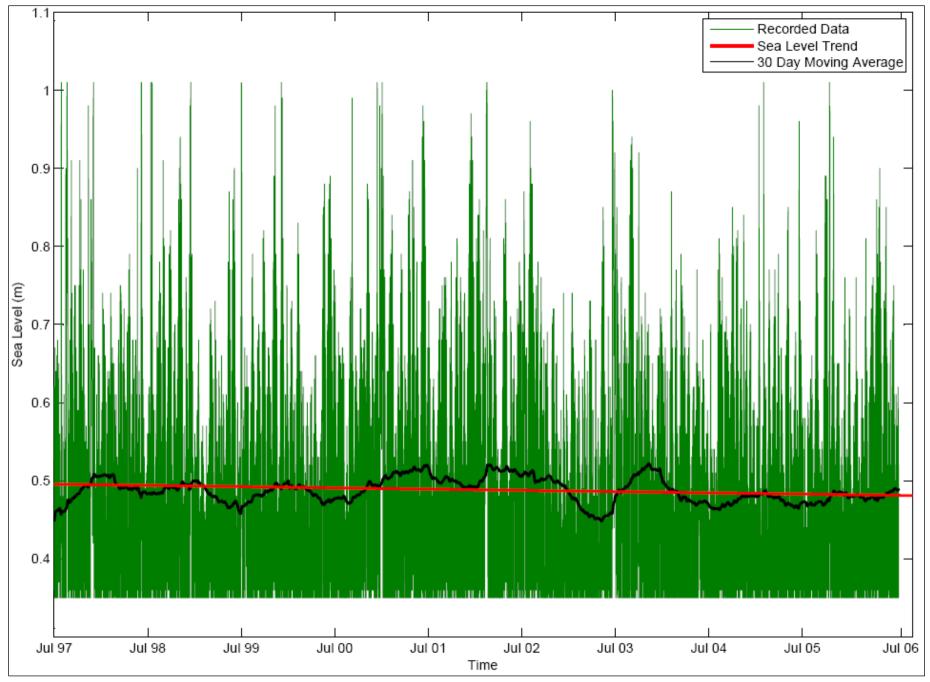
FIGURE 4.17 OLD BRIDGE, ERINA CREEK, GAUGE HISTORIC WATER LEVEL

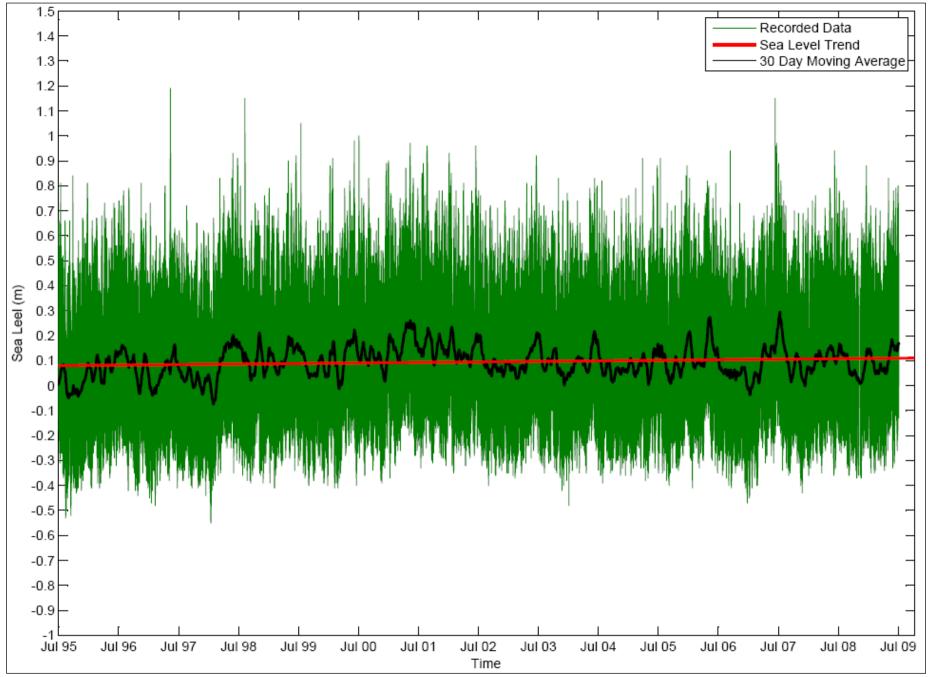
FIGURE 4.18 PUNT BRIDGE GAUGE HISTORIC WATER LEVEL ANALYSIS

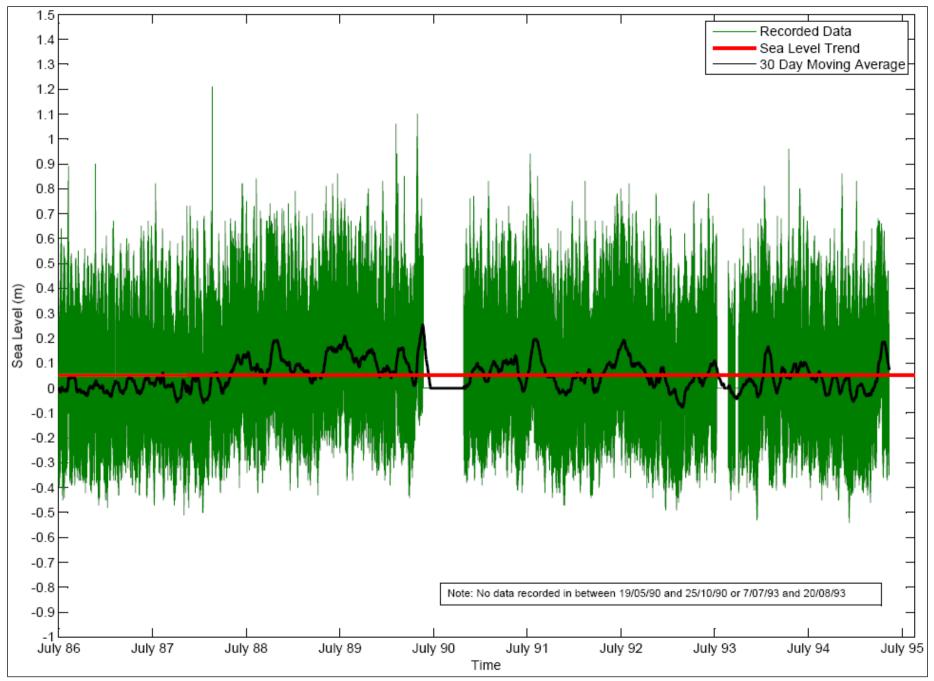
FIGURE 4.19 WHARF STREET GAUGE HISTORIC WATER LEVEL ANALYSIS
