Tuggerah Lakes Entrance Management Study: Stage 1 Review of Previous Studies

Report MHL2781
April 2021

Prepared for:
Central Coast Council

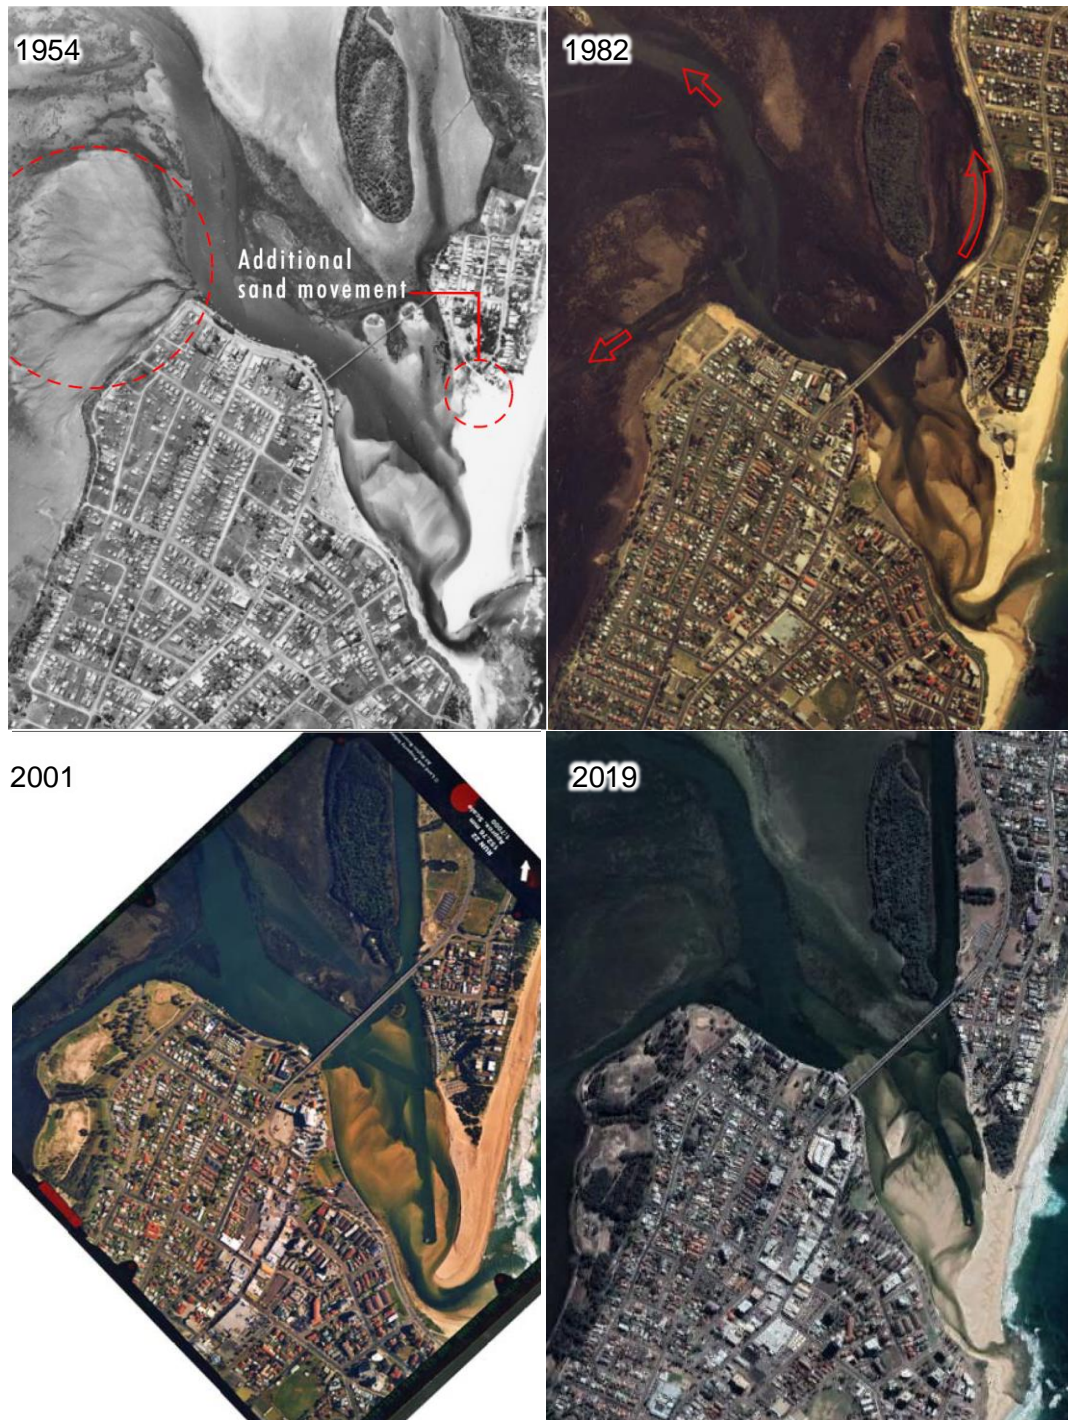
Figure 1.3: Selected historical aerial images 1950s to present. Sources: Umwelt (2011) and Google Earth.

Selected historical aerial images are provided in **Figure 1.3** showing entrance changes from the 1950's to present. Major foreshore reclamation and stabilisation works in the entrance region noted by CSIRO (1999) and Umwelt (2011) have included:

- Late 1930's reclamation and seawall shore protection of southern foreshore east of bridge;
- Early 1960's reclamation and seawall shore protection of northern foreshore east of the bridge at North Entrance;
- Early 1980s foreshore reclamation commencing on the western side of the tidal delta; and
- Late 1980's and early 1990's straightening Terilbah channel and reclamation of foreshore to the north of the bridge. Continuing reclamation of the western shore.

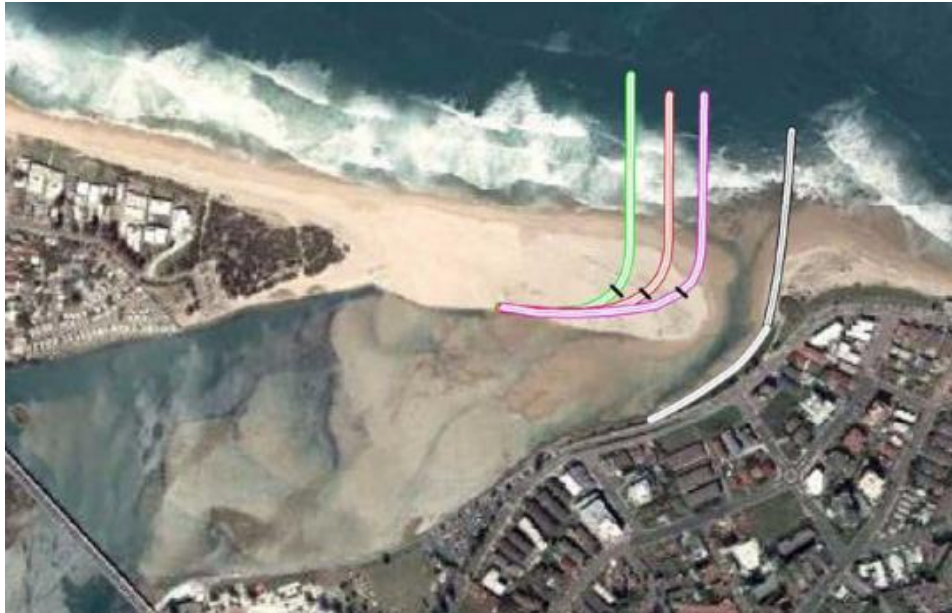
Figure 2.5: Training walls investigated by Cardno 2013.

The study utilised a Delft3D package to model the potential effectiveness of entrance training walls in addressing water quality issues. The model covers the entire area of the three lakes, adjacent ocean and beaches. The model was calibrated based on dry weather conditions and for the severe flood of June 2007 to replicate the observed behaviour of the existing lakes system.

The impact of training walls on the flooding was investigated by simulating the passage of 1% AEP flood event. Several scenarios were investigated including the existing case (no training wall), a single training wall located 150 m north of the entrance training walls, dual training walls at 100, 150 and 200 m apart.

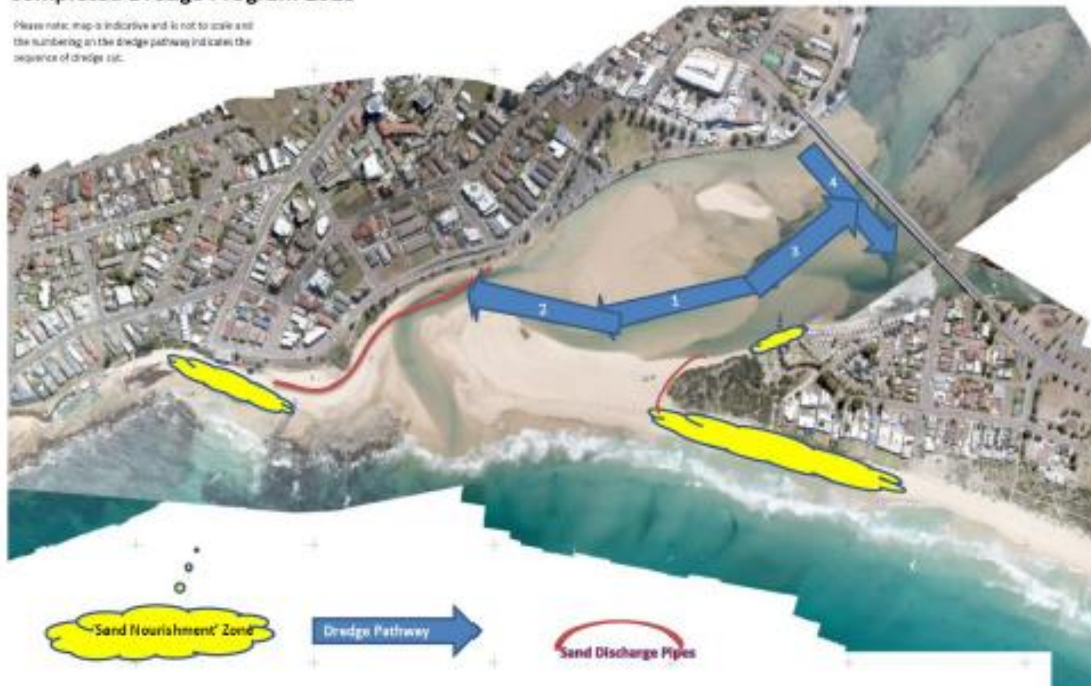
Please note: map is indicative and is not to scale and the numbering on the dredge pathway indicates the sequence of dredge cut.

Figure 2.6: Dredge pathway and sand nourishment areas, reprinted from (GHD, 2019).

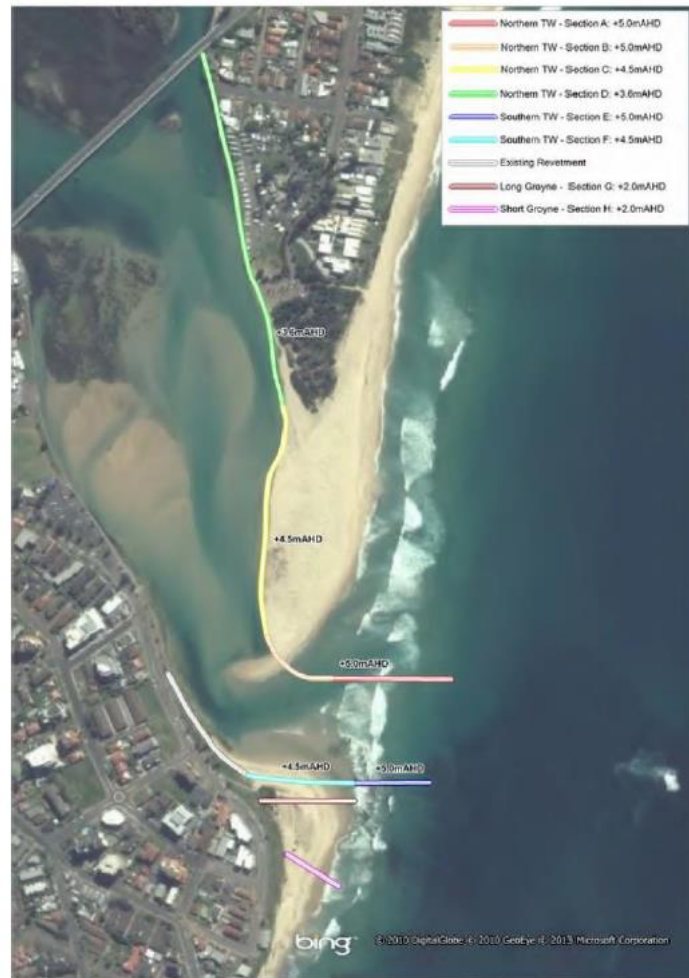
Figure 2.7: Fully trained entrance wall at the Entrance channel, reprinted from (GHD, 2019).
