## Review of the Wyong Coastal Zone Hazard Study : JbUI Report

November 2018

Prepared for: Central Coast Council

Prepared by: BMT WBM Pty Ltd (Member of the BMT group of companies)

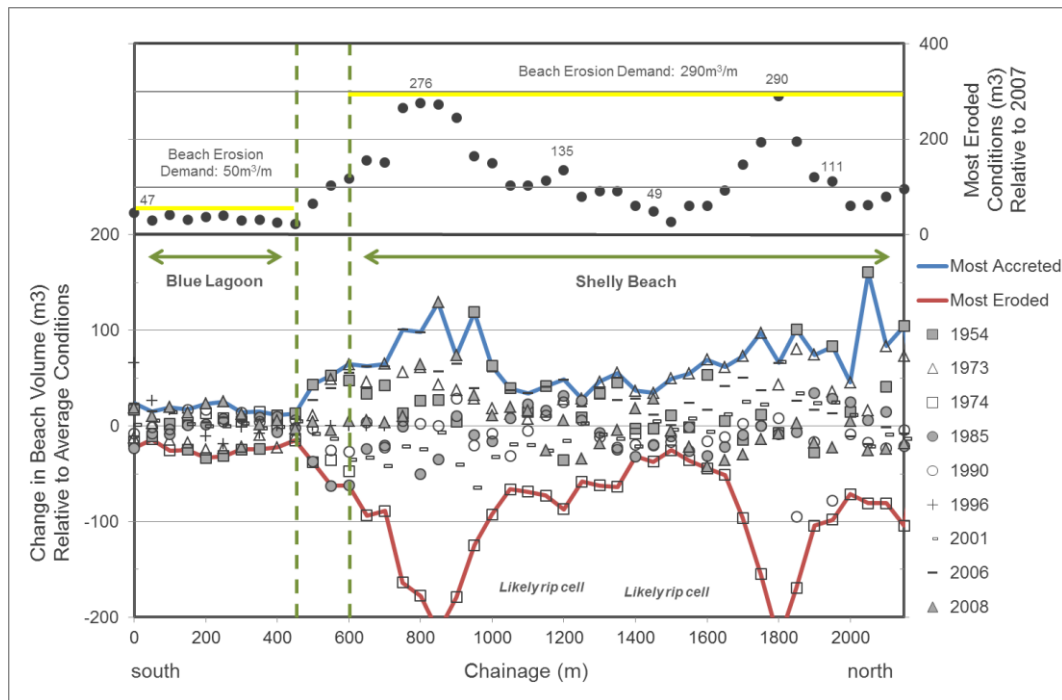
**Figure 2-2 Envelope of Beach Profile Volume Change for Blue Lagoon and Shelly Beach, with Erosion Demand Volumes Measured Relative to circa 2007 Conditions to Allow Accurate Hazard Line Mapping from the Available LiDAR Topography from that Year**

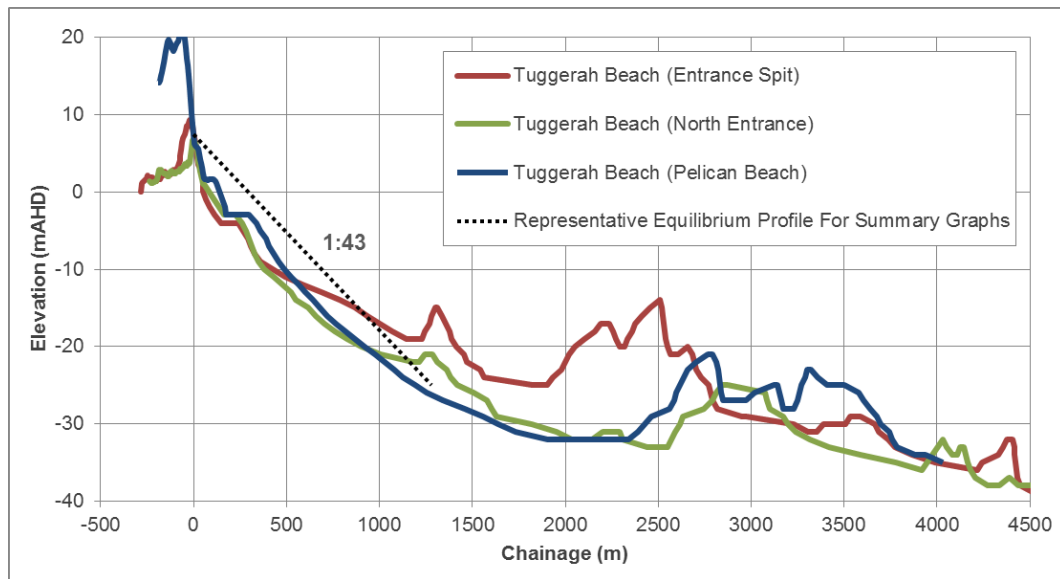
Figure 2-6 Cross Shore Profiles from the Tuggerah Beach Compartment

Submerged rocky reef is a common feature of the shoreface across Wyong’s coast, as demonstrated by the cross shore profiles below. The presence of rocky substrate near to the shore typically resulted in Bruun rule slope factors being estimated within a range of 1:35 to 1:50 for Wyong’s beaches.

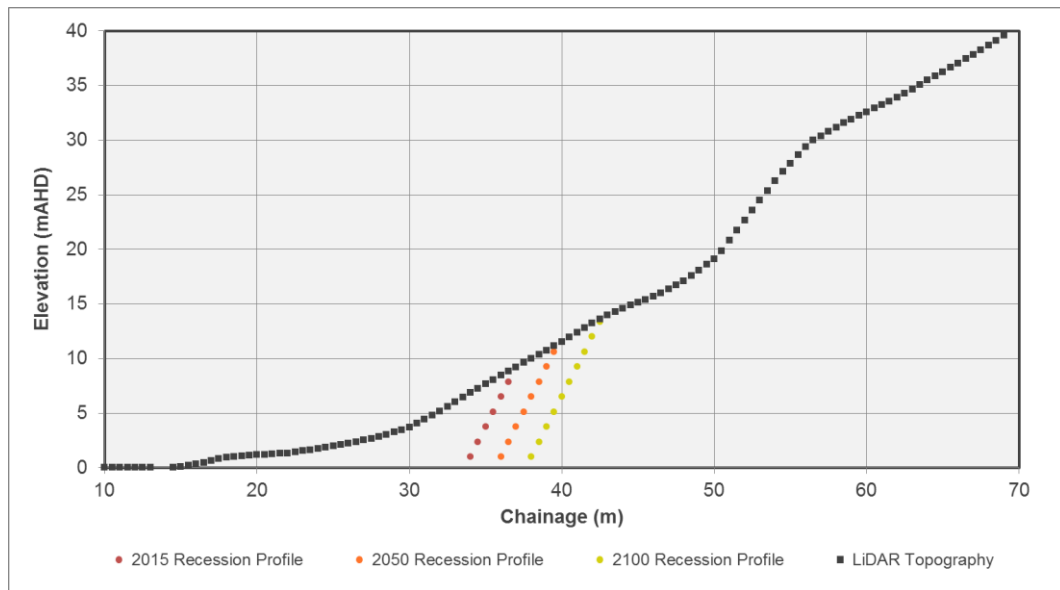
**Figure 2-11 Cliff Recession Geohazard Lines Projected at Crackneck, noting a thin residual soil adjustment factor is added to these projected cliff faces lines**

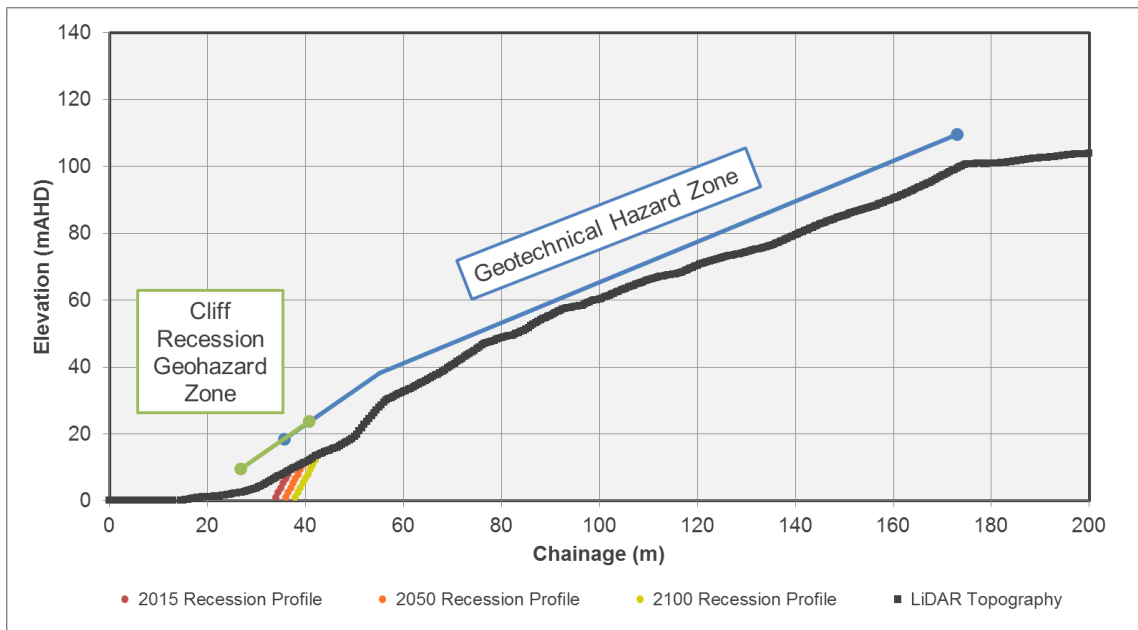
**Figure 2-12 Cross Shore Headland Profile from Crackneck, showing relationship between ‘coastal’ geohazards and ‘non-coastal’ (landslip/soil creep) geotechnical hazards**

Where the above geotechnical hazard zones occur immediately adjacent to the shoreline, the hazard zones have been mapped down to the immediate cliff recession hazard line (e.g. Figure 2-12).

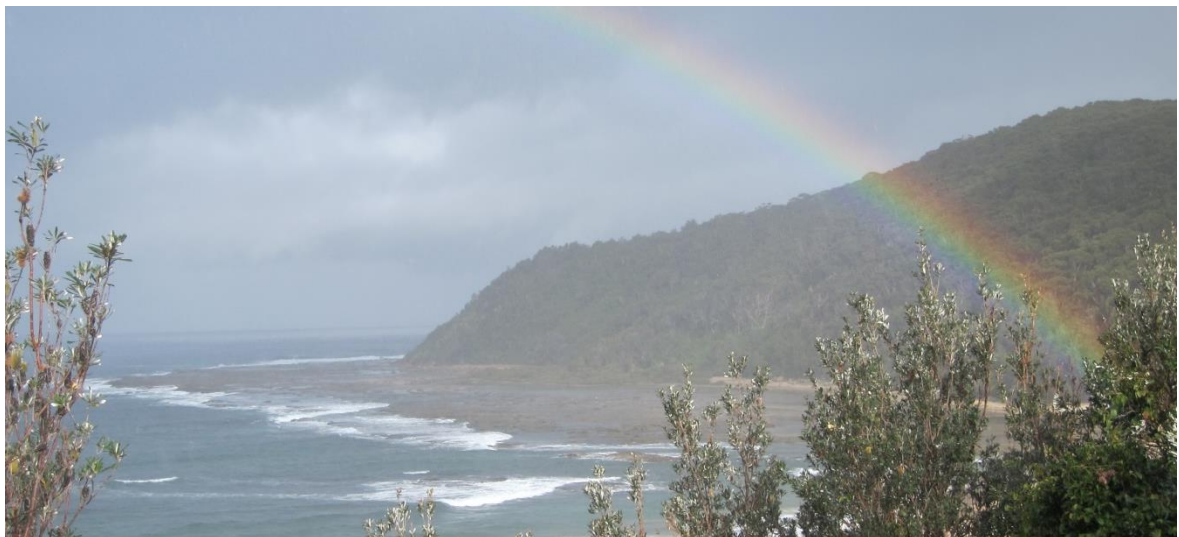
**Figure 3-1 Coastal Cliffs and Slopes of Crackneck Point, fringed by a well formed Rocky Shore Platform. Photo looking southeast from Bateau Bay Bluff**

Crackneck Point to the south extends some 1 km southeast of the embayment to shelter the beach from swell out of the southerly sector (see Figure 3-1). The unnamed headland adjoining the northern end the bay is less prominent, sitting around 15 m tall and fringed by a wide rocky shore platform. This headland is formed predominantly of Patonga Claystone with a base of Tuggerah Formation.

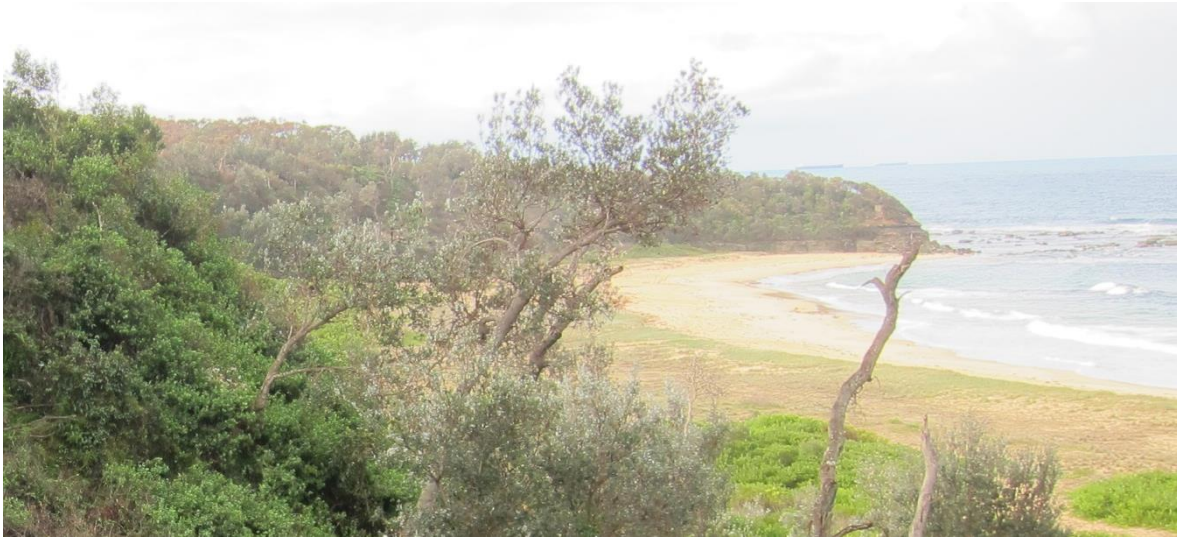
**Figure 3-2 Bateau Bay looking east, showing the Steep and Vegetated Indurated Sand Bluff (foreground) that backs the Small Curving Beach and Low Dune Field (midground)**

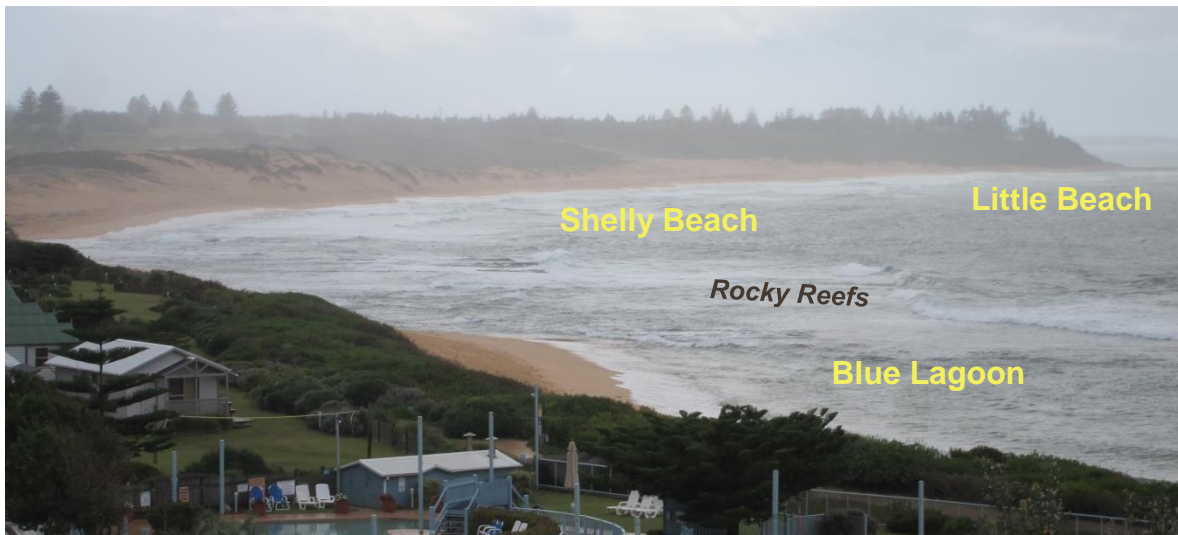
**Figure 3-9 Shelly Beach Compartment looking north, showing the Semi Protected Blue Lagoon Foreshore with Fronting Rocky Reefs and Developed Low Dunes (foreground), the Exposed Shelly Beach with a Large Dune System (midground); and the Little Bay Beach that is Backed by Rocky Slopes (background – top right)**

The 2.5 km long Shelly Beach coastal compartment is comprised of three separate shoreline segments including Blue Lagoon, Shelly Beach and Little Bay. **Blue Lagoon** is the southernmost section of foreshore that comprises a 500 m long sheltered beach protected by continuous rocky reefs that extend offshore. This shoreline segment is backed by a moderately tall (5-6 m AHD) dune systems that has been flattened by the development of a foreshore caravan park / tourist resort. **Shelly Beach** is an exposed sandy beach that is backed by a high foredune which adjoins a

mostly vegetated transgressive dune field which extends inland for a considerable distance. **Little Bay** is a 200 m long curving beach that stretches northward from the northern end of Shelly Beach to adjoin with the Toowoong Bay tombolo. The narrow, perched, and semi protected beach is fronted by a continuous rocky reef and backed by a steeply rising rocky embankment, formed of Patonga Claystone.

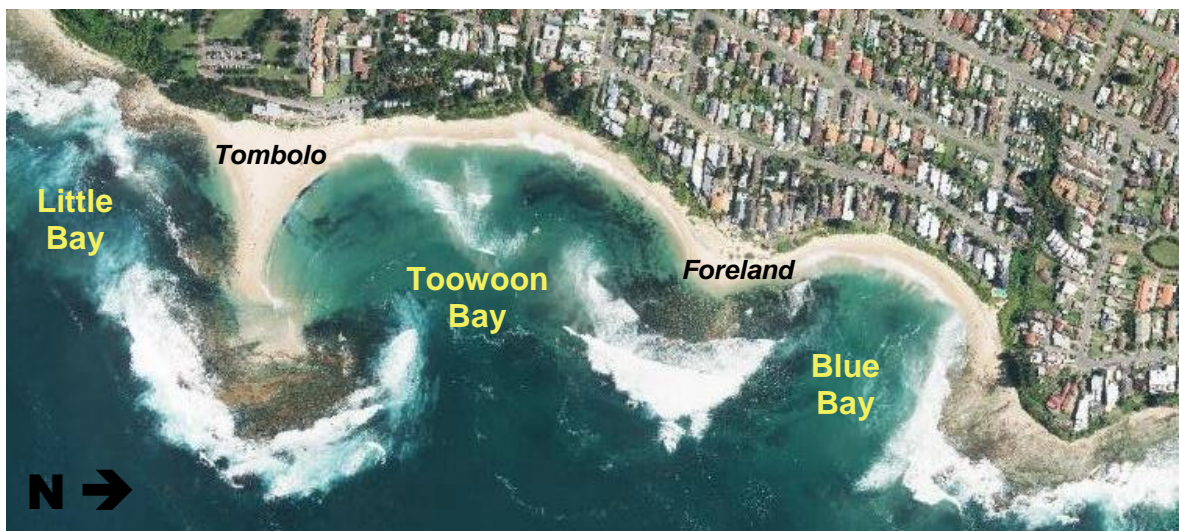
Figure 3-16 Aerial Image of Toowoan Bay and Blue Bays, showing the Toowoan Bay Tombolo (left) separating the Toowoan and Little Bays, and the Sandy Foreland Feature (middle) separating the Toowoan and Blue Bays (Image source: NSW Land and Property Information)

Toowoan Bay and Blue Bay are two adjacent semicircular shaped bays, bounded by a sandy tombolo in the south and a rocky headland in the north (see Table 3-27). Both bays are strongly controlled by the presence of rocky reefs and shore platforms. Residential development is located very close to the active shoreline at both bay locations.

**Toowoan Bay** is the southernmost bay that curves for some 700 m northward of the Toowoan Bay tombolo to adjoin a sandy foreland at its northern end. Both the tombolo and foreland are major depositional features connected to offshore rocky reefs. As such, Toowoan Bay is relatively protected with a low lying and poorly developed dune system. The bay is backed by moderately rising slopes comprised of Patonga Claystone. **Blue Bay** forms the smaller of the two bays, curving for some 250 m from the southern sandy foreland to a wide rocky shore platform in the north. Again the beach is relatively protected, but receives marginally higher waves than Toowoan Bay. Blue Bay beach is backed by a poorly developed and low lying dune system. A locally incised creek drains the hinterland to the northern end of the beach.

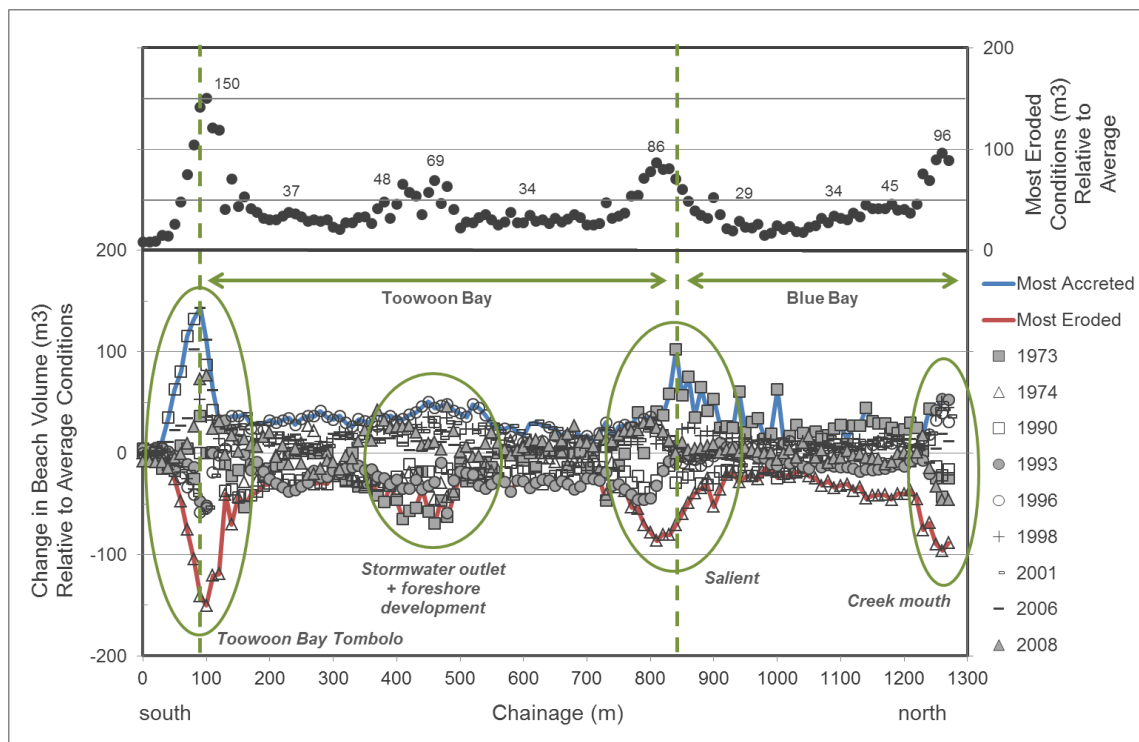
Figure 3-17 Changes in Beach Profile Volume for Toowoan and Blue Bays

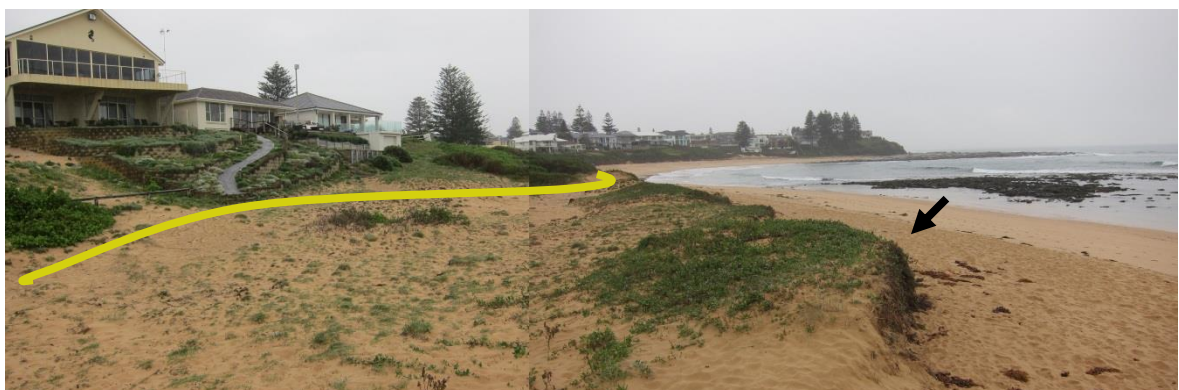
**Figure 3-20 Foreland Feature Separating Toowoan and Blue Bay, showing the current dune scarp (black arrow) and historic dune scarp (yellow line)**

This assumption is further backed up by geomorphic evidence. For example, the profiles of the low dunes at Toowoan Bay display broadly convex forms, as opposed to concave profiles which are typical of receding beaches. Also the current dune face/scarp position at Blue Bay and the adjoining foreland feature is located further seaward than the 1974 scarp position that can be clearly identified in the LiDAR (Digital Elevation Model) DEM. Figure 3-20 demonstrates this observation, with the photographed dune face located some 10 to 35 m seaward of the relict scarp identified on the foreland feature. The *Toowoan and Blue Bays Historical Beach Behaviour* study by PWD (1992) also noted that no significant changes could be observed in the shoreline location at Blue Bay, based on a comparison between two photographs from 1910 and 1990.

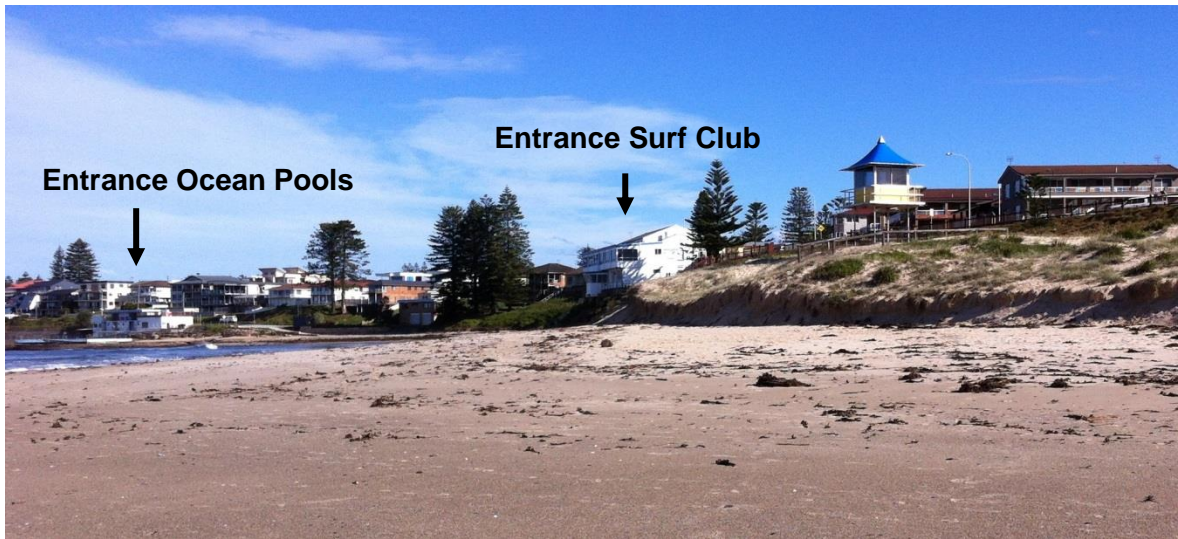
Figure 3-22 South Entrance Beach, looking south

South Entrance Beach is a small beach located at the base of a rocky bluff and adjacent the southern side to the Tuggerah Lakes entrance channel. The beach is mostly east facing and exposed to all swell directions, but experiences some protection from submerged rocky reefs located immediately offshore in places. The beach widens to the north to adjoin a near shore rocky reef located off the mouth of the estuary, before curving westward and narrowing into the Entrance Channel. Much of the beach is underlain by a rocky platform and backed by a rocky bluff that is now buried by landscaping works which may include a revetment in places. The historic Entrance Surf Club and Entrance Ocean Pools are located at southern end of the beach (see Figure 3-22). Southward from here, the shoreline is rocky, comprising east facing cliffs and bluffs formed of Patonga Claystone that extend for some 900 m to adjoin with Blue Bay. A sandstone rock wall fronts the historic surf club and extends northward beneath a wide incipient dune for an unknown distance. This sandstone wall appears overly steep and may not have been constructed to coastal engineering standards.

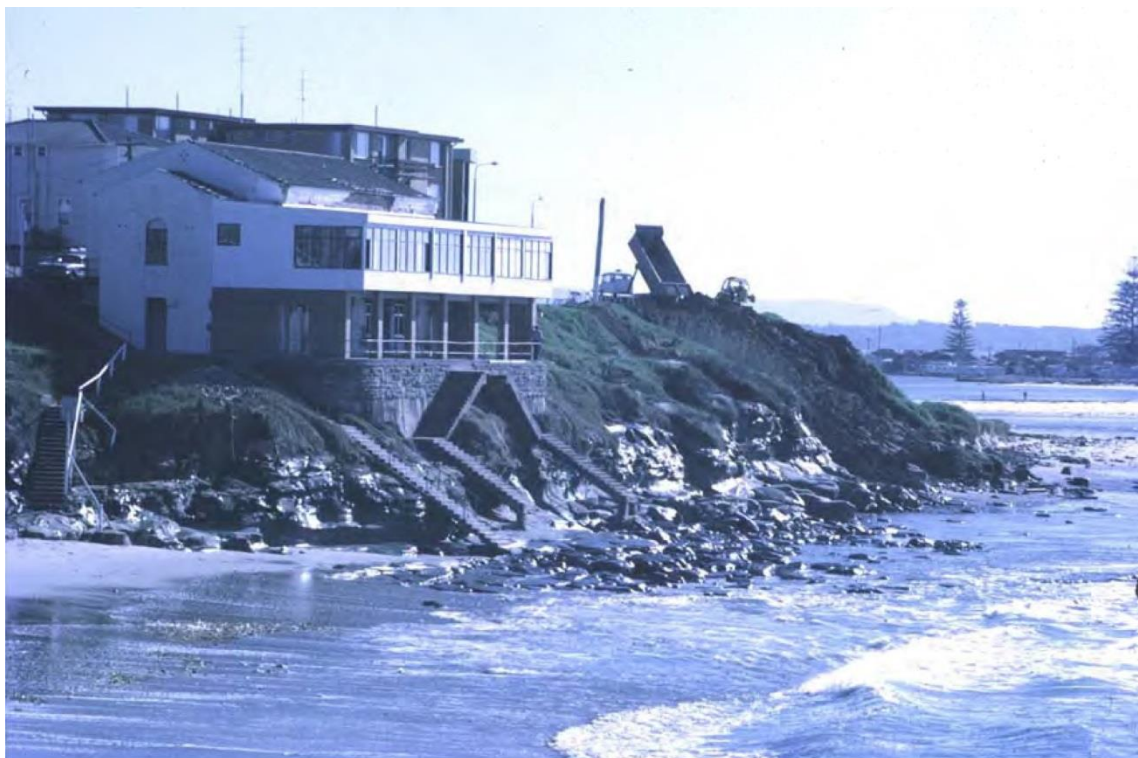
Figure 3-25 South Entrance Beach in 1974 showing the Beach Completely Eroded Away after Extreme Erosion Event(s) (image sourced from Umwelt, 2011a)

Considering the dynamic nature of South Entrance Beach, which is influenced by both wave and tide action, and has a history of becoming completely eroded away by extreme storm activity; this section of coastline will be assessed for geohazards only (see below)

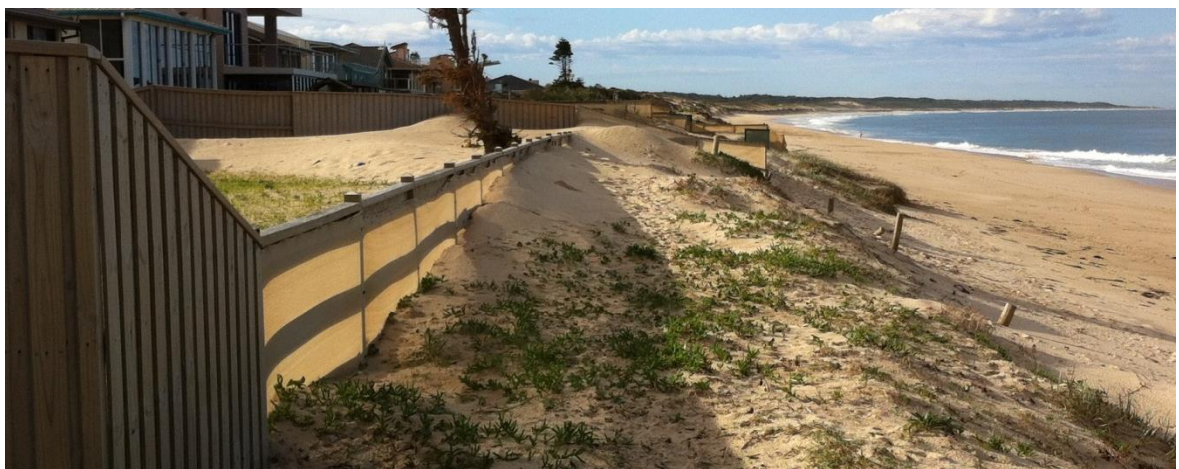
Figure 3-27 Tuggerah Beach Compartment, looking north from North Entrance Beach (Curtis Parade); note the Sand Drift and Proximity of the Houses to the Foreshore

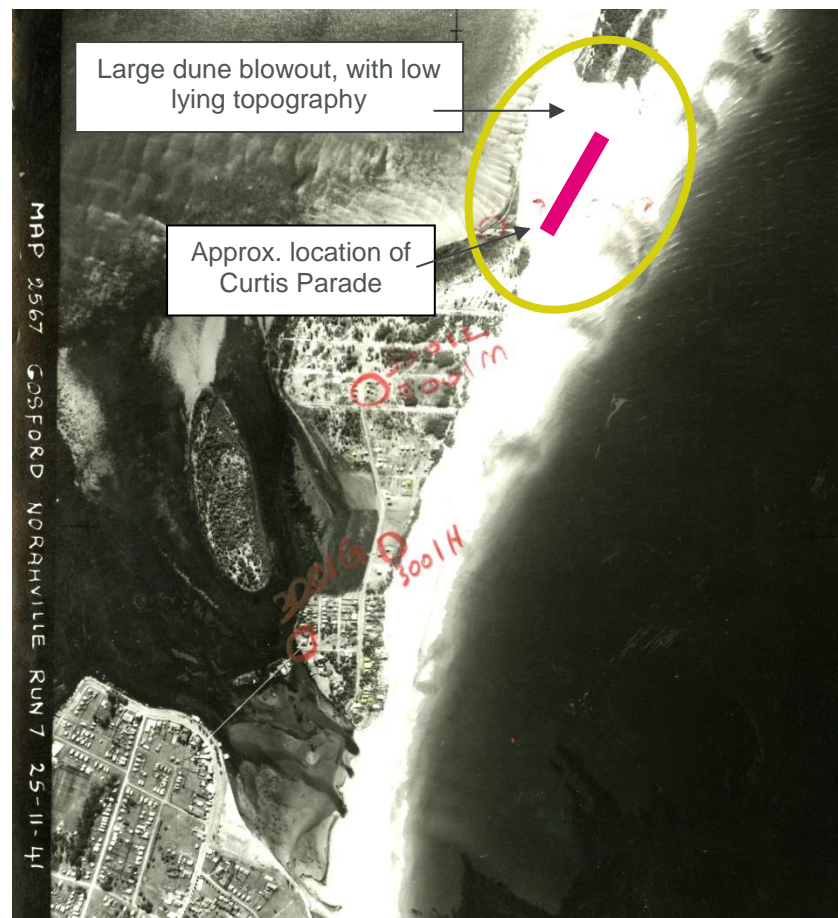
**Figure 3-35 Historic Aerial Photograph of North Entrance Beach in 1941, showing the Location of a Large Dune Blowout**

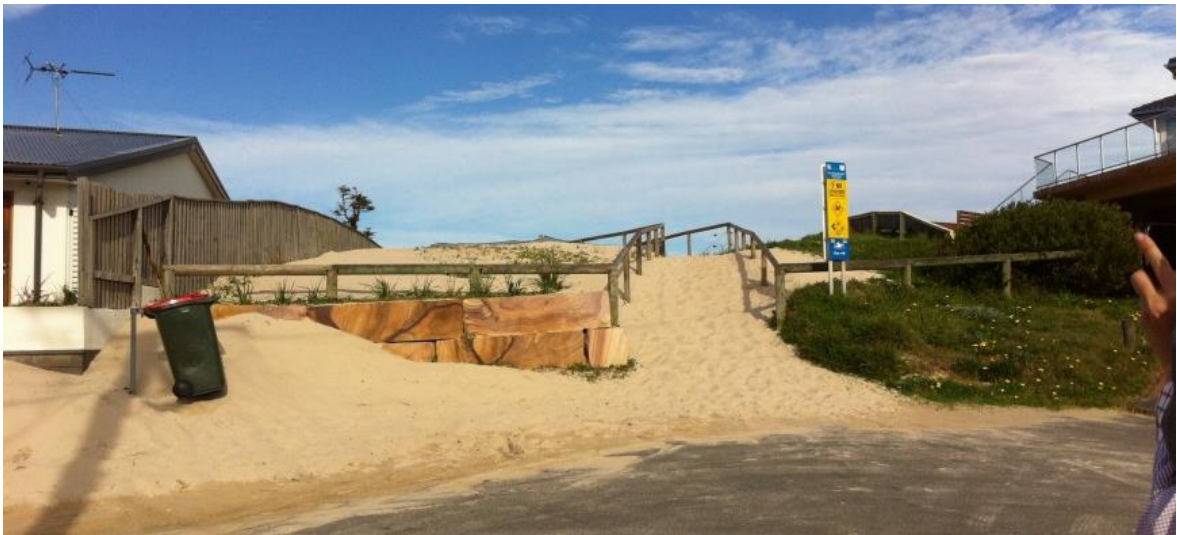
**Figure 3-36 Sand Drift at the Southern End of Curtis Parade, North Entrance, Demonstrating the Ongoing Dune Activity which may be Contributing to the Sediment Deficit at this Beach**

- The receding segment of North Entrance Beach (SS2) is backed by active transgressive dunes for much of its length which includes regular dune blowouts. These blowouts allow beach deposited sand to be readily transported landwards of the active beach system. These dunes are clearly a contributing factor towards the net loss in beach volume through time. Historical photographs show that an extensive dune blowout was located in the vicinity of Curtis Parade, prior to the expansion of residential development into this area (Figure 3-35). The Curtis Parade houses have provided some stability to the dunes, although sand drift still occurs under stormy conditions, as experienced in the April of 2015 event (see Figure 3-36).

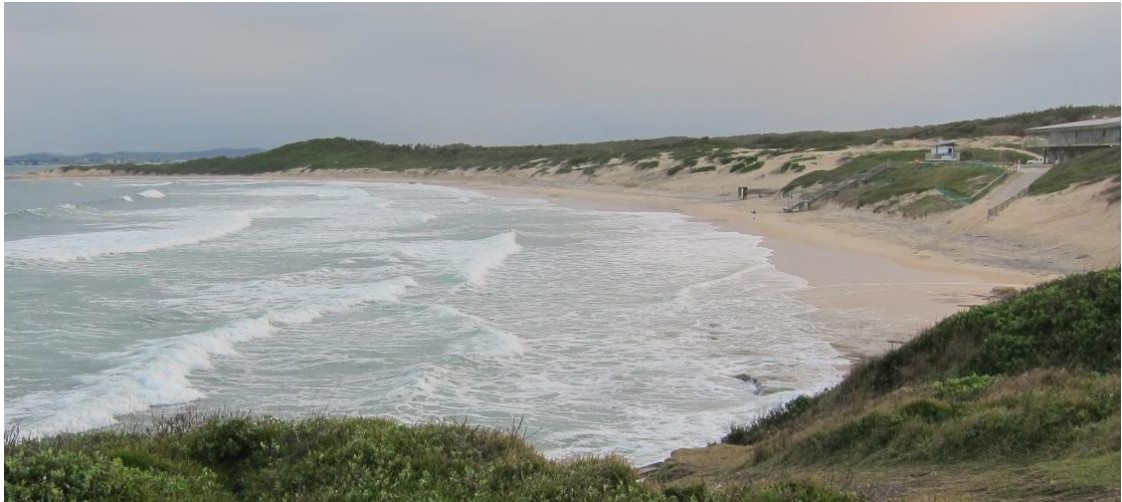
**Figure 3-39 Soldiers Beach looking south from Soldiers Point, with the SLSC in the Left; note the Tall and Steep Profile of the Dunes and Presence of Many Localised Blowouts.**

Soldiers Beach is a sweeping southeast facing beach that stretches for some 900 m between Pelican and Soldiers Points, from south to north. A tall continuous sand dune backs much of the beach, which is blown out in places, and transgressive up the backing bedrock hinterland. The surf club is located on top of this dunefield, behind the northern end of the beach. Pelican Point to the south comprises a low rocky reef that is joined to the beach by a sandy tomobolo separating Soldiers and Pelican Beaches. Soldiers Point in the north comprises a more substantial rocky headland comprised of Munmorah Conglomerate (with possible dyke intrusions) which is fronted by a large rocky shelf that extend a few hundred metres offshore of the low headland cliffs. Both points protrude seaward of the sandy beach resulting in the waves becoming slightly refracted and reduced in size.

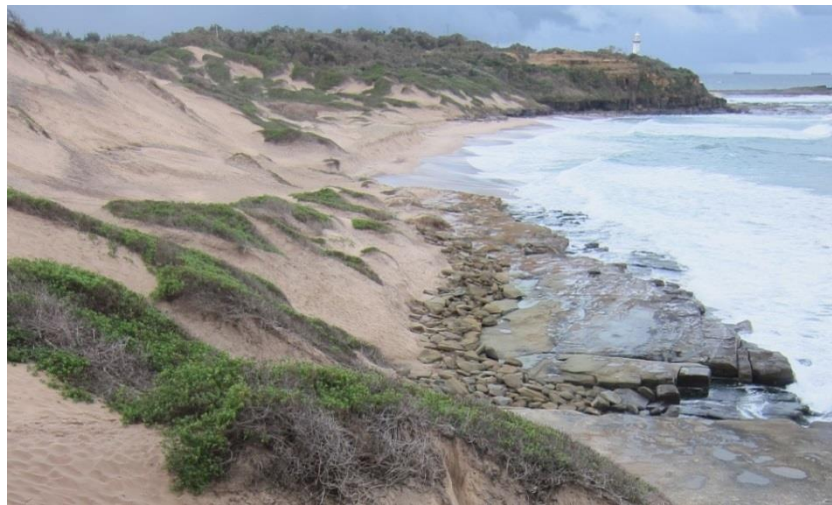
**Figure 3-46 Pebbly Beach looking northward towards Norah Head from Soldiers Point, showing the Rocky Substrate Located at Both Ends of the Beach and the Tall and Active Transgressive Dune System**

Pebbly Beach is a 500 m long, southeast facing beach located between two prominent rocky headlands (see Figure 3-46). The beach is backed by tall, steep and active transgressive dunes, which climb landwards up the backing rocky slopes. The dunes are perched on a 2 to 3 m tall rocky platform in its southern end. Soldiers Point to the south and Norah Head to the north form low bluffs that protrude seaward of the beach, providing a small level of protection to the beach. The headlands are comprised of Munmorah Conglomerate and underlain by Tuggerah Formation rocks, which have been intruded by dykes in some locations. An exposed section of cliff is located at the southern section of this beach and bedrock is exposed in the dunes deflation hollow behind the middle section of beach.

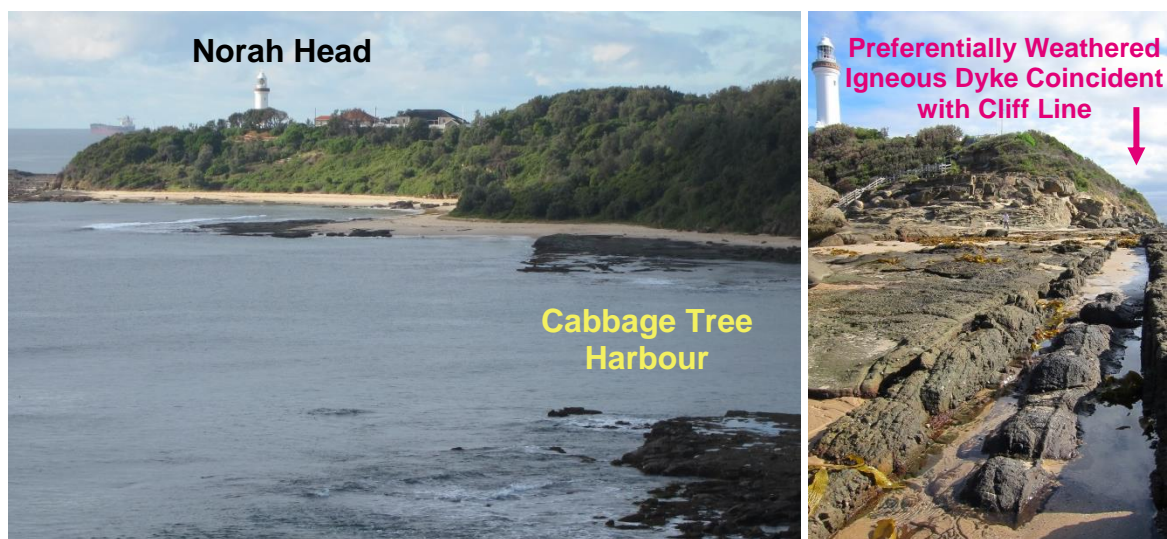
**Figure 3-48 Norah Head Headland looking southeast across Cabbage Tree Bay (left) and looking northwest showing the Relationship Between Cliff Formation and Presence of Igneous Dyke within Surrounding Sandstone Bedrock**

Norah Head is considered to form a secondary level coastal compartment boundary (GA, 2013), which indicates that little to no sediment is transported either side of this landform on a decadal timescale. The low lying headland (20 to 30 m AHD) is comprised of Munmorah Conglomerate and fringed with generally wide rocky shore platforms, formed of Tuggerah Formation rocks. Both rock types are well jointed and intruded by igneous dykes in some places. These geological structures have strongly influenced the formation of the headland cliff and slopes (see Figure 3-48). Lighthouse Beach is located on the northern side of Norah Head and forms a narrow curving beach that is perched on top of rocky platforms and reefs and backed by narrow and low lying dunes.

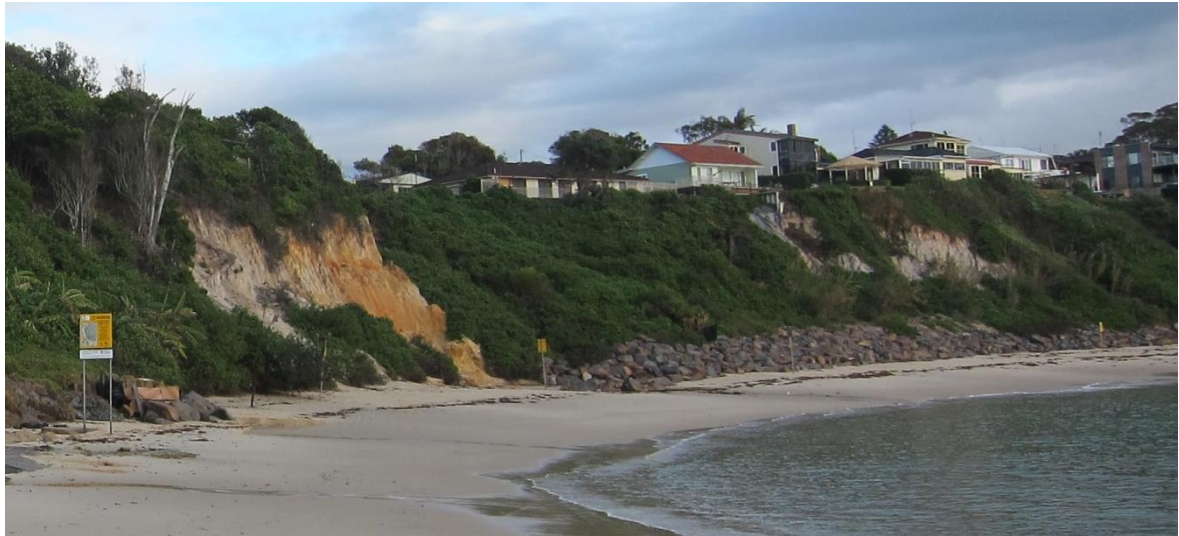
**Figure 3-49 Cabbage Tree Harbour Beach and Tall Sand Bluffs looking east, showing the Actively Retreating Indurated Sand Cliff (left) and Toe Protection Structure that Protects the Developed Length of Sand Bluff (middle-right).**

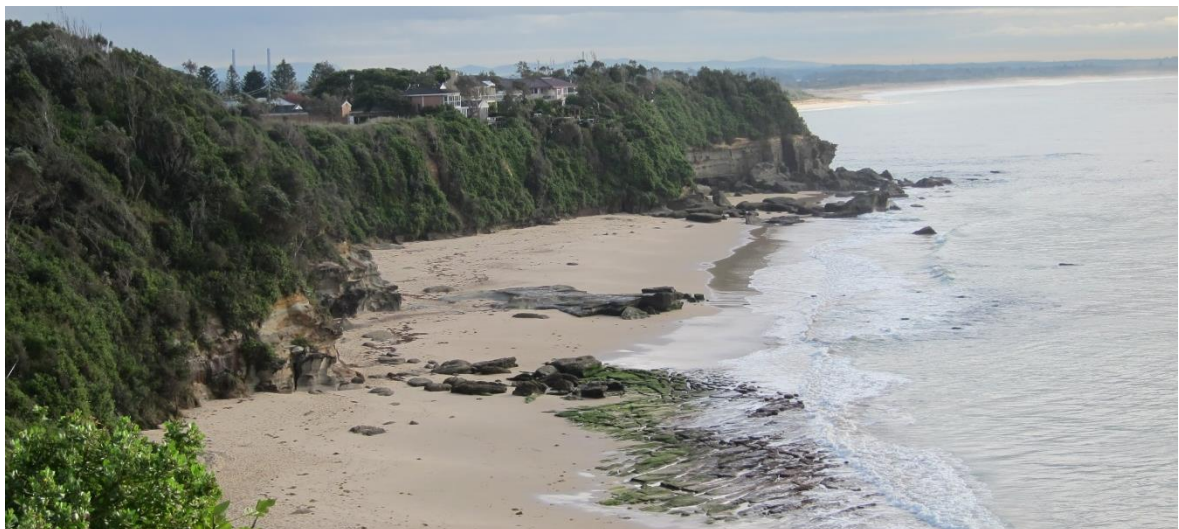
**Figure 3-51 Jenny Dixon Beach looking north, showing the Beach to be Comprised of a Thin Veneer of Sand Only that Overlies Rocky Platforms and is Backed by Steep Cliffs for Most of its Length**

Jenny Dixon Beach is a very narrow sandy beach located at the base of low bedrock cliffs bound by two rocky headlands. The east facing beach is 300 m long, and overlies shallowly buried rocky platform exposed in the middle and ends of the beach (see Figure 3-51). Rocky reefs also extend seaward from the adjoining headlands. The backing and bounding bedrock cliffs and slopes are formed of Tuggerah Formation and Munmorah Conglomerate rocks. While the beach experiences reduced waves from the offshore reefs, the investigation of the cross shore beach topography extracted from a LiDAR DEM indicates the volume of beach sand is small and could be easily eroded by an extreme storm event. Therefore, this section of coast is assessed for geohazards only.

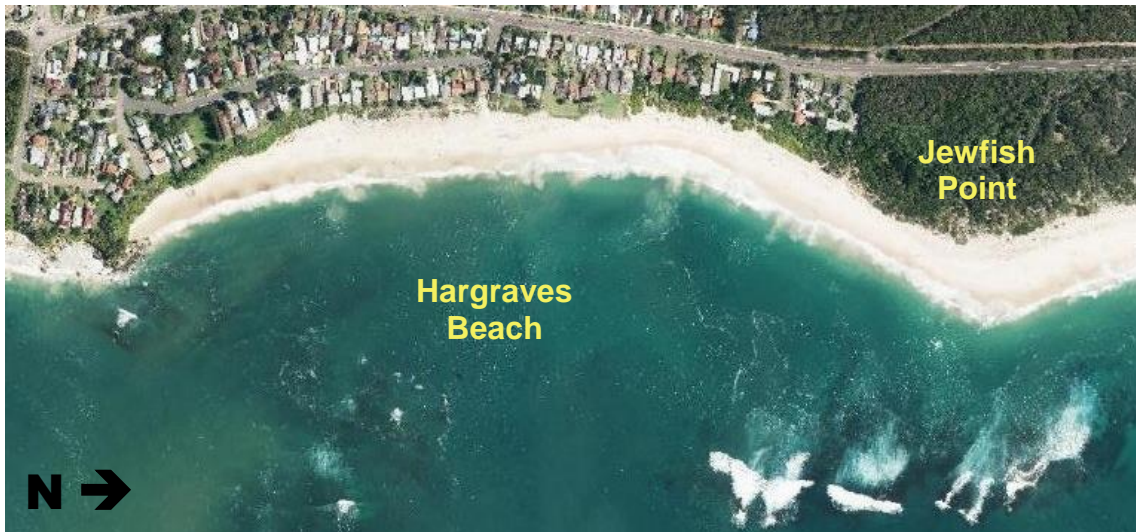
Figure 3-52 Aerial Image of Hargraves Beach, showing the Two Offshore Reefs and Their Control on the Beach Form (e.g. Jew Fish Point); Note the Proximity of Residential Development to the Foreshore in the Middle Section of Beach

Hargraves Beach is a gently curving, east facing sandy beach that stretches for 1.2 km between Jewfish Point in the north and a small rocky outcrop in the south. Two offshore rocky reefs control the planform of the beach, with a prominent sandy foreland forming in the lee of the northern reef. The submerged reefs reduce the wave heights experienced on the beach, while the adjacent Norah Head provides additional protection from the southerly directed swells. The beach is backed by a single, shore parallel dune that is low lying (4 m AHD, or less) for much of its length. Foreshore property is located on and immediately behind this dune.

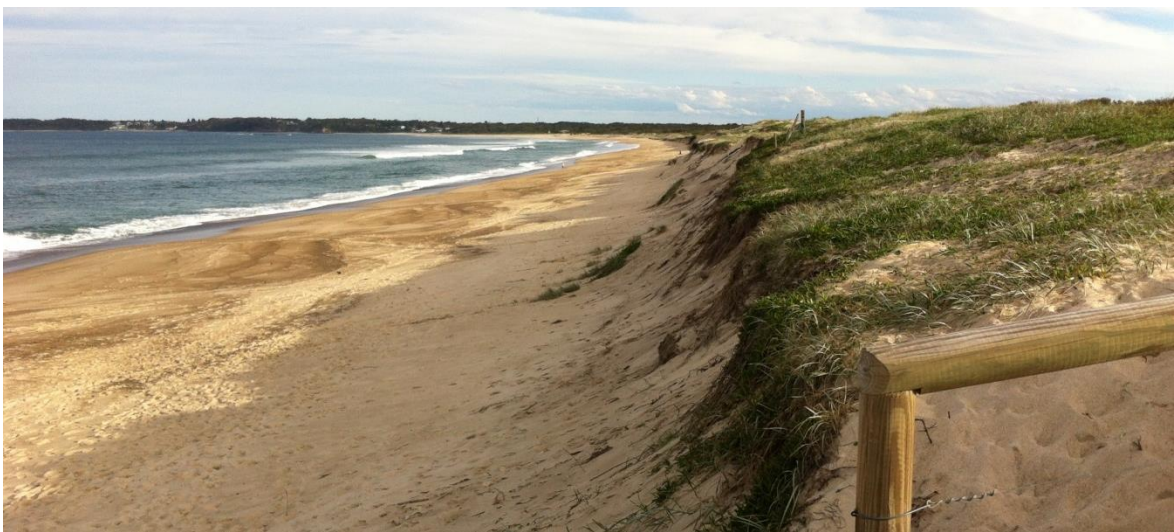
**Figure 3-59 Budgewoi Beach Embayment looking south towards Lakes Beach**

Budgewoi Beach compartment is a long (8 km) exposed southeast facing sandy embayment that stretches northward from the sandy foreland at Jewfish Point to a rocky headland adjacent the mouth to Birdie Lagoon. This large sandy embayment includes Lakes Beach in the far south, Budgewoi Beach (see Figure 3-59), Birdie Beach and Red Ochre Beach in the far north, with Lakes and Budgewoi Beaches included within the project study area and Birdie and Red Ochre Beach backed by Munmorah State Conservation Area.

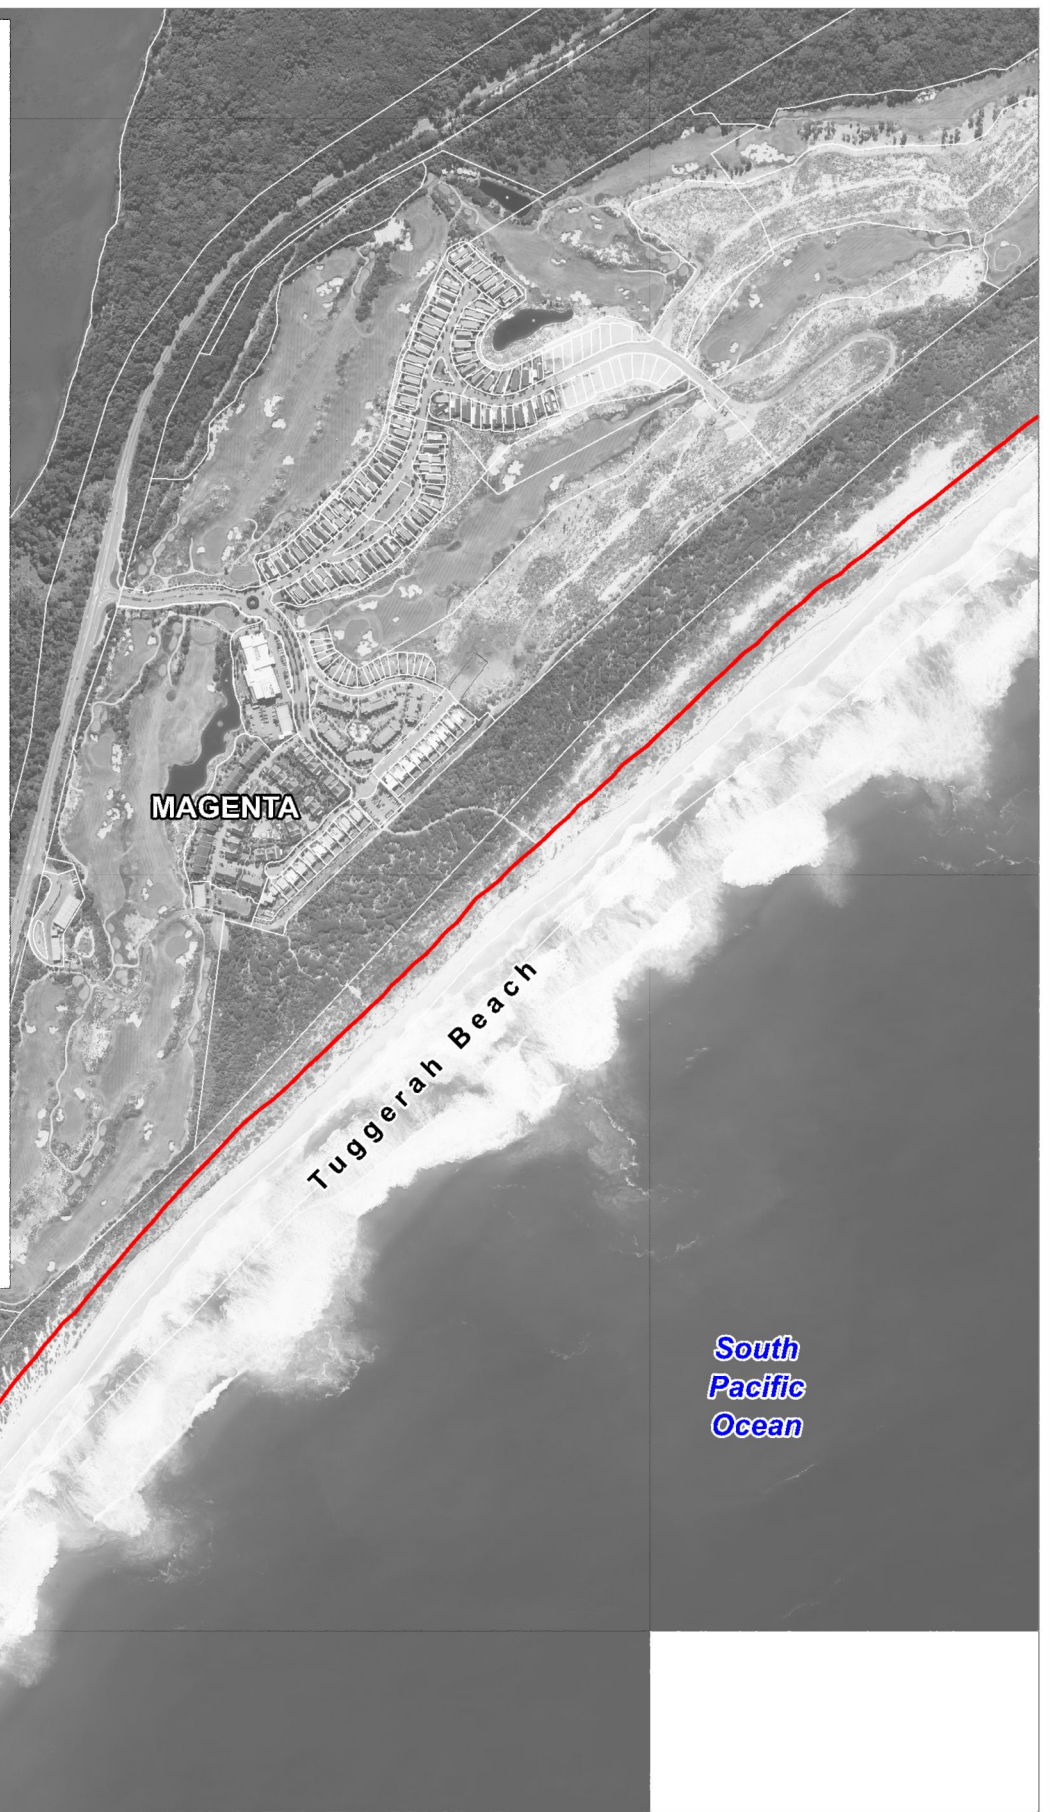
Figure:  
**B-07**

Title:  
**Coastal and Geotechnical Hazard Definition**  
**No Sea Level Rise Scenario - Tuggerah Beach (Magenta)**

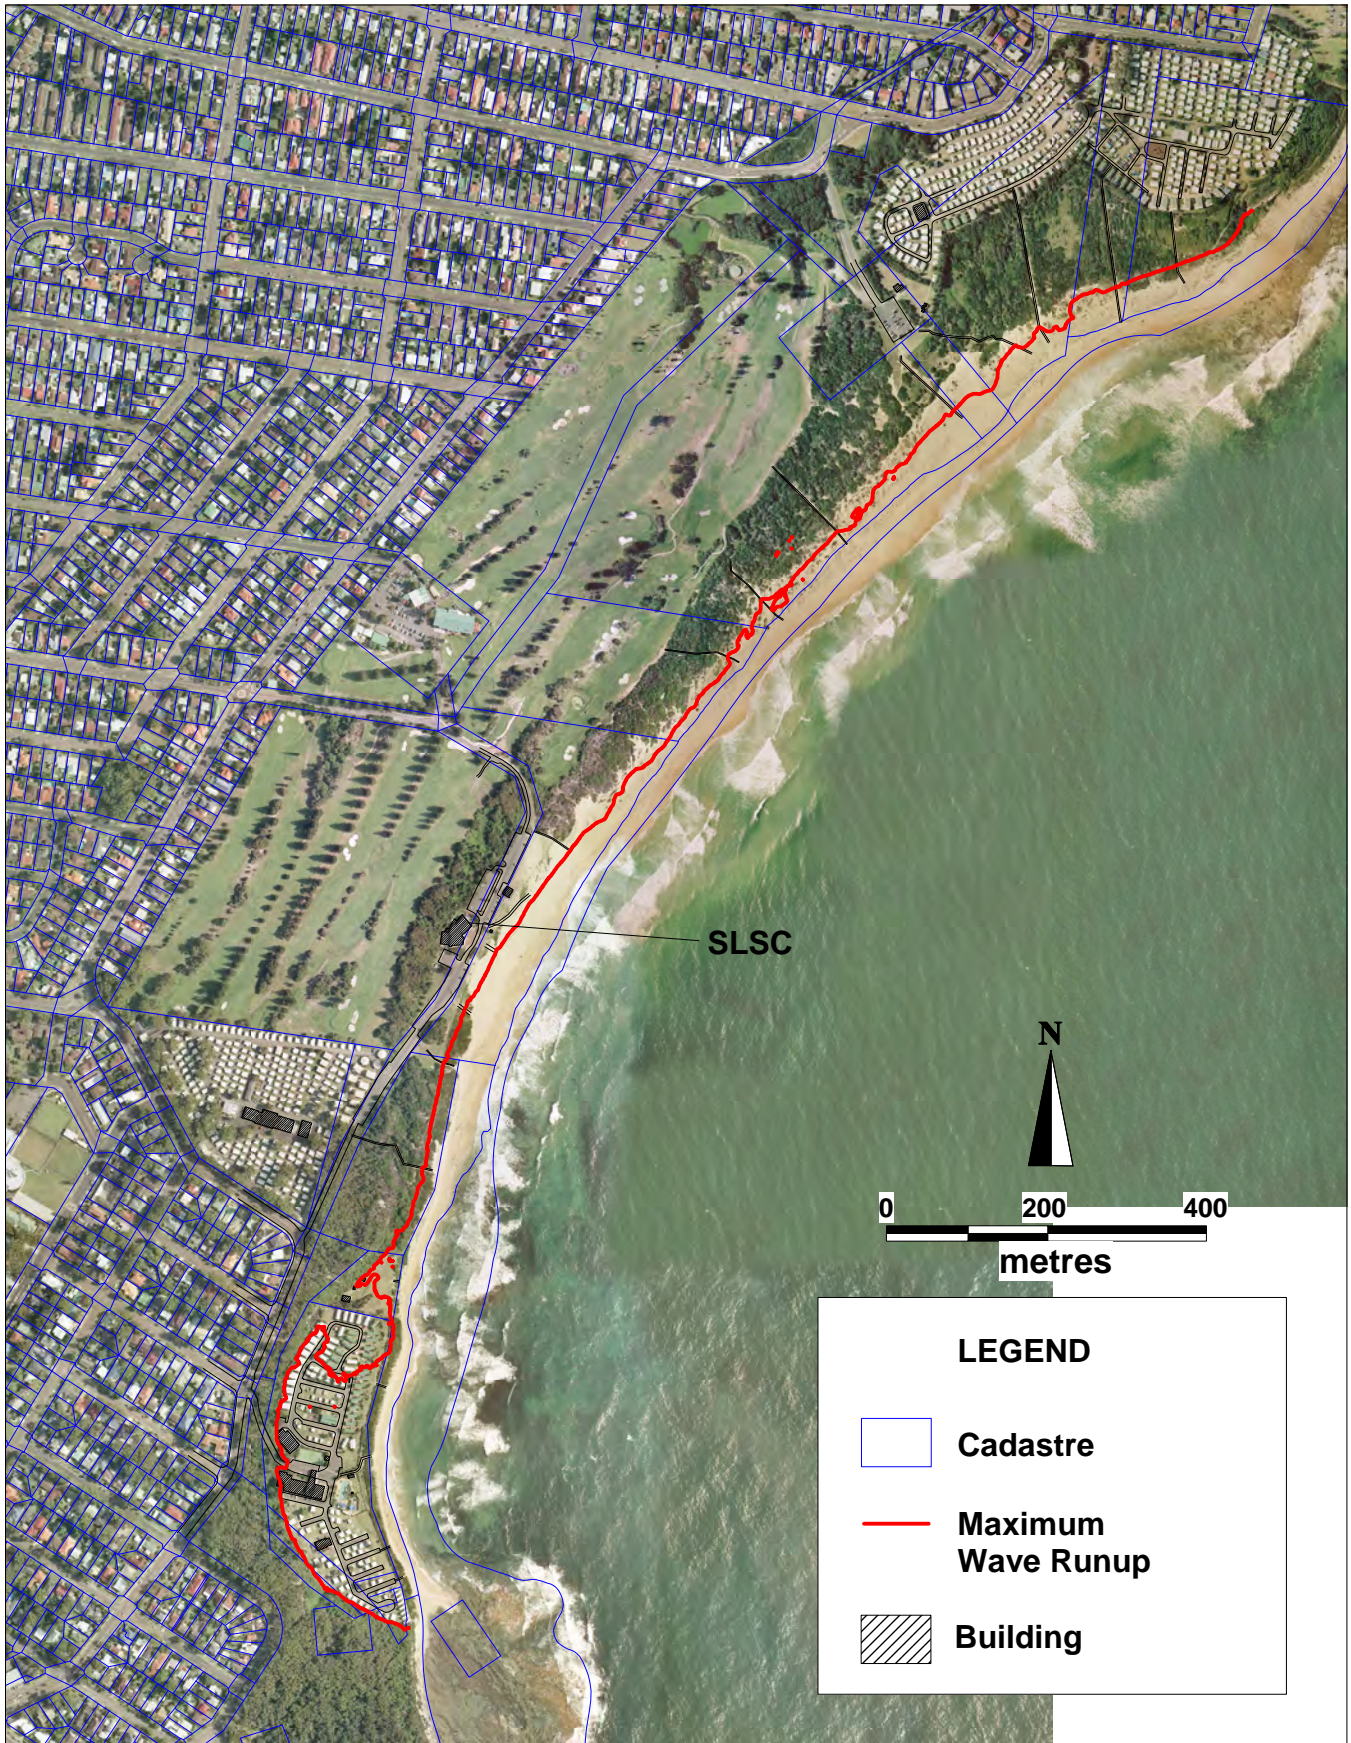
**Maximum Runup  
Toowoon and Blue Bays**

Wave runup mapping for the immediate timeframe produced by SMEC for the Wyong Coastal Hazard Study completed in October 2010 is provided below.
