## Review of the Wyong Coastal Zone Hazard Study : JbUI Report

November 2018

Prepared for: Central Coast Council

Prepared by: BMT WBM Pty Ltd (Member of the BMT group of companies)

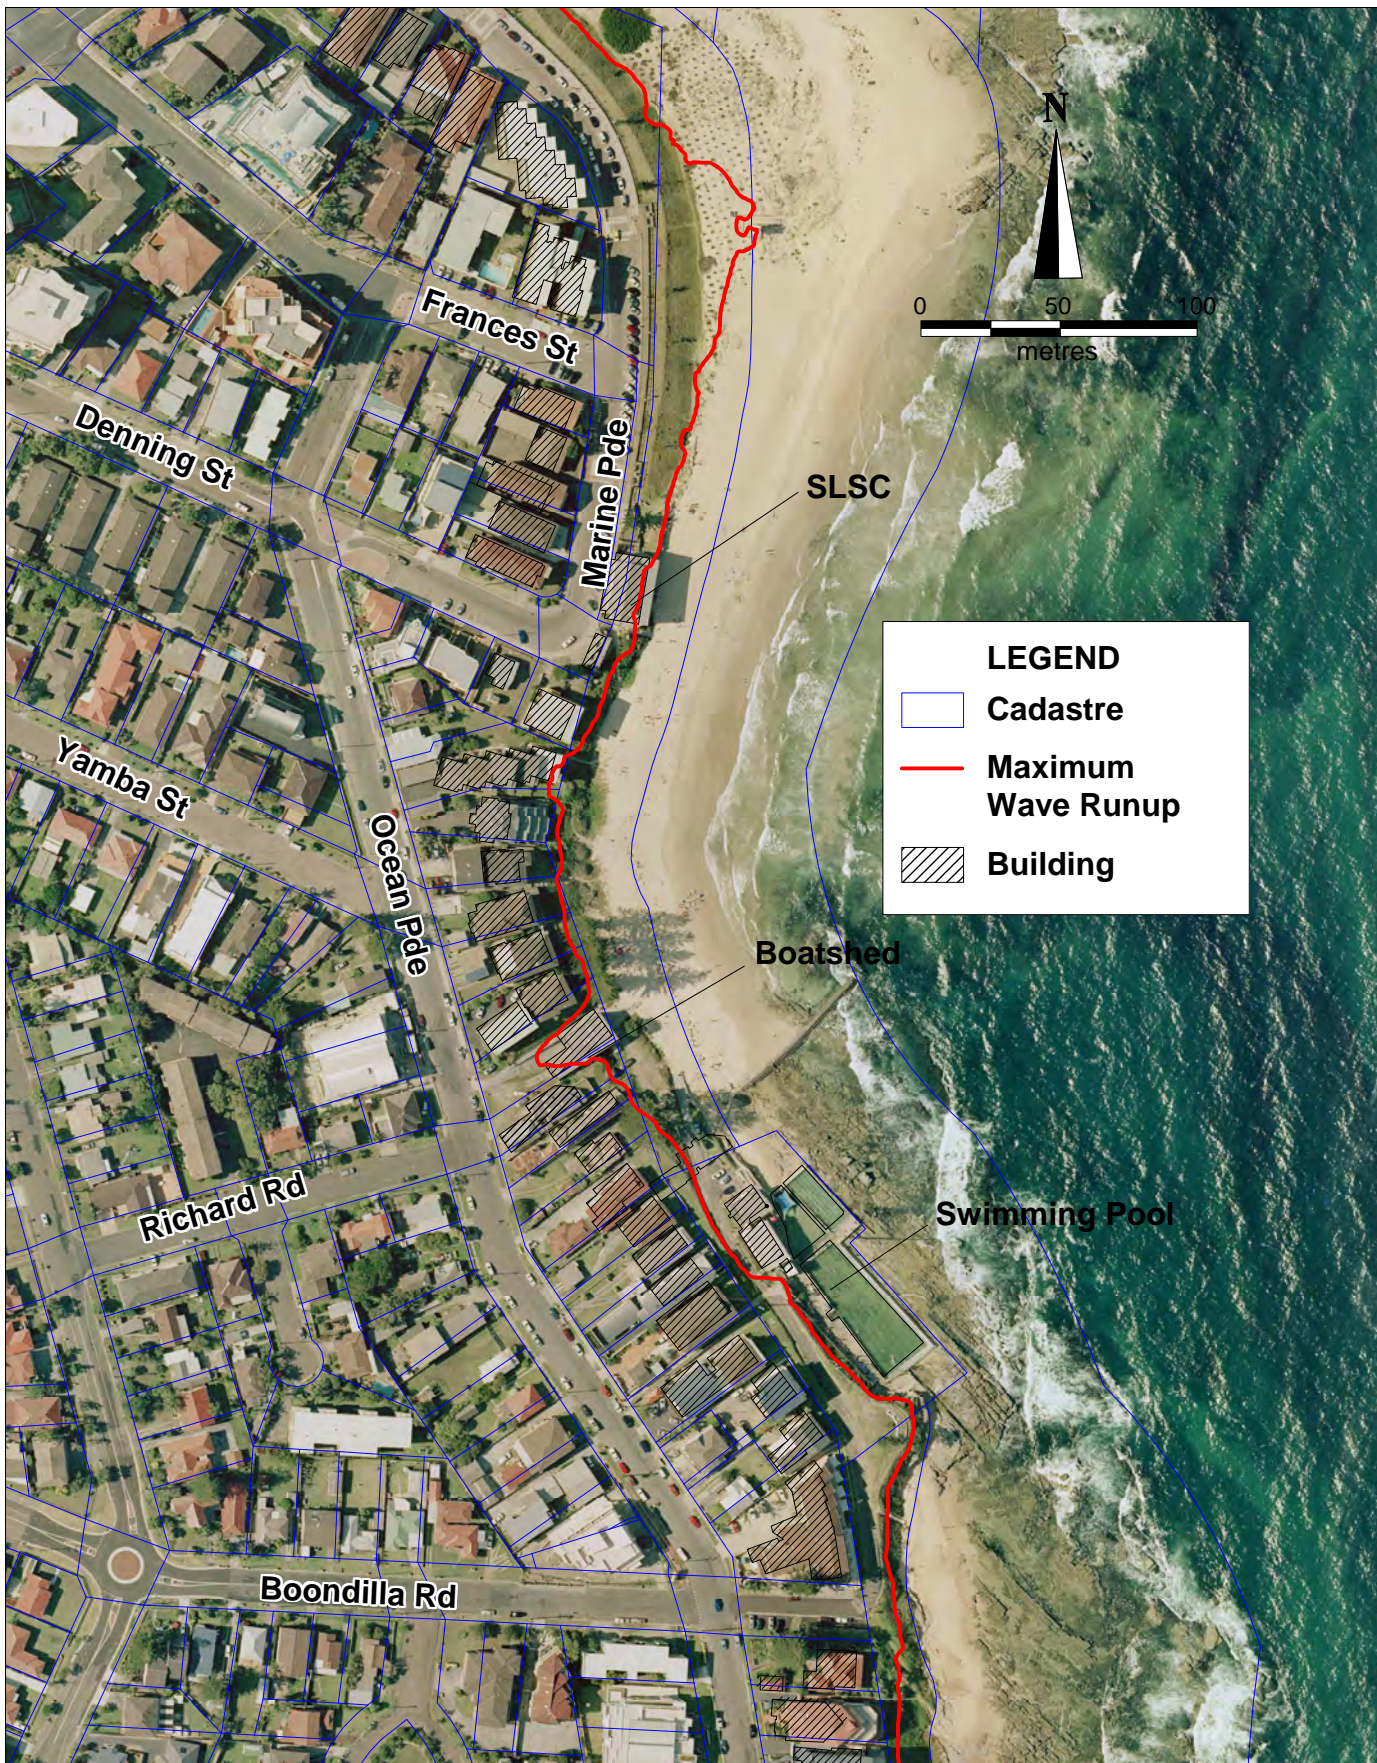
**Maximum Wave Runup  
Lakes Beach**

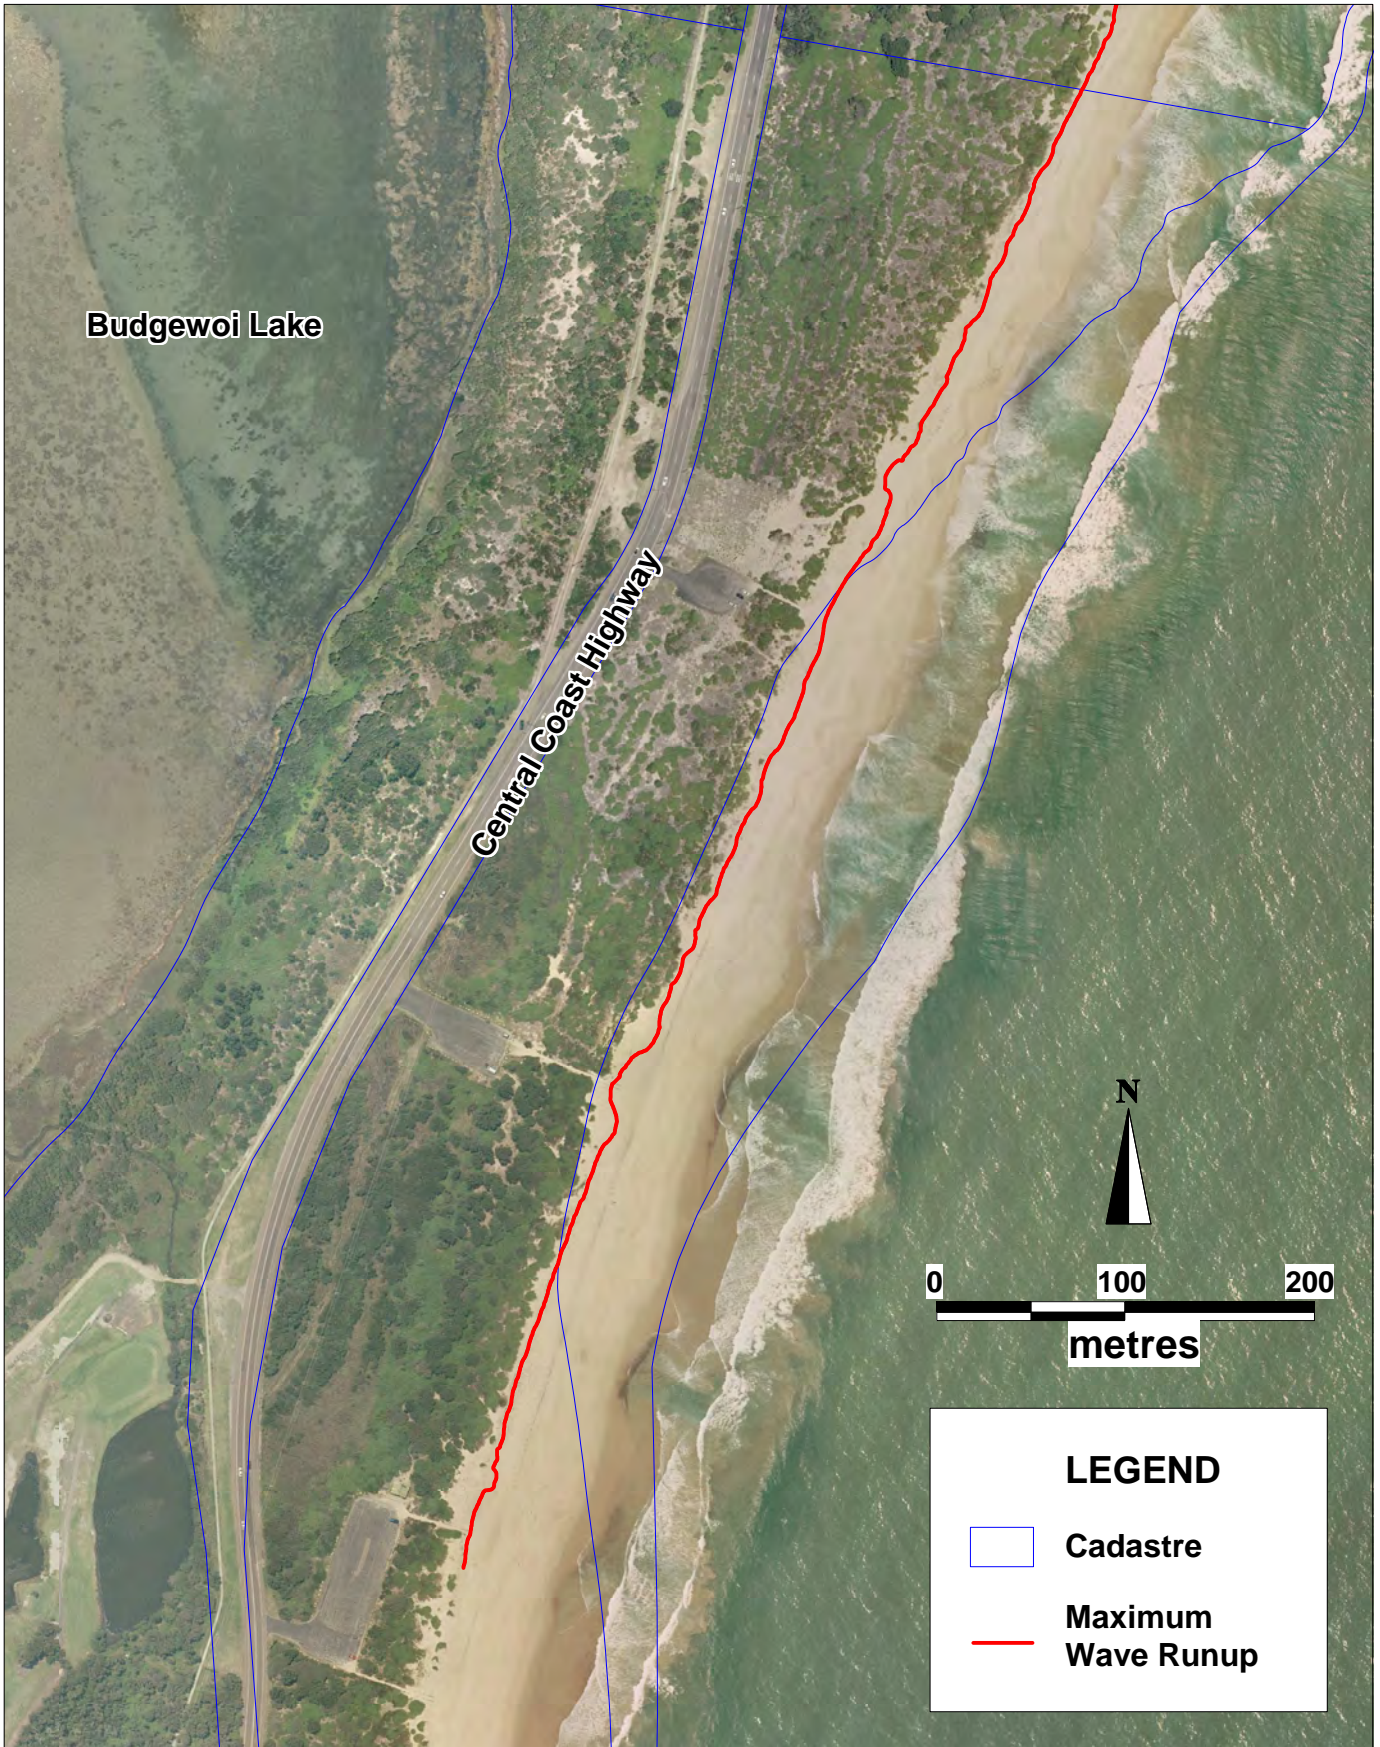
Maximum Wave Runup  
North of Lakes Beach
