Terrigal Catchment Audit

Initial water quality investigation report

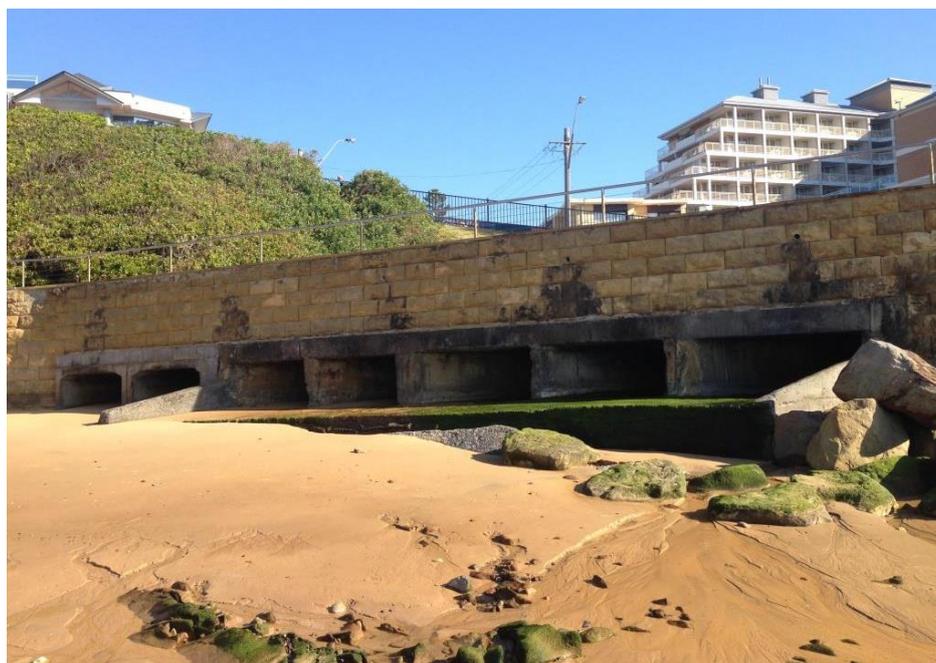
Figure 6: Large stormwater culverts where the majority of stormwater from the catchment exits onto Terrigal Beach.

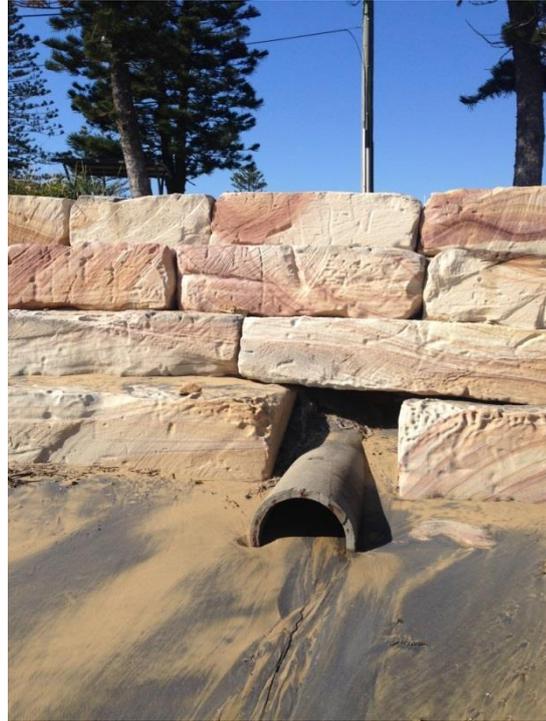
Figure 8: Central stormwater drain entering Terrigal Haven Beach from carparks, streets, oval and beach shower.

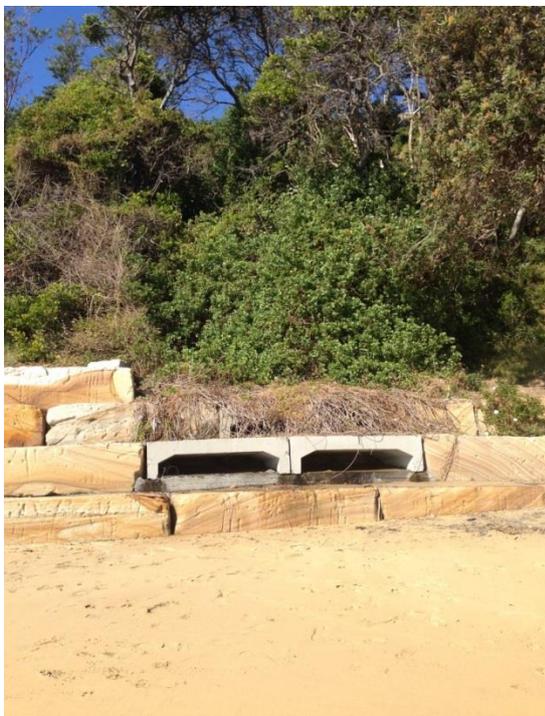
Figure 9: Eastern stormwater culverts entering Terrigal Haven Beach from Scenic highway and residential areas.

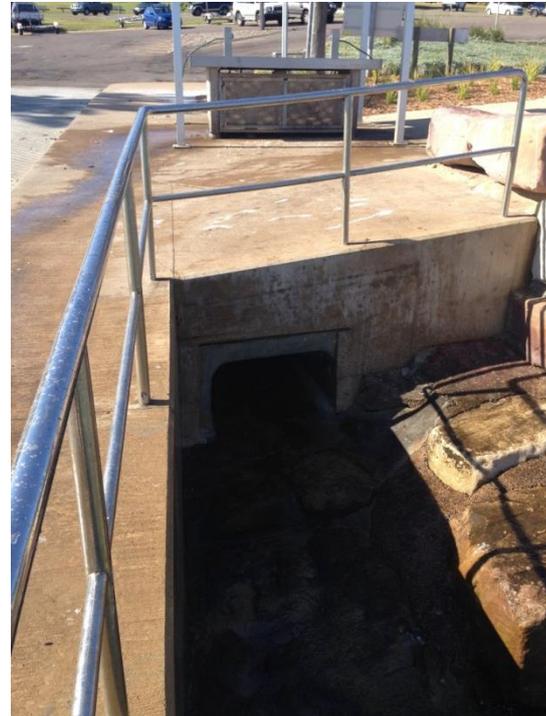
Figure 10: Western stormwater culvert entering Terrigal Haven Beach from carpark and Terrigal Haven streets near the dog off-leash park.

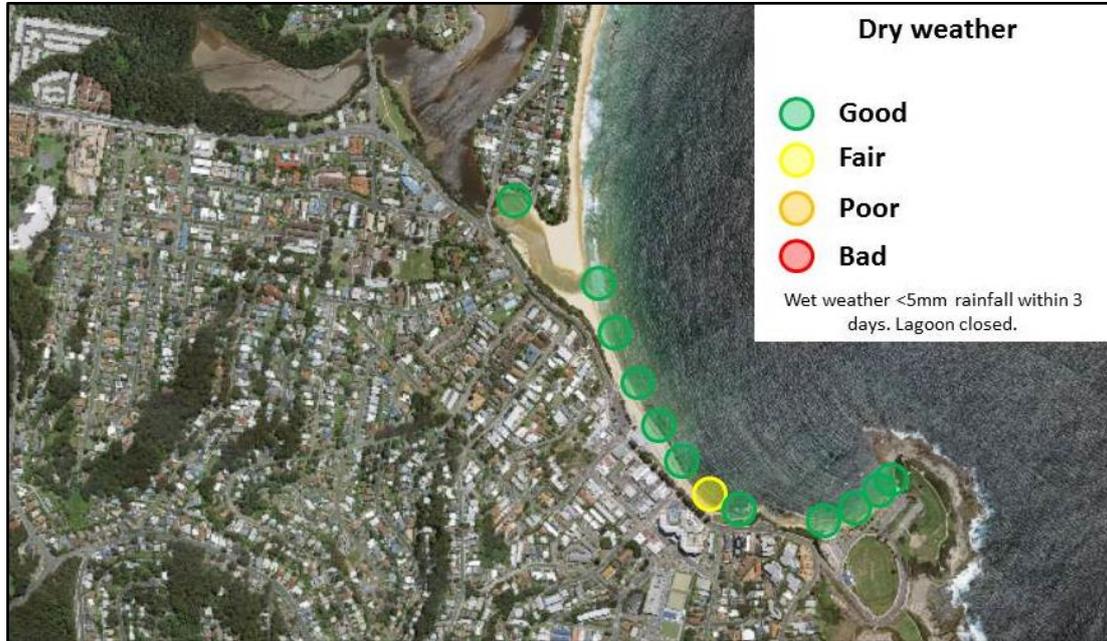
outliers), the *Marine Rescue* site generally showed low Enterococci results, with a maximum of Fair (121mpn/100ml) in dry weather.

Figure 11: Average water quality 20 sampling days 17 January – 31 May 2019 (average excludes a single outlier at the Marine rescue which is discussed in-text).

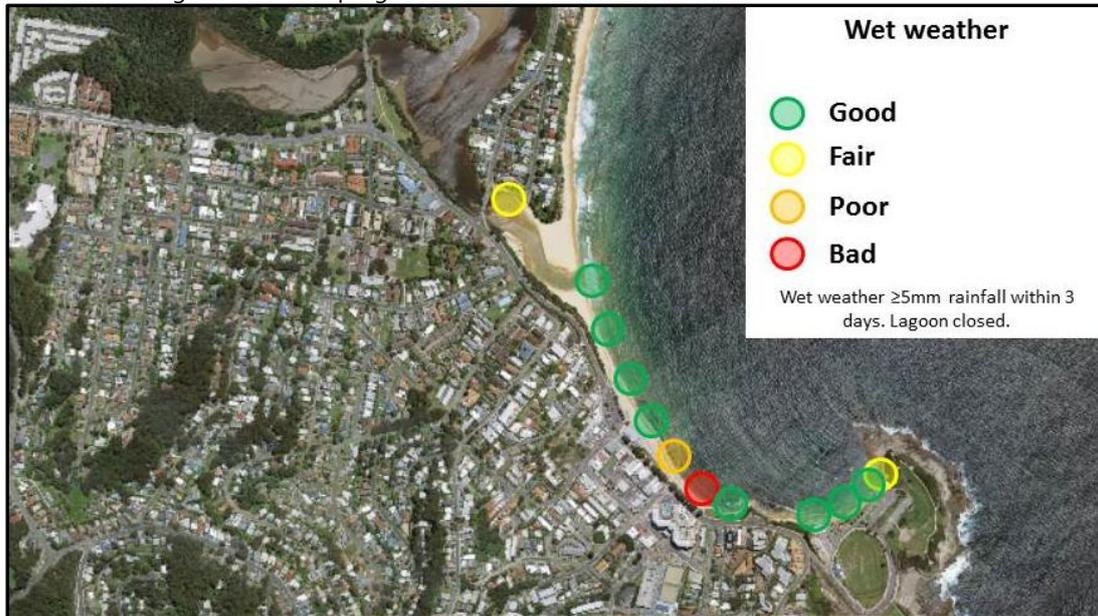
Marine Rescue boat ramp (Appendix 3 and 4). This was not associated with any overflows on Council records. These results are being further investigated.

Figure 12: Average water quality 20 sampling days 17 January – 31 May 2019.

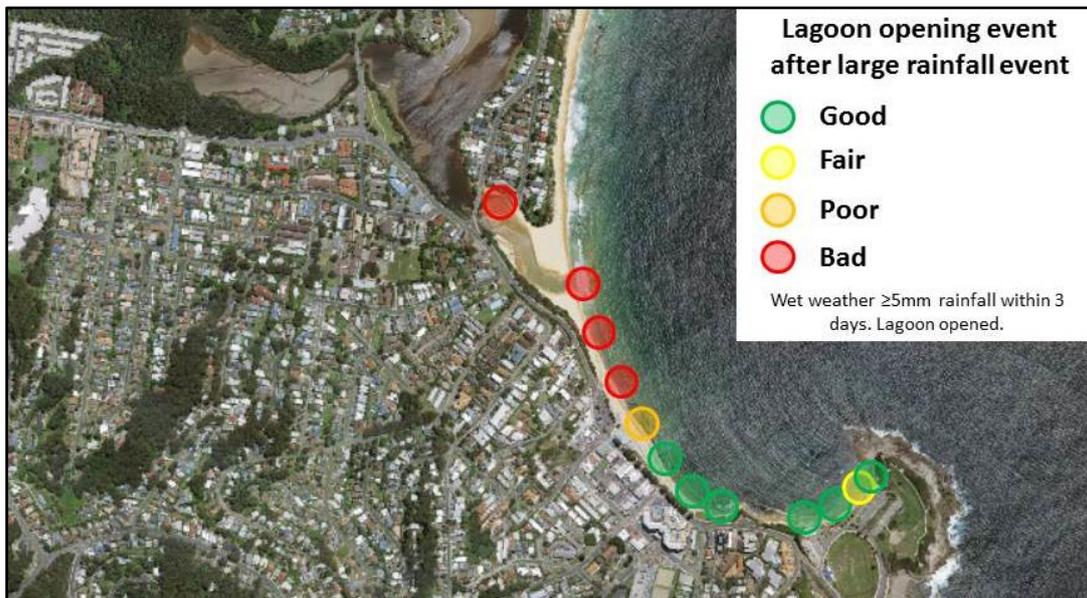
During the lagoon opening on the 2/4/2019, the Terrigal Catchment Audit took samples before (1/4/2019) and after (3/4/2019) the lagoon was manually opened. Rainfall over the day of and three days prior to lagoon opening was 44.5mm. Ocean conditions resulted in the lagoon water moving south, in front of the SLSC and evidence of turbid water was seen at the sample site known as Sth of Flags. Enterococci sampling indicated that beach sites were not suitable for swimming, and despite water being dark brown with large volumes of froth forming on the beach (Figure 13 and 14), a number of community members were swimming despite permanent warning signs about swimming after rainfall and despite the unappealing conditions at the beach. Water samples as of the 9/4/2019 showed that the beach was considered "Good" for swimming at 100% of Terrigal Beach and 75% of Terrigal haven Beach.

Figure 12: Water quality (single day sample 3/4/2019).

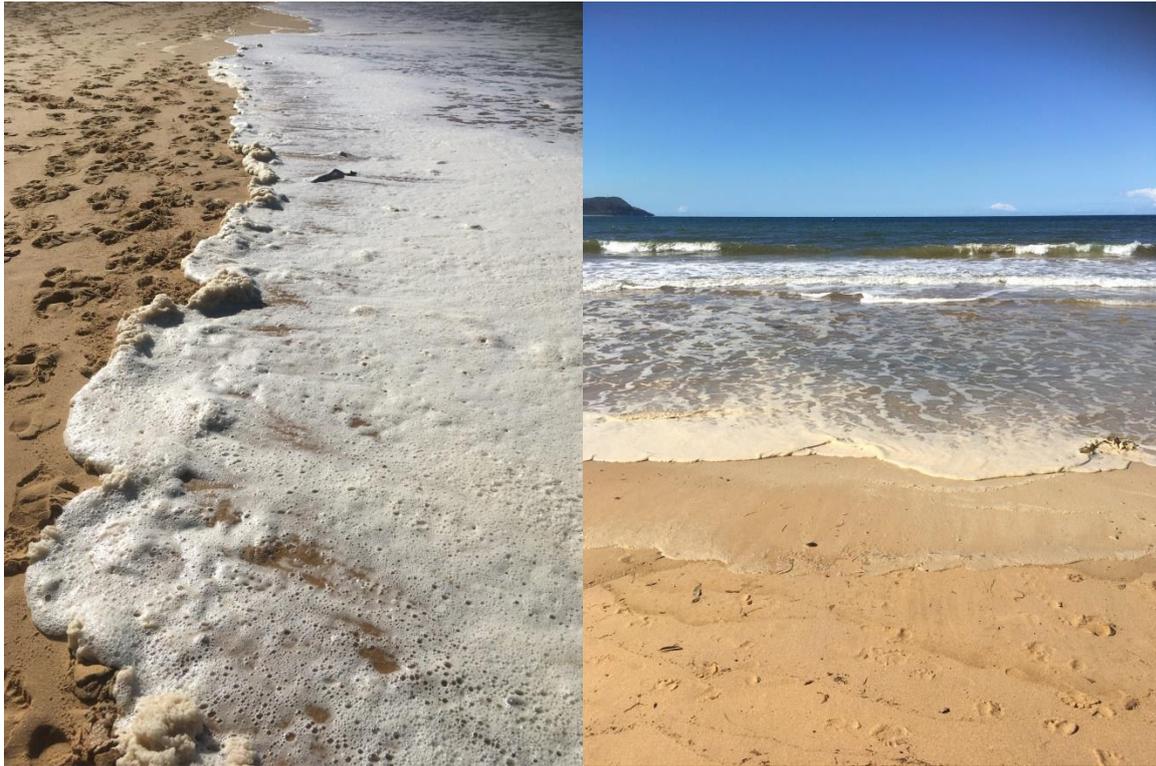
Figure 13 and 14: Poor conditions and unappealing appearance of Terrigal Beach after lagoon opening. Photos taken on the 3/4/2019.

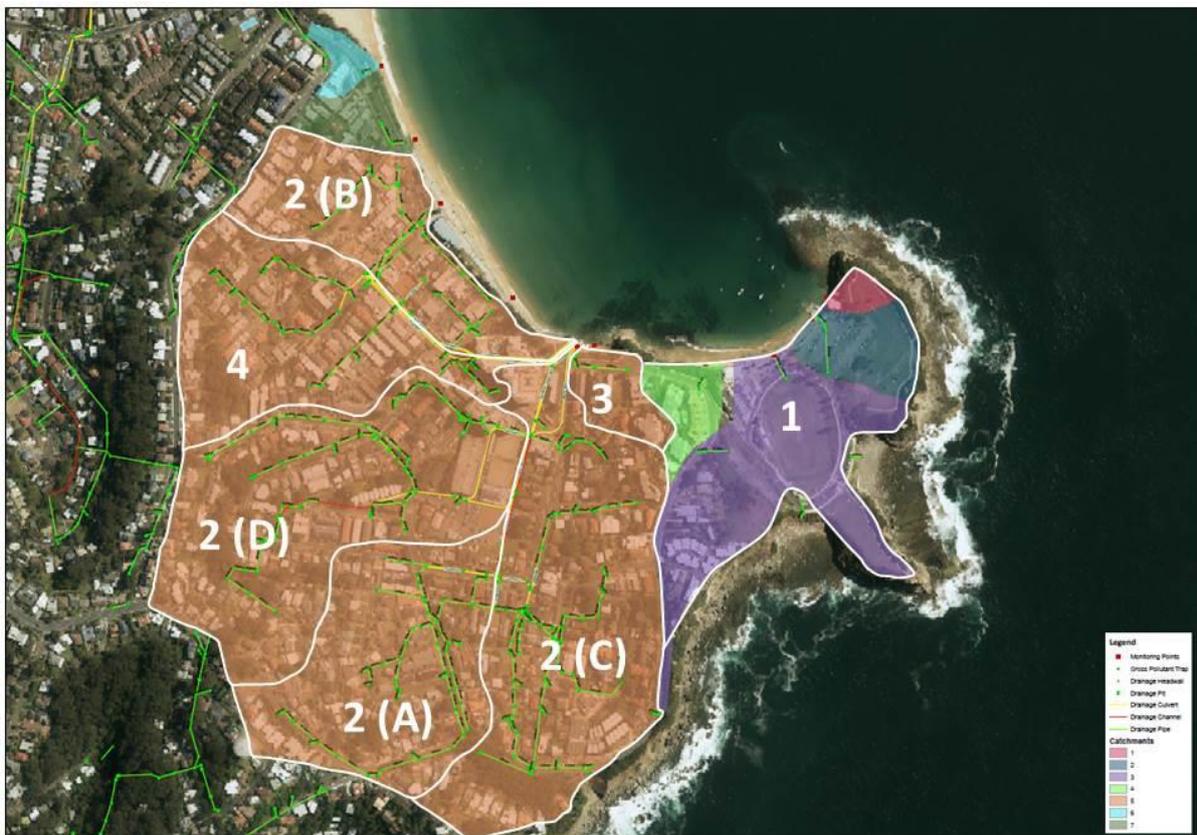
Figure 16: Priority sub-catchment zones scheduled for works in the 2018-2019 and 2019-2020 financial year based on stormwater quality. Later stages of the audit with the NSW Government will reassess the priority sub-catchment map based on microbial load.

In Terrigal Haven and Terrigal Beach CCTV investigations have started (Zone 1 Figure 16) and zone 2 (A) ("7 drains" T6-T9) (Table 4). The details in the work schedules will change, adapting to water quality results. Currently the works schedule extends until

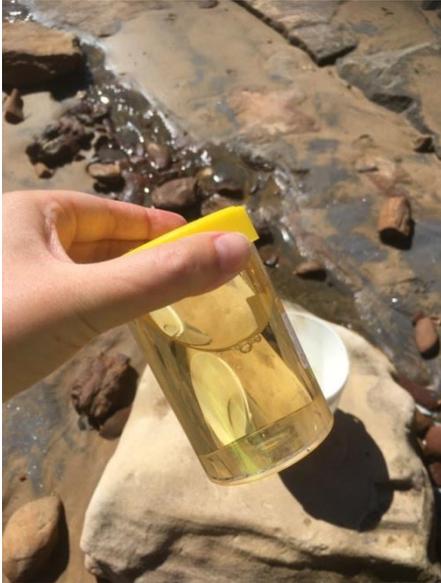
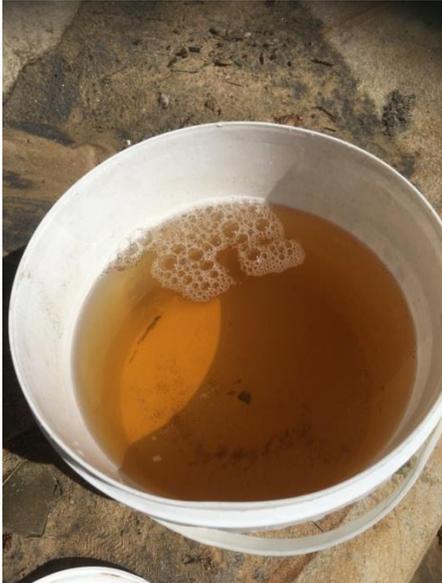
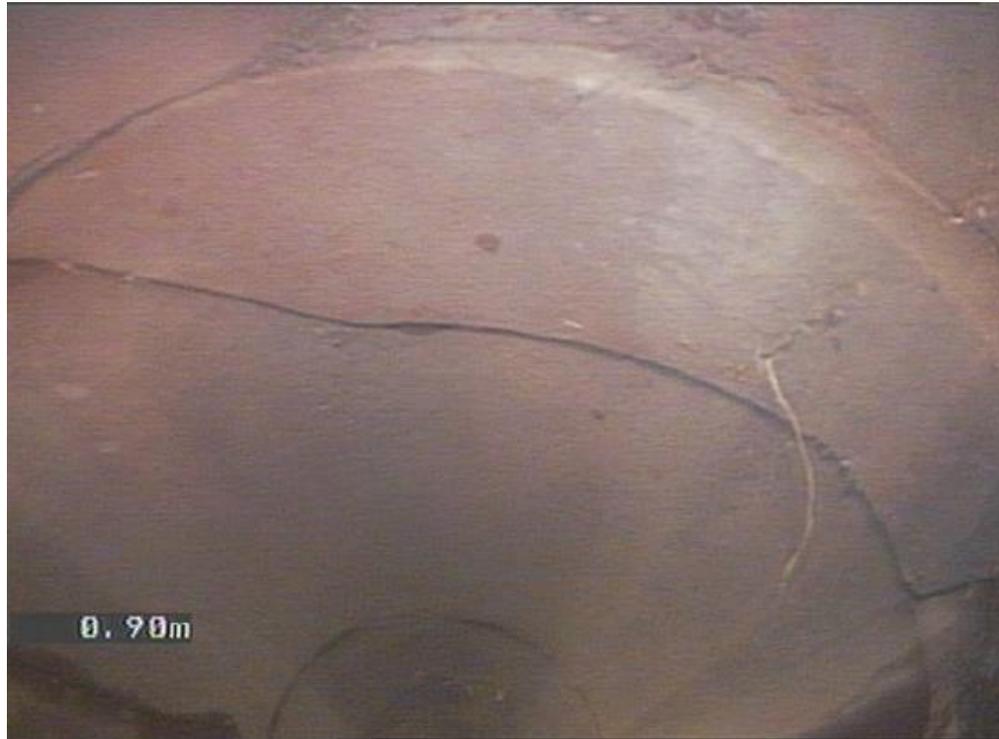
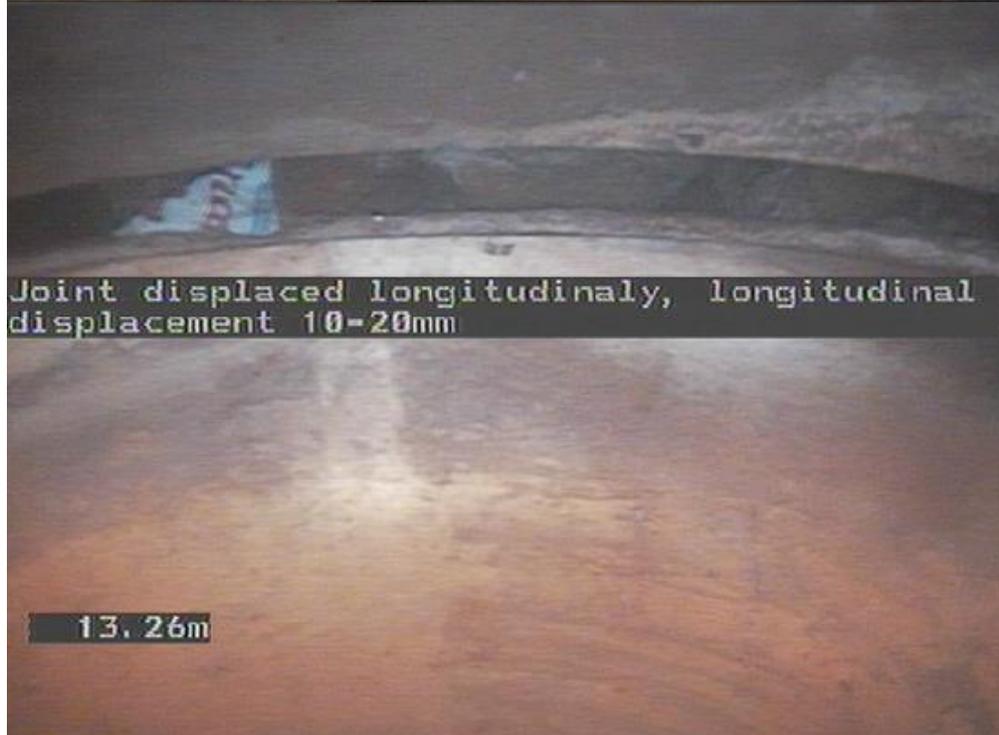
Examples of stormwater pipe issues at H2

Stormwater Pipe H2	
Audit information	<p>Investigations at the drain H2 have direct indicators of sewage input. A possible source includes infiltration from the underground sewage network which may infiltrate into the stormwater system. To cover other possible sources of discolouration further analysis was undertaken.</p> <div style="display: flex; justify-content: space-around;">

Response to audit data	<p>A) Once water quality was confirmed as poor, the audit program assessed the beach water quality directly outside the pipe. Water quality at the beach did not have elevated levels of Enterococci, and swim safety was not affected by poor stormwater quality. The pipe H2 has minimal water flow during dry weather, and is intermittent, having very low flow at the time that the audit was undertaken. These low volumes of poor water quality were not affecting swim safety, however, the infrastructure required investigation and works to prevent sewage from entering stormwater. Organic fertiliser is not used on the oval and therefore cannot be a source of Enterococci.</p> <p>B) CCTV works were immediately undertaken assessing infrastructure condition stormwater pipe H2 and the sewer main directly crossing underneath the stormwater pipe. Both stormwater and sewer were determined to be in poor condition and in need of immediate works (See photographs below). It is</p>

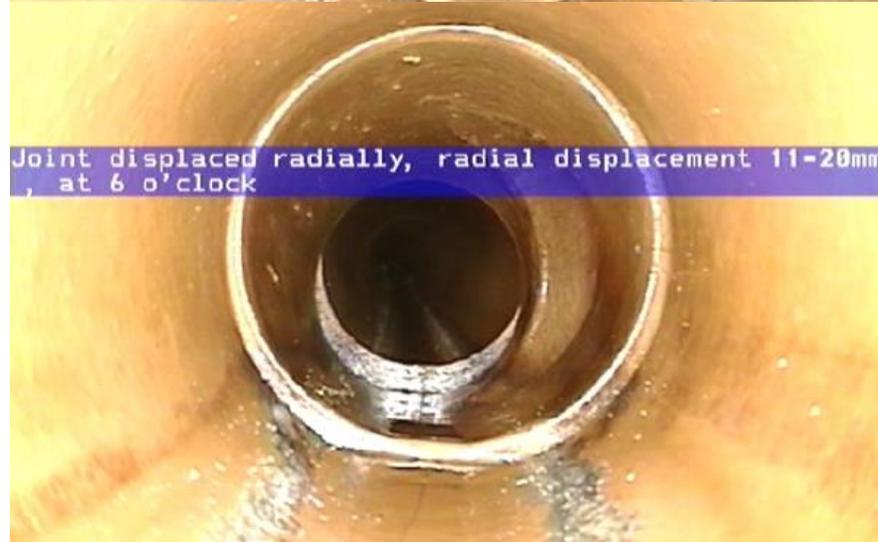
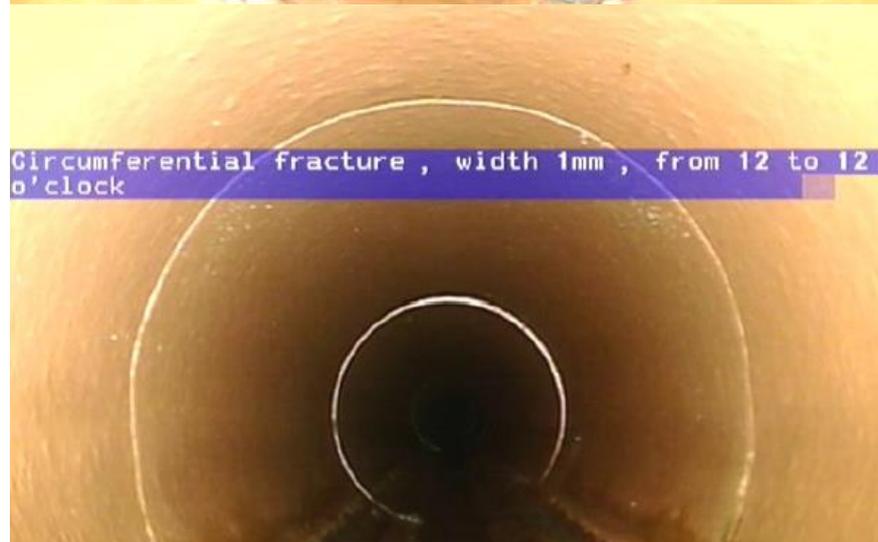
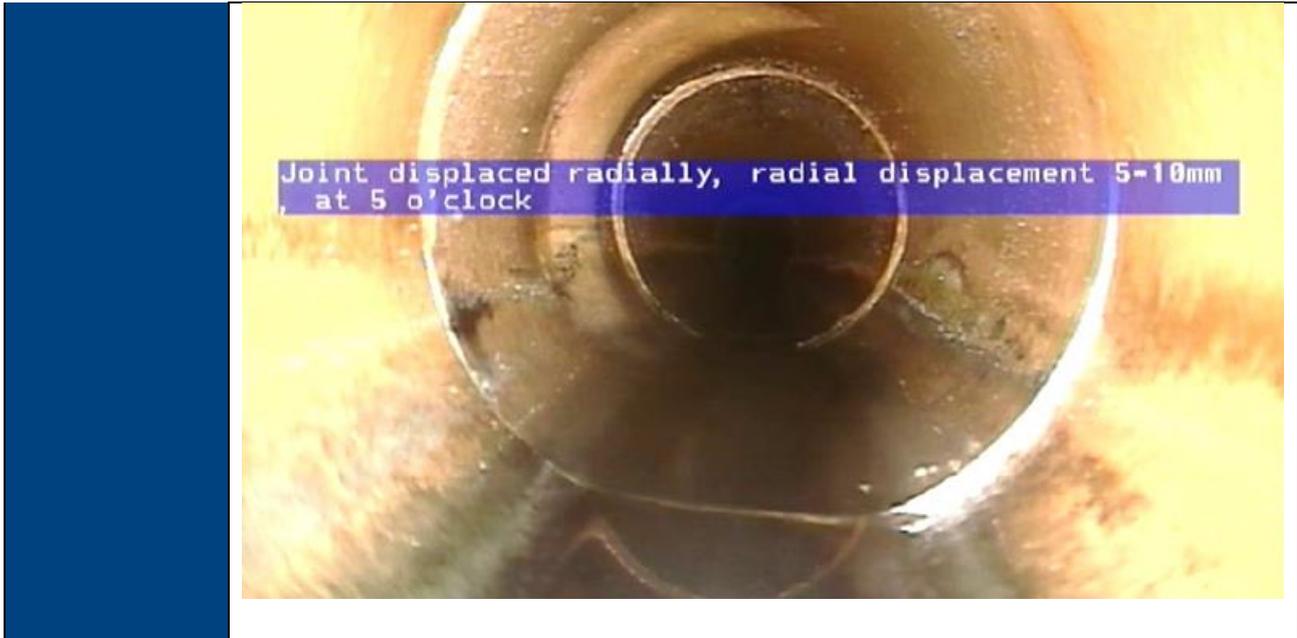
Examples of sewer pipe issues

Sewer pipes leading to stormwater Pipe T9	
Audit information	General sewer CCTV work throughout the catchment detected minor structural issues in a sewer pipe. There is currently no evidence to suggest that the sewer pipe is affecting stormwater quality. The stormwater pipe in close proximity (T9) does not have dry weather flows suggesting there is little to no cross-contamination. T9 is a small catchment unlikely to receive regular catchment water in dry weather e.g. car washing/sprinklers, as other pipes in the "7 drains" do.

Response to audit data	Not applicable - There is currently no evidence to suggest the sewer pipe is affecting stormwater quality.
Works scheduled	Relining of sewer mains identified as being in poor condition due to commence in the first quarter of the 2019-2020 financial year and completed at the end of second quarter of the 2019-2020 financial year.
Remaining investigations	<p>A more detailed investigation into possible infiltration from the sewer pipe to the stormwater pipe is advised. The audit program will continue monitoring the water quality from T9 when available. Further CCTV survey work to be performed in the upstream sewer sub-catchments that relate to sections 2A and 2C in Figure 15 to assess sewer network condition.</p> <p>Whilst T9 does not experience regular dry weather flow, T8 does. It is currently not known if T8 and T9 are connected underground. Works are scheduled to determine if these stormwater pipes are connected and assess their current condition.</p>

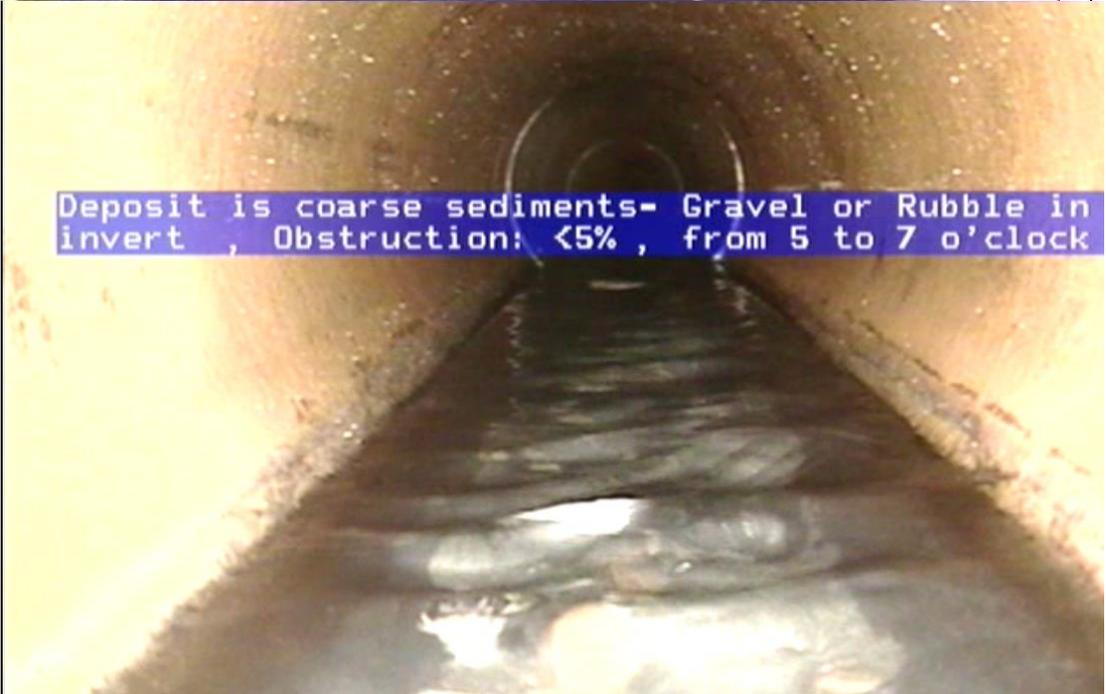
Deposit is coarse sediments- Gravel or Rubble in invert , Obstruction: <5% , from 5 to 7 o'clock

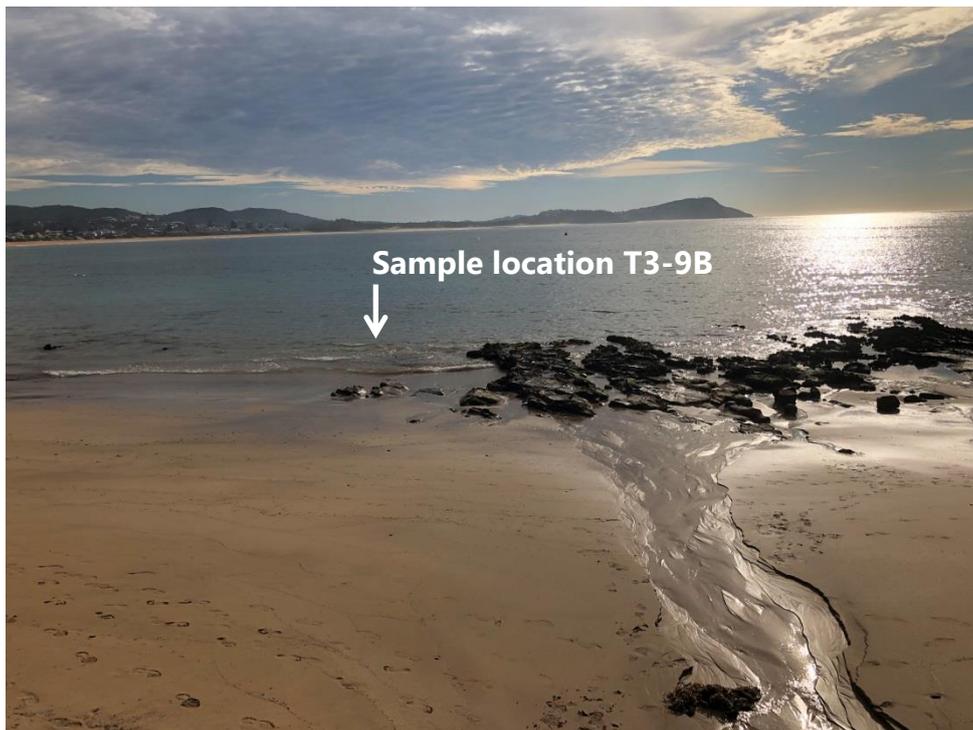
Appendix 2: Photograph of ocean sample location T3-9B which received two days of elevated Enterococci in 23 days of sampling. Photograph shows dry weather flow from drain T8.

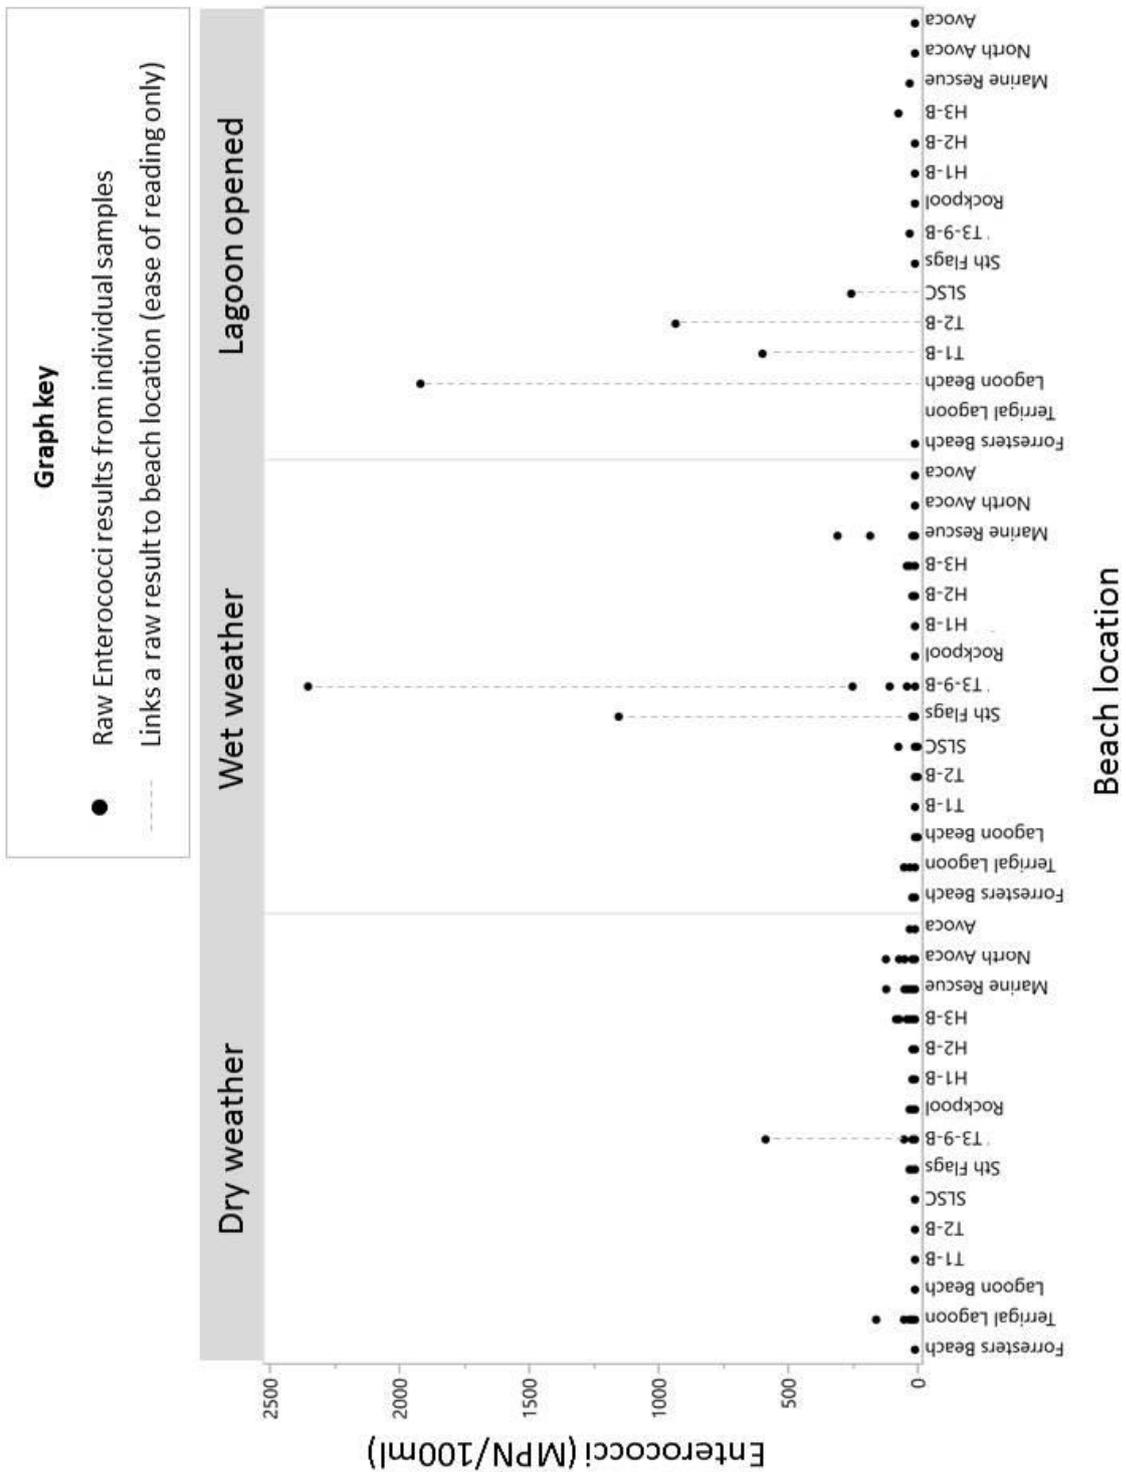
Appendix 4: Outliers excluded. Raw Enterococci data for beach samples from 17 January – 31 May 2019 with outliers excluded to see data more easily.
