Central Coast Council

ORDINARY COUNCIL MEETING

Central Coast Council
Enclosures to the
Ordinary Meeting
to be held in the Council Chamber,
2 Hely Street, Wyong
on Tuesday, 29 January 2019,
Commencing at 6.30pm

Attachment 1 Terrigal and Wamberal Beach Site Inspection Report and Risk Management Plan

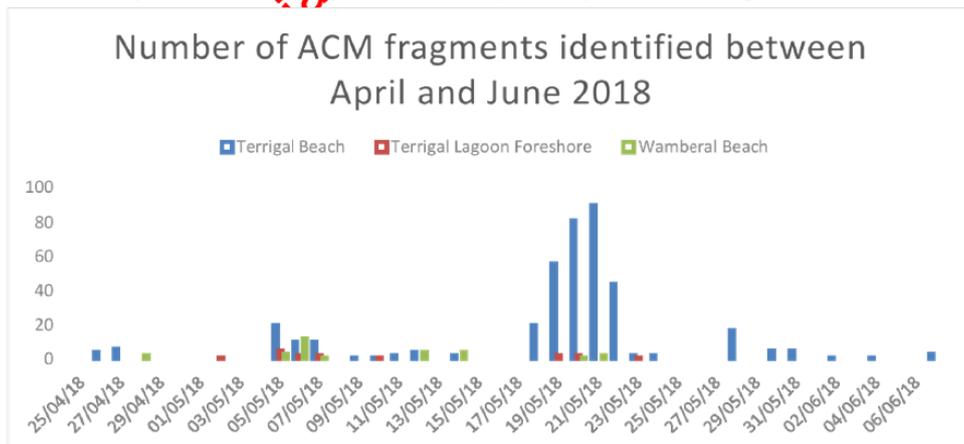
Figure 1: Number of ACM fragments identified during Council site inspections between April and June 2018.

Council have implemented an online data capture program to log the identification of suspected ACM at the site. A review of the data collected by Council between April and June 2018 indicates the frequency of ACM identified at the site has reduced, particularly at Wamberal Beach where no ACM has been identified by Council during daily site inspections since 23 May 2018. A summary of the data capture is presented in **Figure 1**.

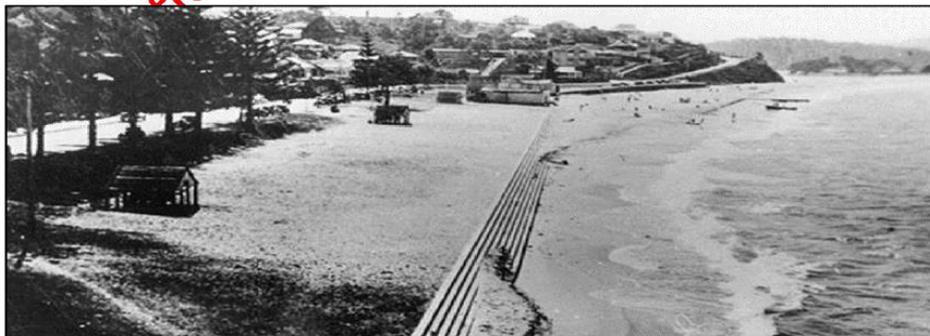
Plate 1 – 1930 historical image of Terrigal Beach

A series of historical images for Terrigal Beach were reviewed by PRM as part of the site history review. The images were accessed online¹ by PRM on 3 July 2018 and included various imagery of Terrigal Beach and surrounds between 1907 and 1958. The images generally show Terrigal Beach to be low density residential and agricultural grazing land. In addition, a 1930s image of Terrigal Beach provided by Council is included in **Plate 1**. The image shows a former timber sea wall on the Beach front.

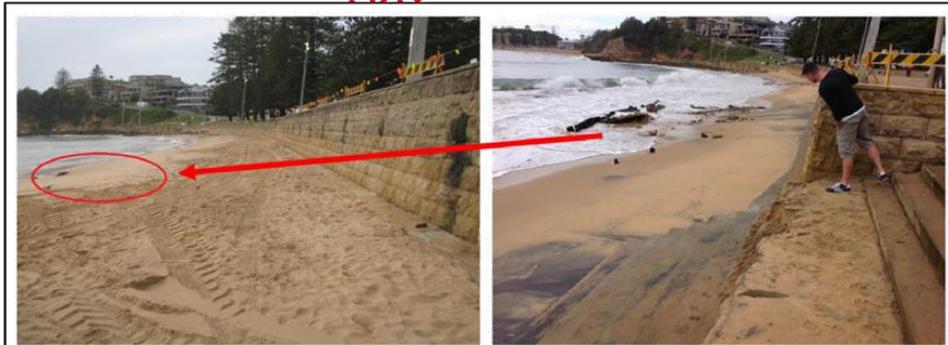
Plate 2 – 2016 Storm event at Terrigal Beach showing exposed timber sea wall and associated fill material.

The exact source/s of the suspected ACM contamination identified at Terrigal Beach is unclear, however, anecdotal evidence suggests it may be associated with the historical construction and backfilling of a former timber sea wall at Terrigal Beach. It is understood that the former sea wall is located beneath the sand at the southern end of Terrigal Beach, between the rockpool and the surf life saving club. Images of the former timber seawall and exposed fill material were provided to PRM by Council on 8 May 2018. **Plate 2** shows the exposed sea wall and fill material exposed during the 2016 storm event. Additional imagery of the exposed former seawall at Terrigal were sourced online² by PRM and are provided in **Plate 3** and **Plate 4**. It is suspected that fragments of ACM are being exposed by tidal erosion and natural beach processes and are being transported within the wash-zone and deposited at random locations at Terrigal Beach. It is important to note that this has not been investigated or confirmed and is currently based on anecdotal evidence only.

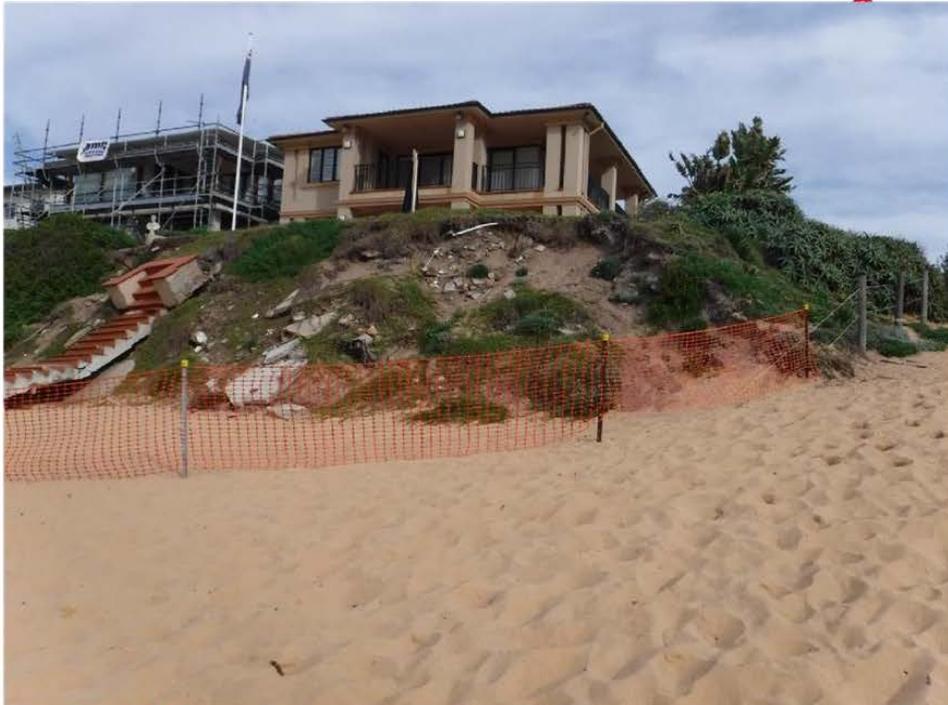
Plate 5 - Foredune erosion and typical filling at Wamberal Beach.

Plate 5 displays the typical condition of the eroded foredune and associated filling at Wamberal beach.

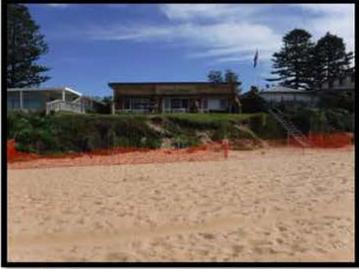
<p>Photo 1: Site: 15</p>

Properties observed with suspected ACM: Refer to Table 1 for details.

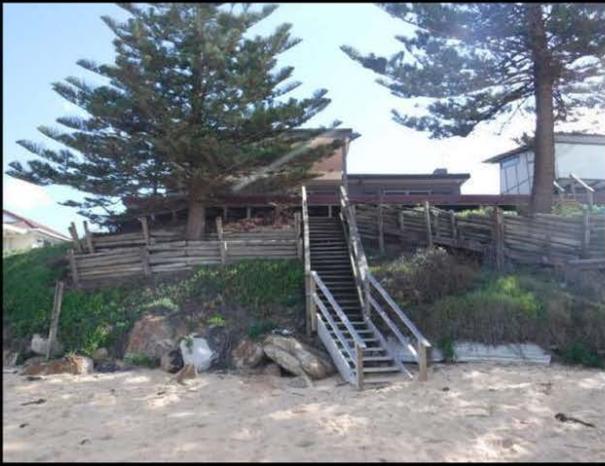
Sample Collection Record - SF02		PRM Preventive Risk Management	
Inspection Particulars:			
Site Personnel:	Geoff Fletcher, Sarah Dale		
Date:	4th May 2018		
Time:	8:30am		
Weather:	Clear skies		
Wind:	No wind		
Public Enquiry:	No		
Google Maps Site ID:	75 Ocean View Drive, Wamberal NSW 2260		
Inspection Results:			
General Comments:			
Embankment Description:	Good vegetation coverage, timber retaining wall on property, no temporary fence on public beach.		
Embankment materials:	Sandstone at base, building rubble, minor exposed fill		
Suspected Asbestos Containing Material Observed?			
Private Property	Yes	Bonded fragments, weathered	
Council Beach	Yes	Bonded fragments, weathered	
Areas of Note:

Note Number:		Comment/Description:	
Note 1:		Suspected Asbestos Fragment	
Note 2:		Suspected Asbestos Fragment SF02	
Note 3:

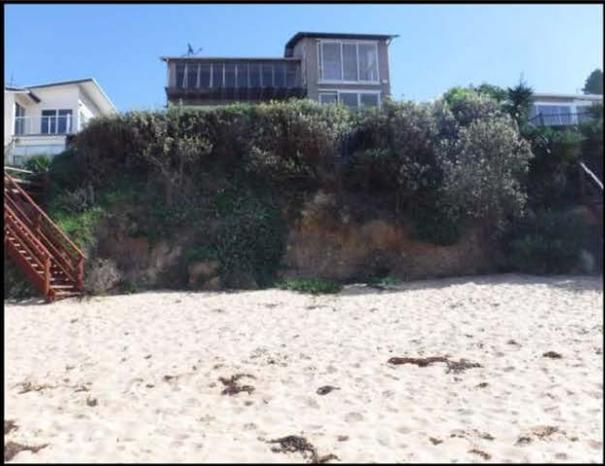
Inspection Particulars:				
Site Personnel:	Geoff Fletcher, Sarah Dale			
Date:	4th May 2018			
Time:	8:30am			
Weather:	Clear skies			
Wind:	No wind			
Public Enquiry:	No			
Google Maps Site ID:	55 Ocean View Drive, Wamberal NSW 2260			
Inspection Results:				
General Comments:				
Embankment Description:	Good vegetation coverage at top of embankment, fill exposed at the base, no temporary fence on public beach.			
Embankment materials:	Concrete, brick and sandstone in exposed fill			
Suspected Asbestos Containing Material Observed?				
Private Property	Yes	Bonded fragments, weathered		
Council Beach	Yes	Bonded fragments, weathered		
Areas of Note:

Note Number:	Comment/Description:
			Note 1:	Suspected Asbestos Fragment
			Note 2:	Suspected Asbestos Fragment
			Note 3:
