# Gosford City Waterways

## The Health of Gosford City Waterways Report 2015

## The Health of Gosford Waterways Report 2015

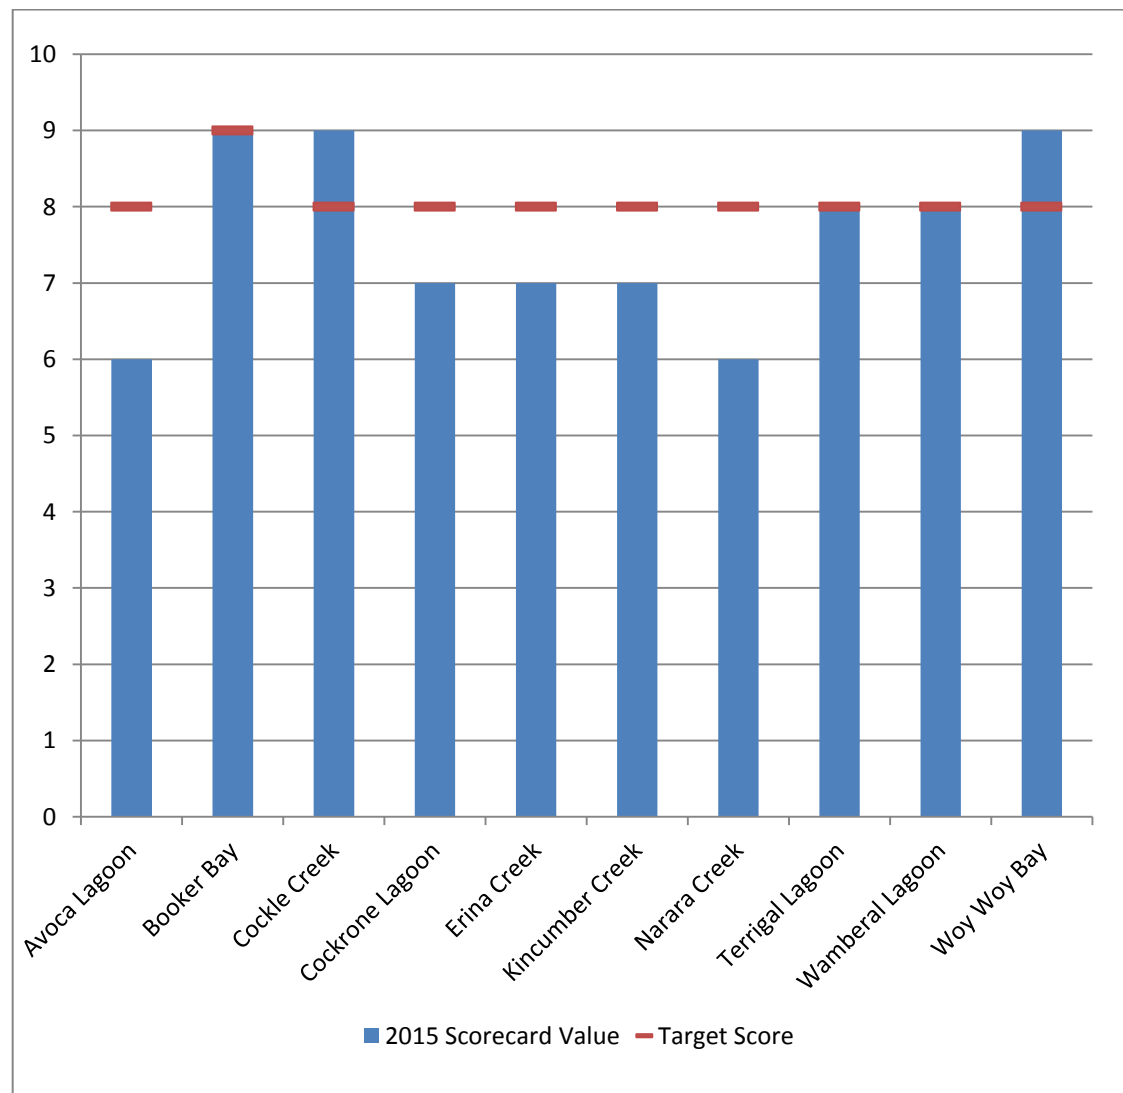
Figure 2: shows the 2015 average scorecard results from January 2015 to December 2015 for the 10 water quality monitoring sites, based on analytical results of physical and chemical parameters (turbidity, dissolved oxygen, ammonium, oxidised nitrogen, total nitrogen, orthophosphate, total phosphorus and chlorophyll a). The scorecard is based on trigger values set for Gosford City Council using ANZECC 2000 and Gosford Councils historical water quality data for the protection of slightly disturbed ecosystems.

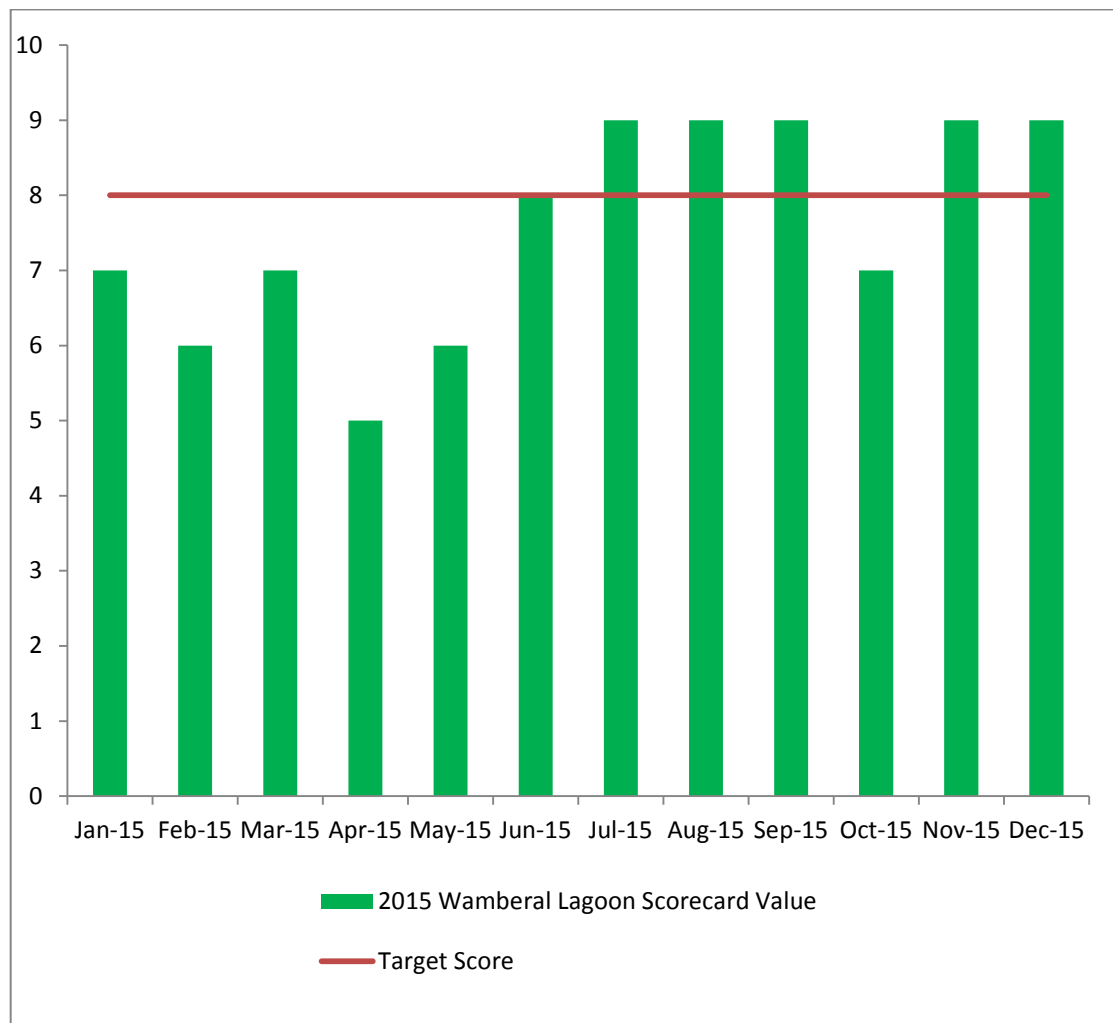
Figure 11: Scorecard results for Wamberal Lagoon during 2015 based on analytical results of physical and chemical parameters (turbidity, dissolved oxygen, ammonium, oxidised nitrogen, total nitrogen, orthophosphate, total phosphorus and chlorophyll a).

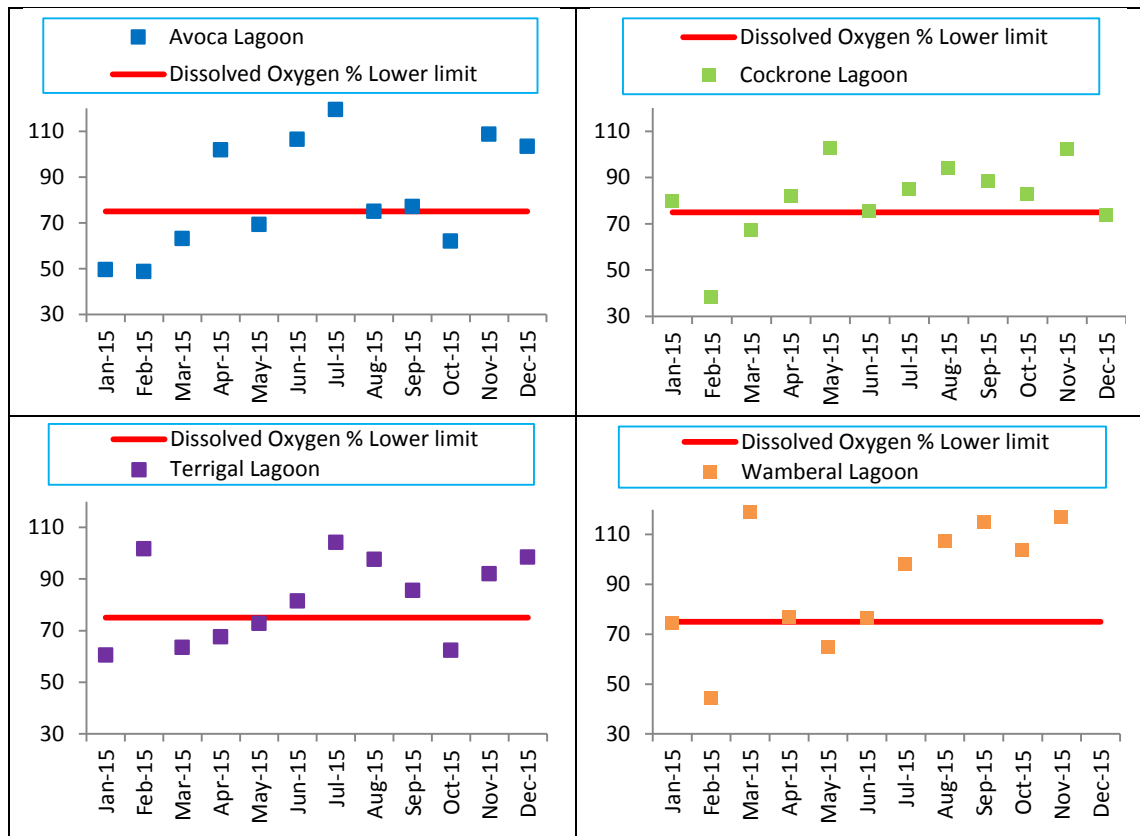
Figure 14: Dissolved Oxygen results for ICOLLS during 2015. The upper and lower limit trigger values are based on ANZECC 2000 guidelines and historical data for the site.

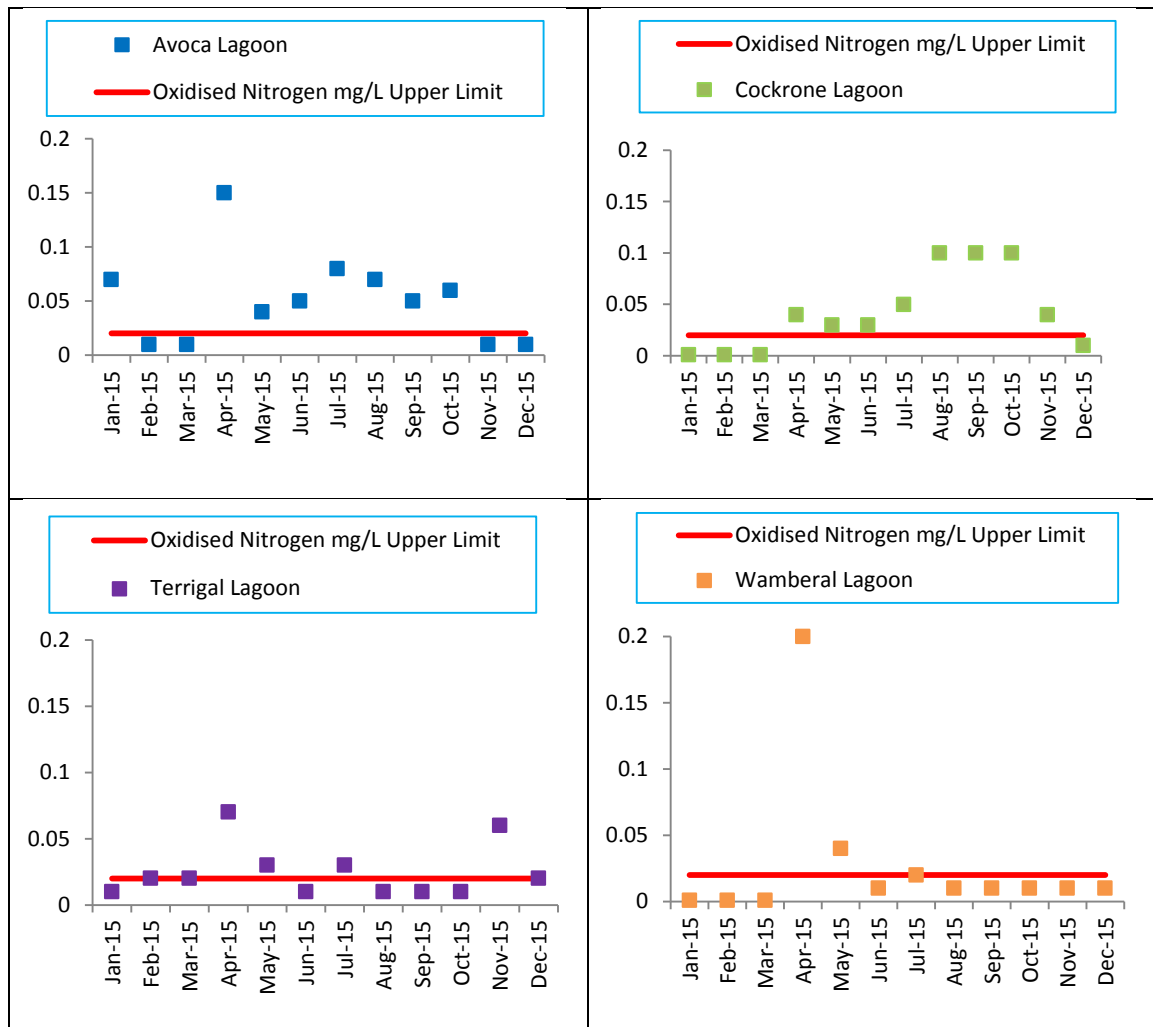
Figure 16: Oxidised Nitrogen results for ICOLLS during 2015. The upper limit trigger values are based on ANZECC 2000 guidelines and historical data for the site.

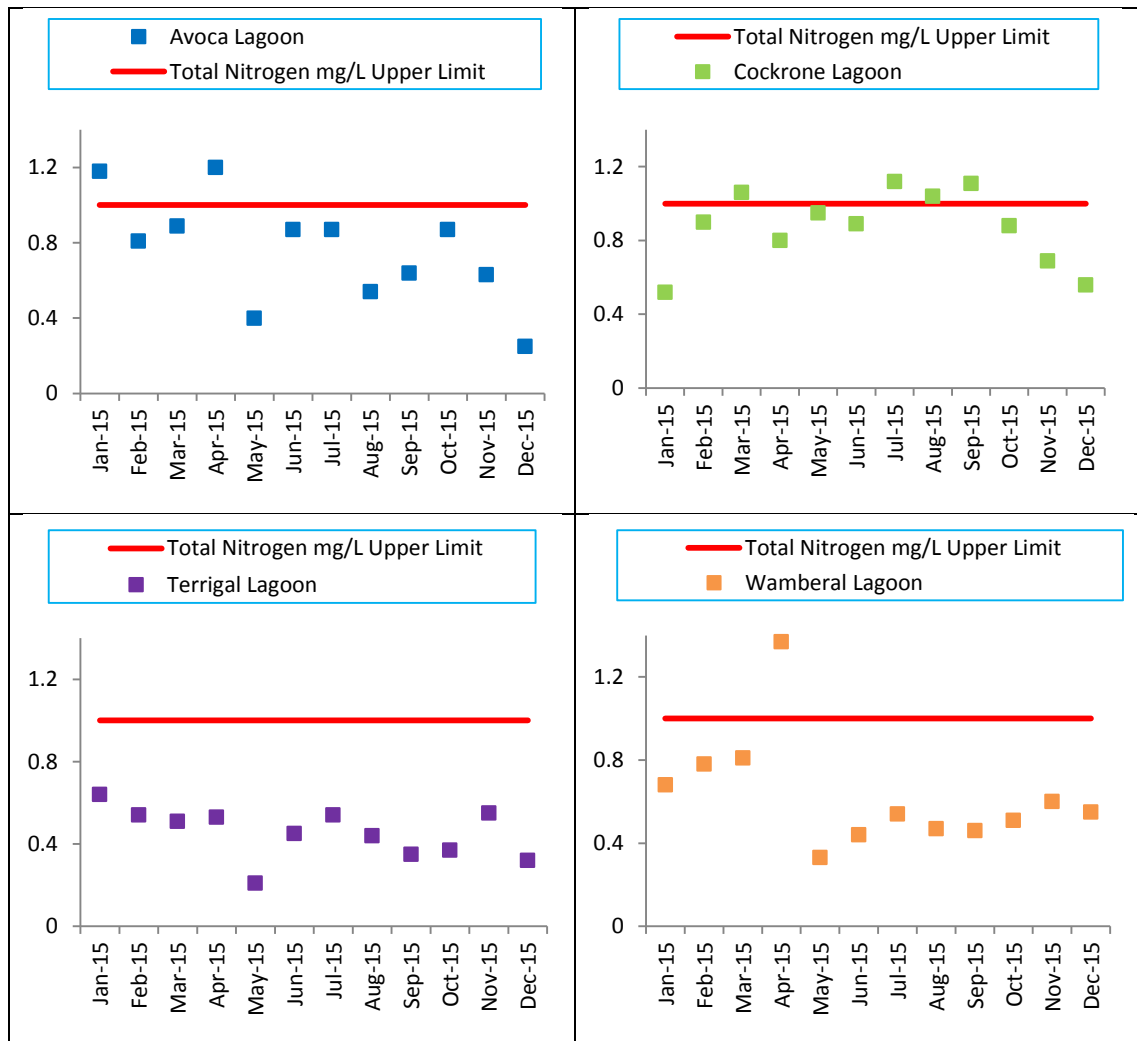
Figure 17: Total Nitrogen results for ICOLLS during 2015. The upper limit trigger values are based on ANZECC 2000 guidelines and historical data for the site.

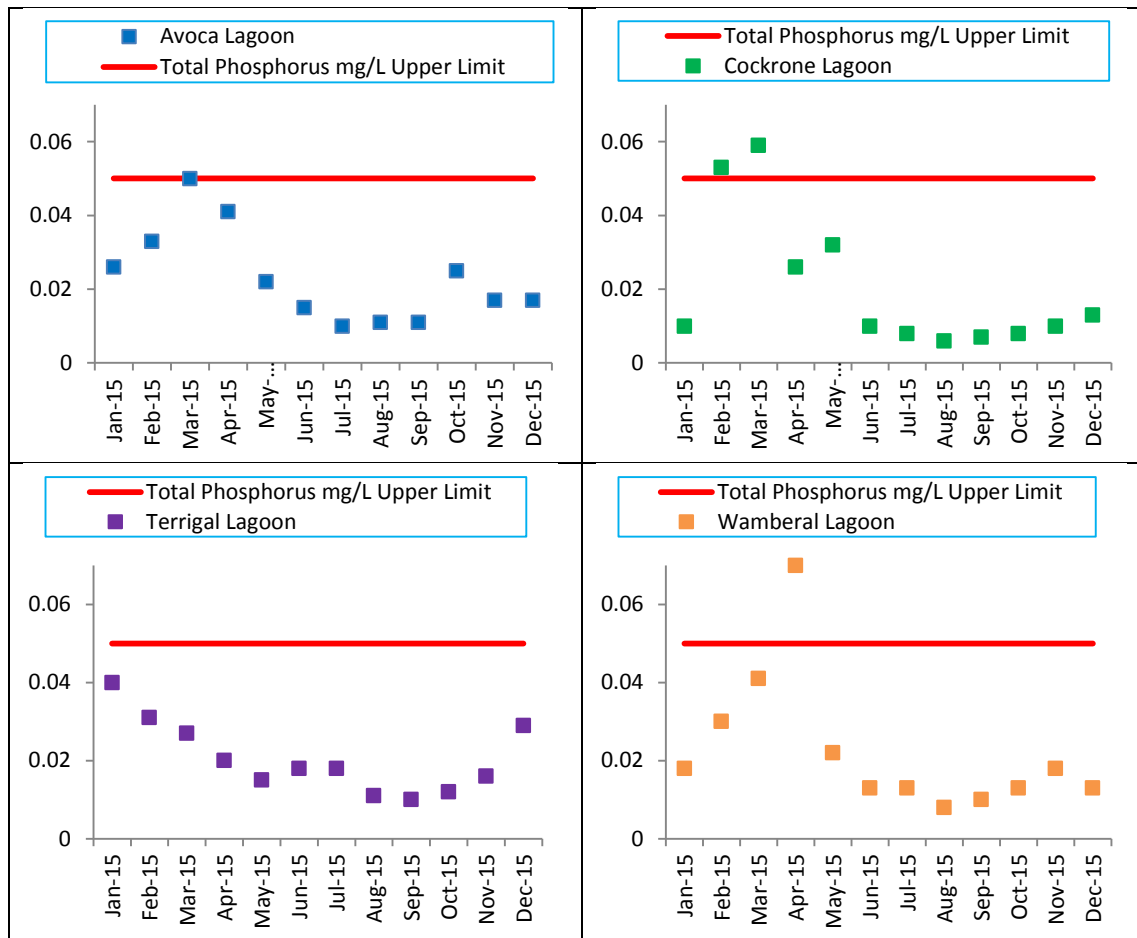
Figure 18: Total Phosphorus results for ICOLLS during 2015. The upper limit trigger values are based on ANZECC 2000 guidelines and historical data for the site.

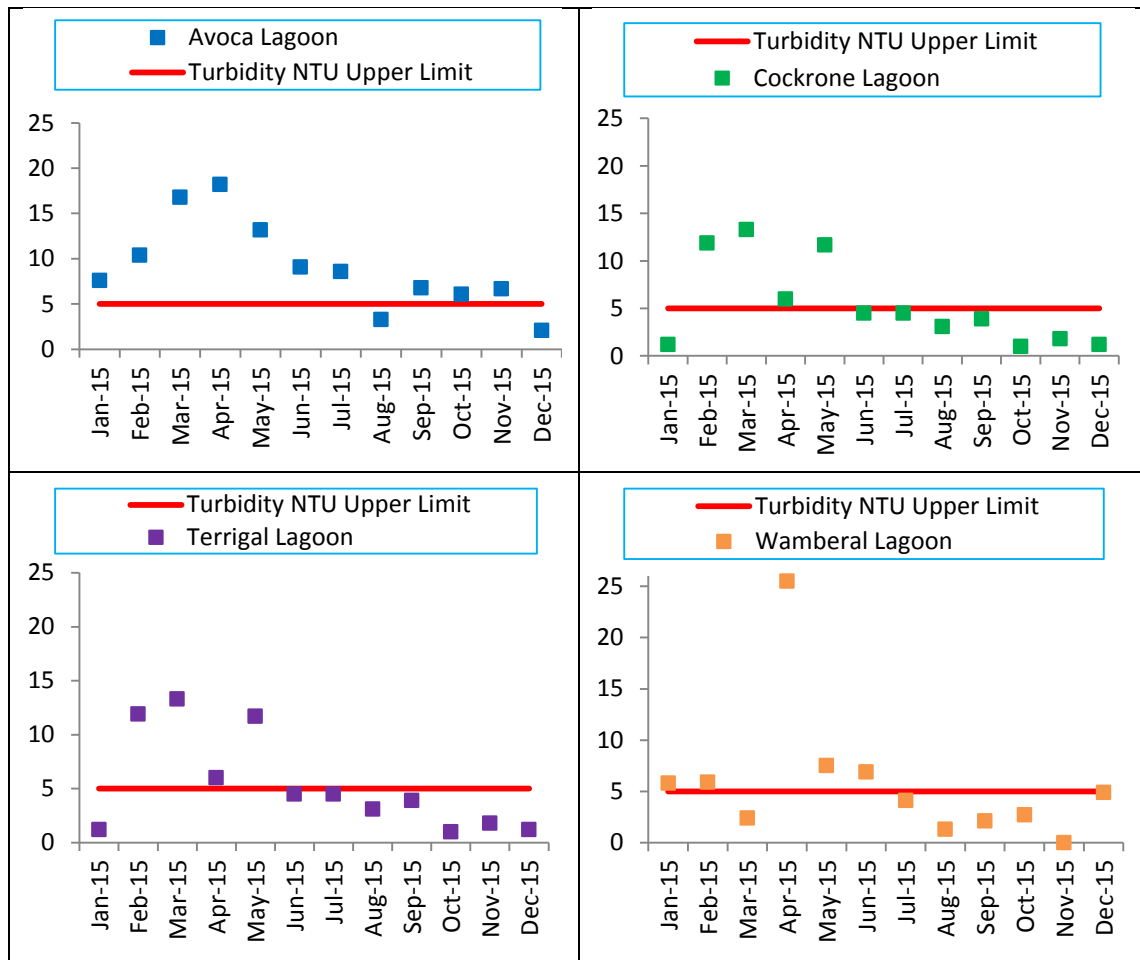
Figure 19: Turbidity results for ICOLLS during 2015. The upper limit trigger values are based on ANZECC 2000 guidelines and historical data for the site.

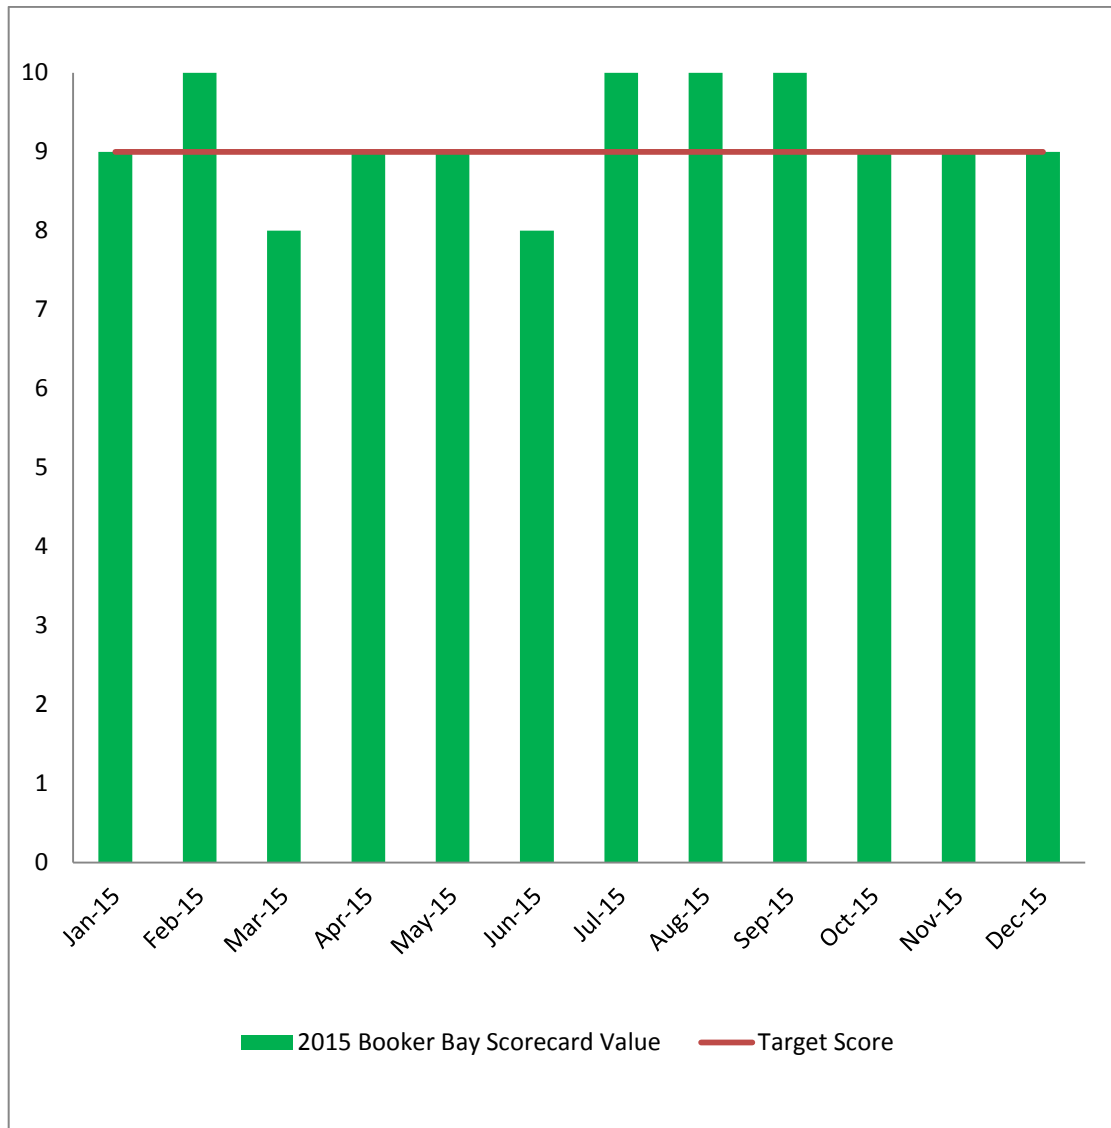
Figure 21: Scorecard results for Booker Bay during 2015 based on analytical results of physical and chemical parameters (turbidity, dissolved oxygen, ammonium, oxidised nitrogen, total nitrogen, orthophosphate, total phosphorus and chlorophyll a).

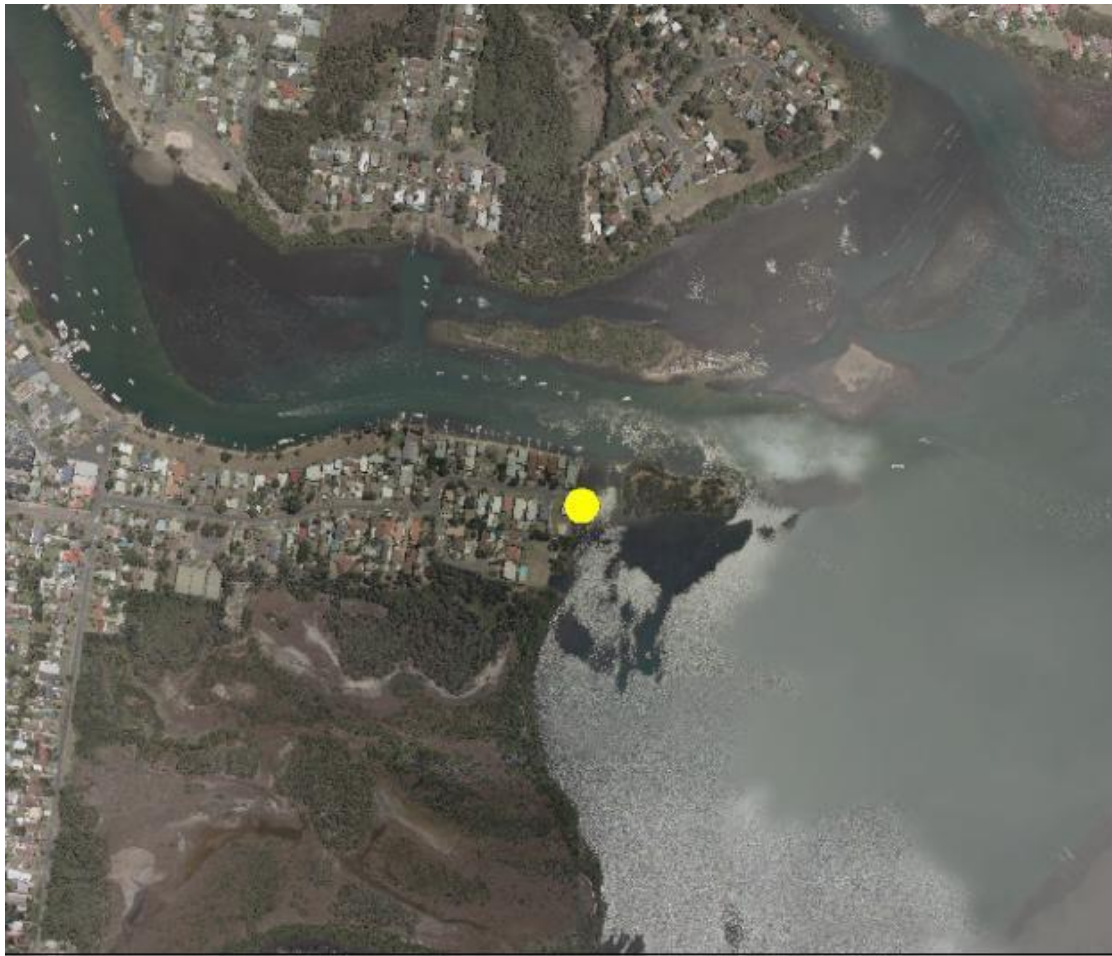
Figure 22. Cockle Creek monitoring location indicated by yellow circle.

Cockle Creek was monitored monthly during 2015. The monitoring location is on Shelly Beach Rd, Empire Bay (Figure 22). The site is deep (more than one metre), experiences tidal movements and a high level of flushing. The bottom substrate is sand.

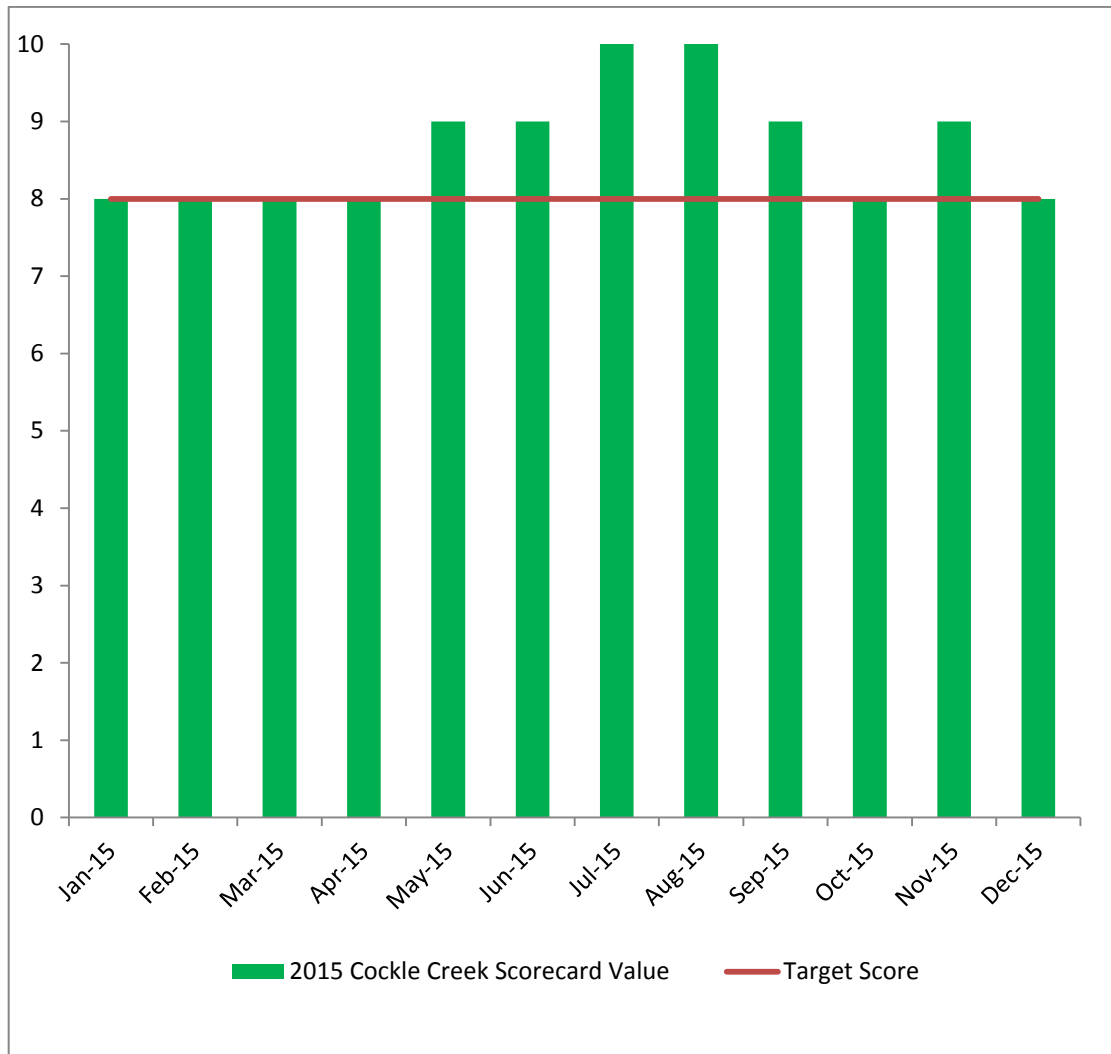
Figure 23. Scorecard results for Cockle Creek during 2015 based on analytical results of physical and chemical parameters (turbidity, dissolved oxygen, ammonium, oxidised nitrogen, total nitrogen, orthophosphate, total phosphorus and chlorophyll a).

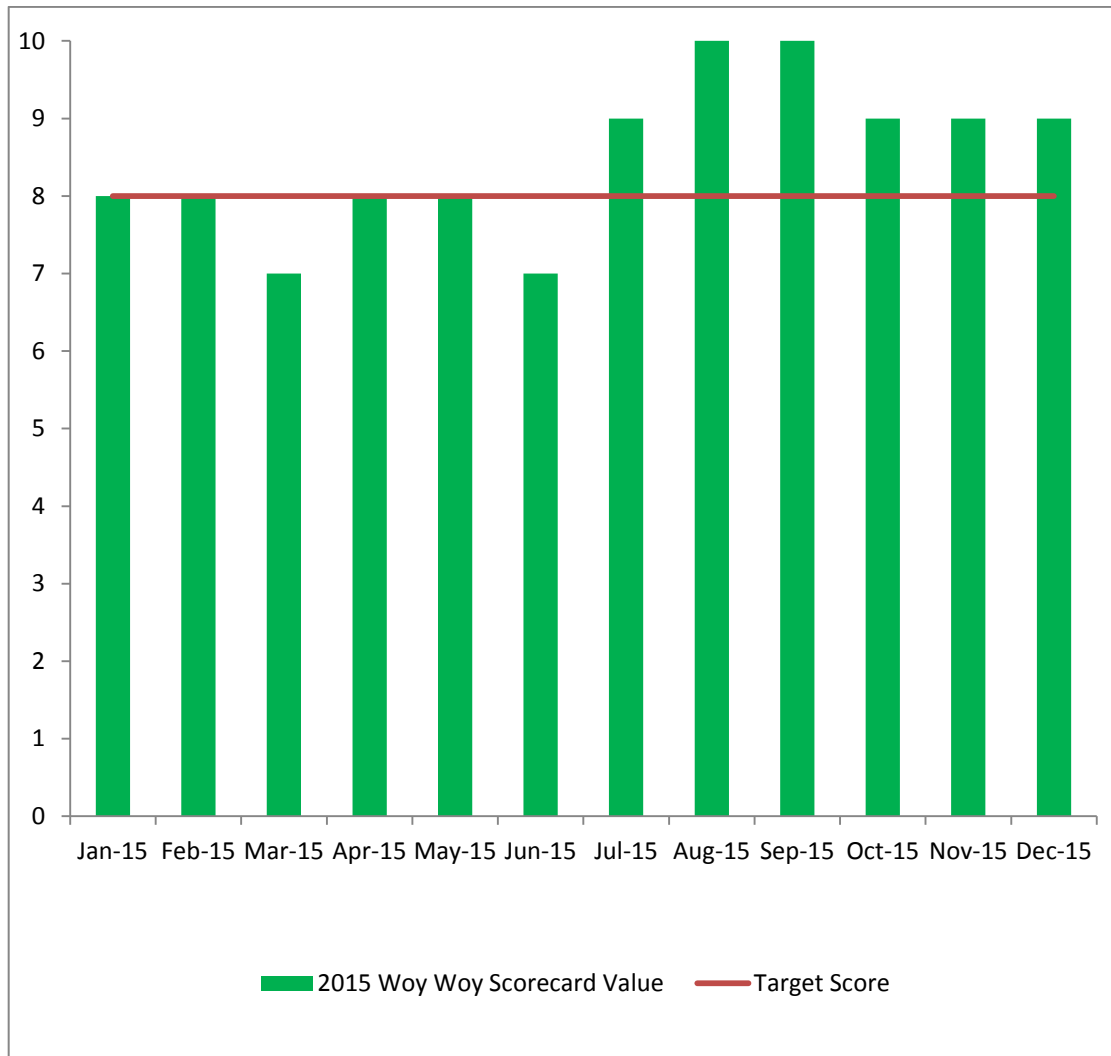
Figure 25: Scorecard results for Woy Woy Bay during 2015 based on analytical results of physical and chemical parameters (turbidity, dissolved oxygen, ammonium, oxidised nitrogen, total nitrogen, orthophosphate, total phosphorus and chlorophyll a).

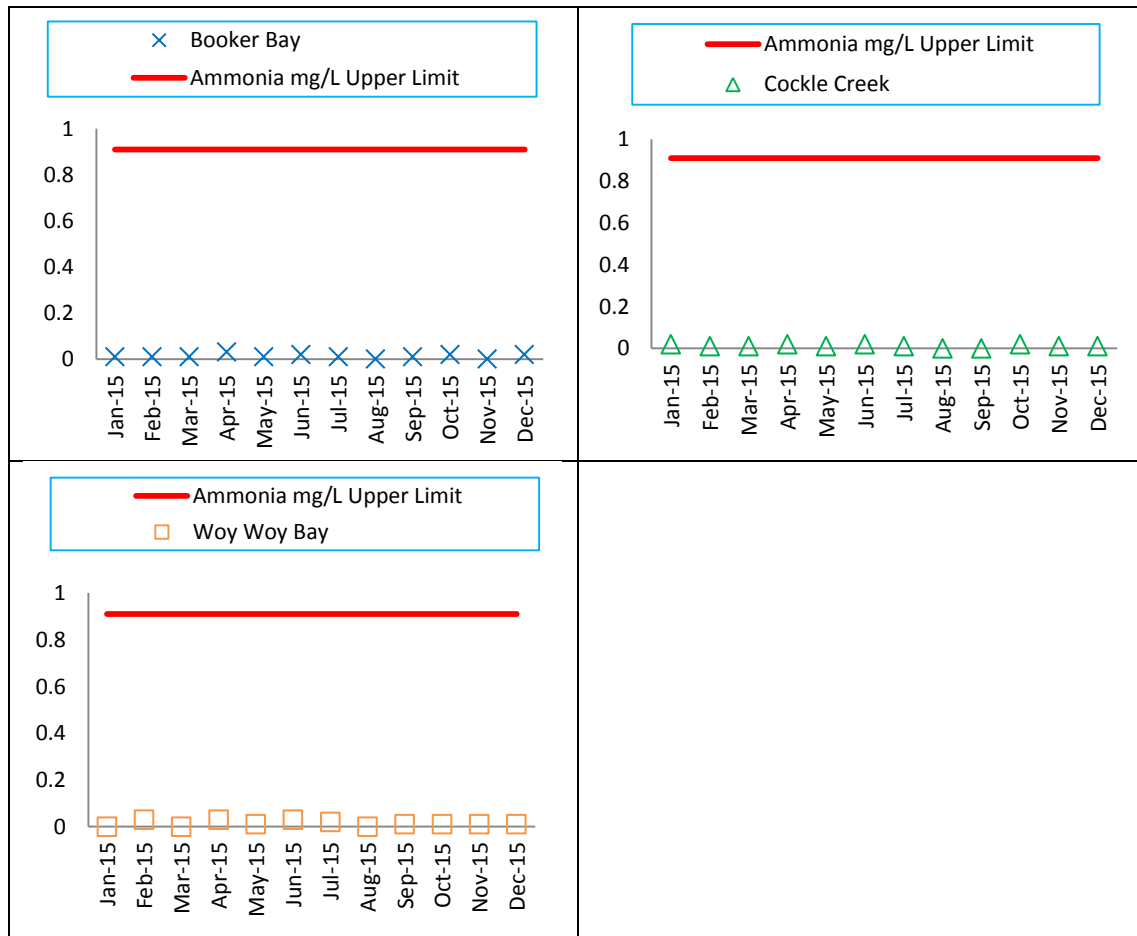
Figure 26: Ammonia results for Brisbane Water Estuary sites during 2015. The upper limit trigger values are based on ANZECC 2000 guidelines and historical data for the site.

Ammonia results were well below the upper limit at all three estuarine sites.

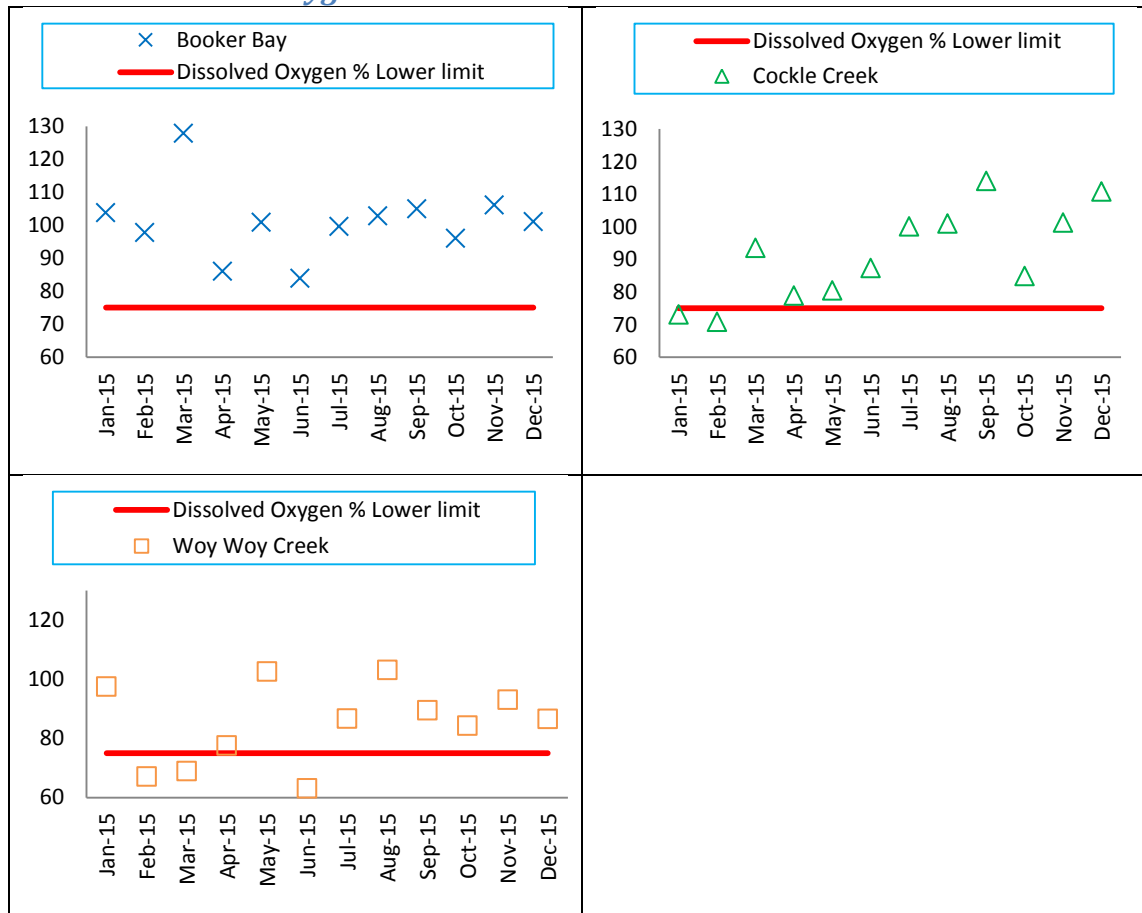
Figure 28: Dissolved oxygen results for Brisbane Water Estuary sites during 2015. The lower limit trigger values are based on ANZECC 2000 guidelines and historical data for the site.

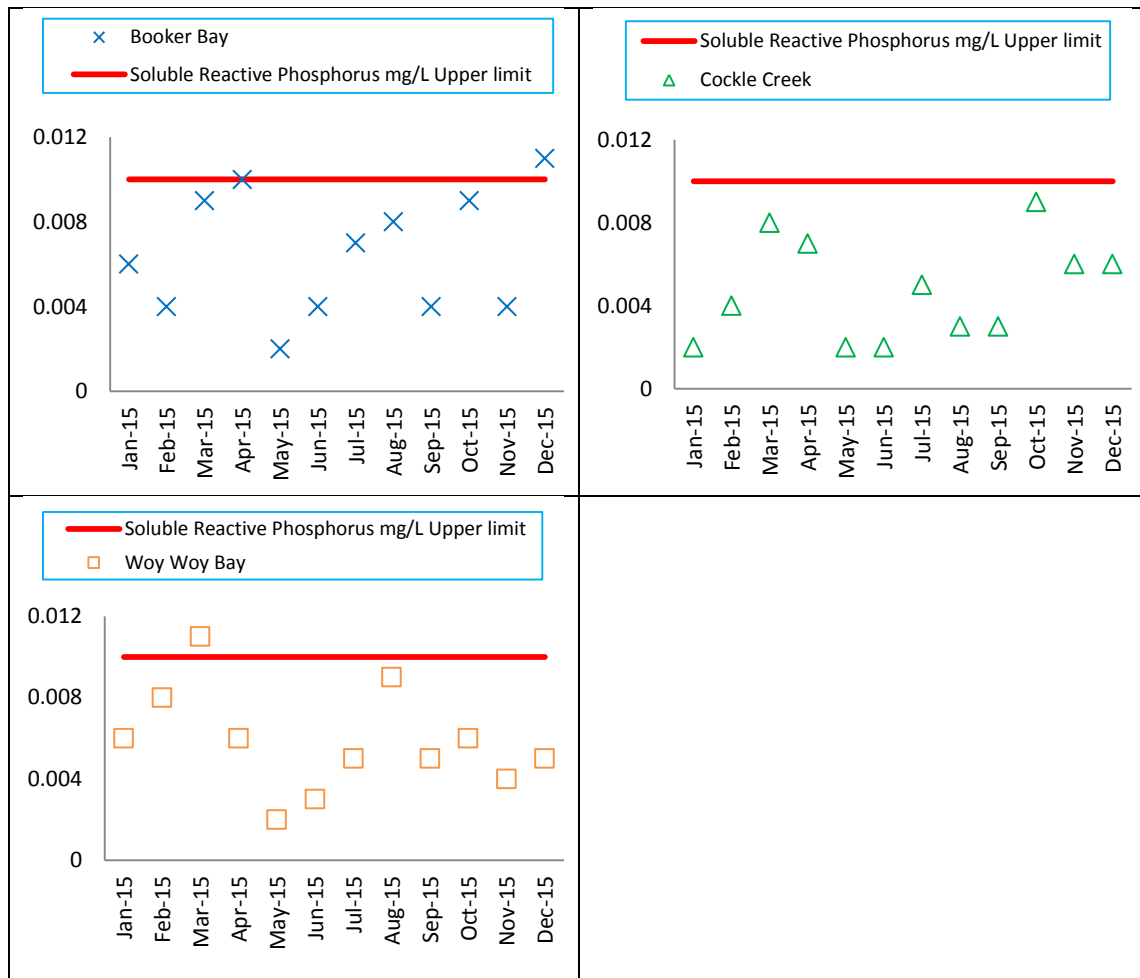
Figure 29: Soluble Reactive Phosphorus results for Brisbane Water Estuary sites during 2015. The upper limit trigger values are based on ANZECC 2000 guidelines and historical data for the site.

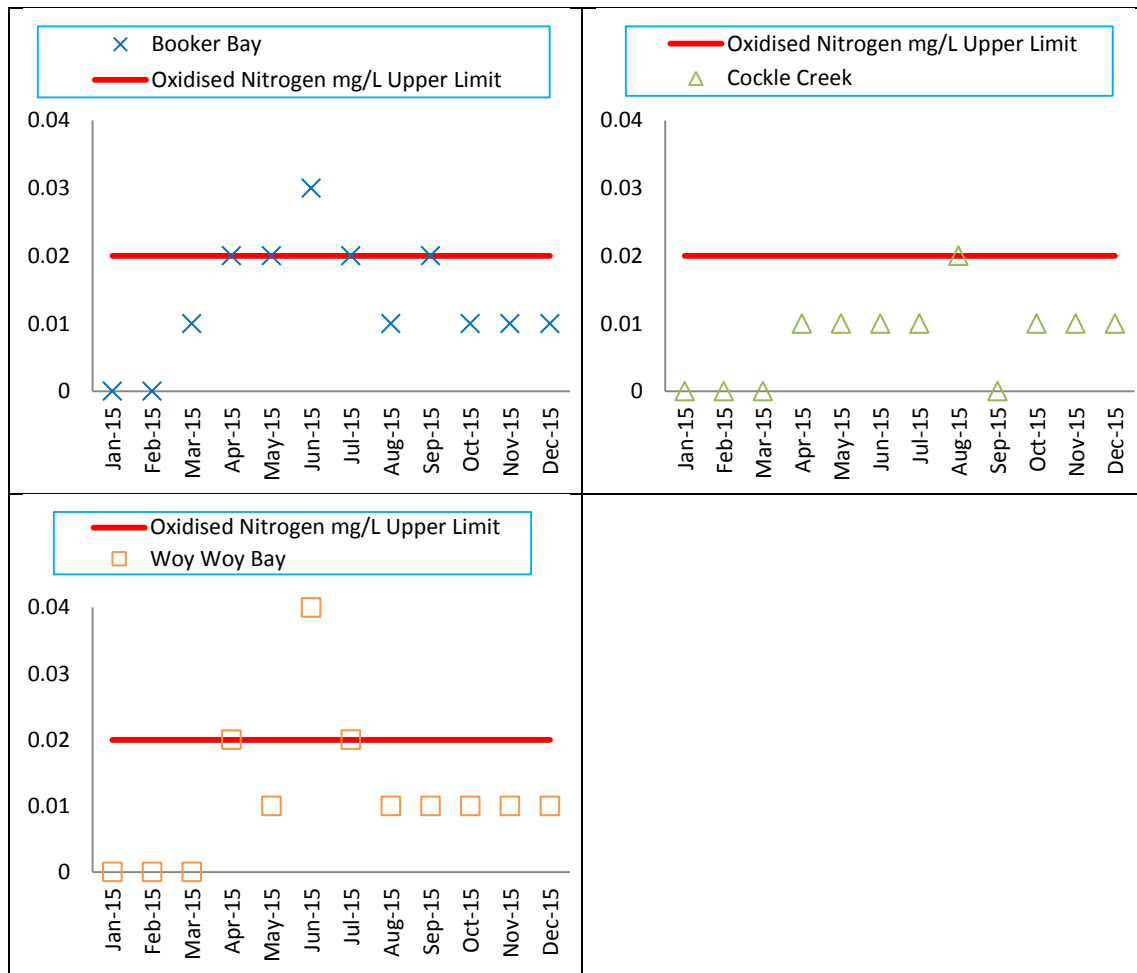
Figure 30: Oxidised Nitrogen results for Brisbane Water Estuary sites during 2015. The upper limit trigger values are based on ANZECC 2000 guidelines and historical data for the site.

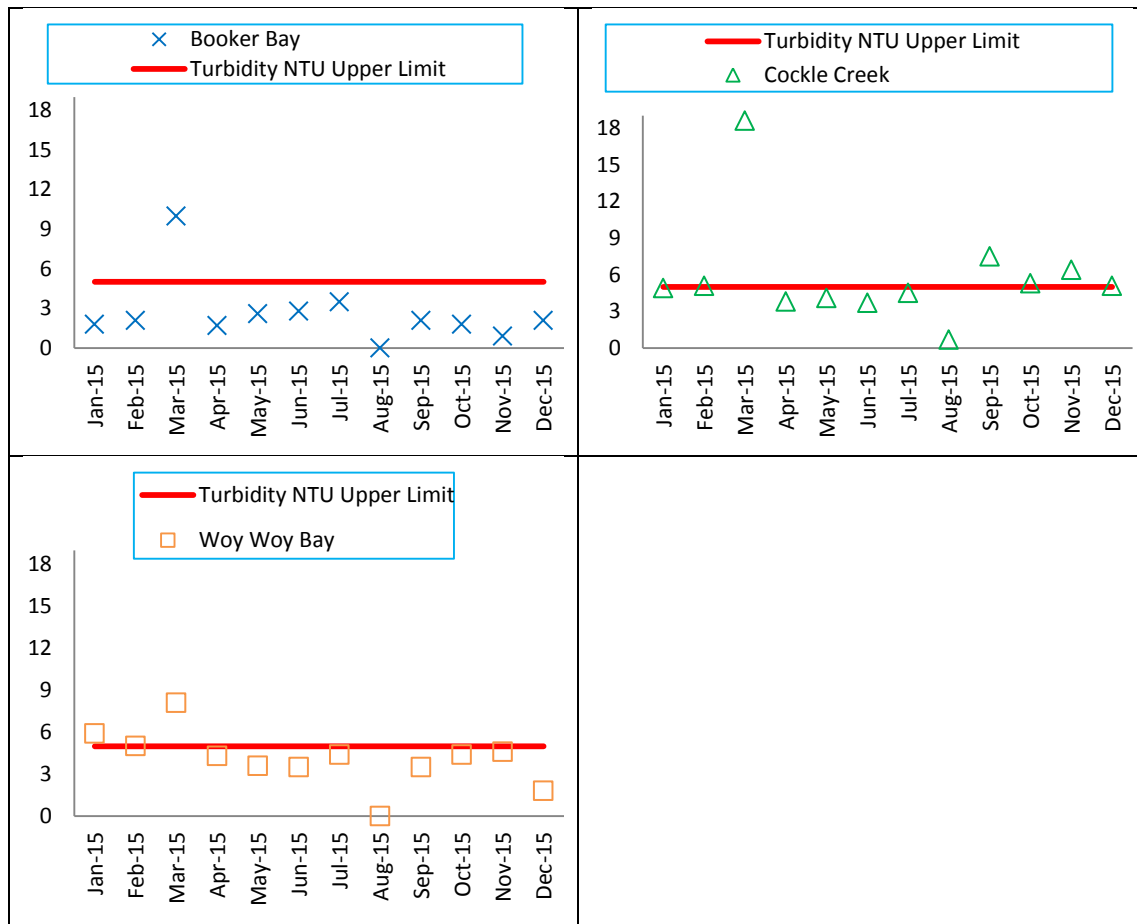
Figure 33: Turbidity results for Brisbane Water Estuary sites during 2015. The upper limit trigger values are based on ANZECC 2000 guidelines and historical data for the site.

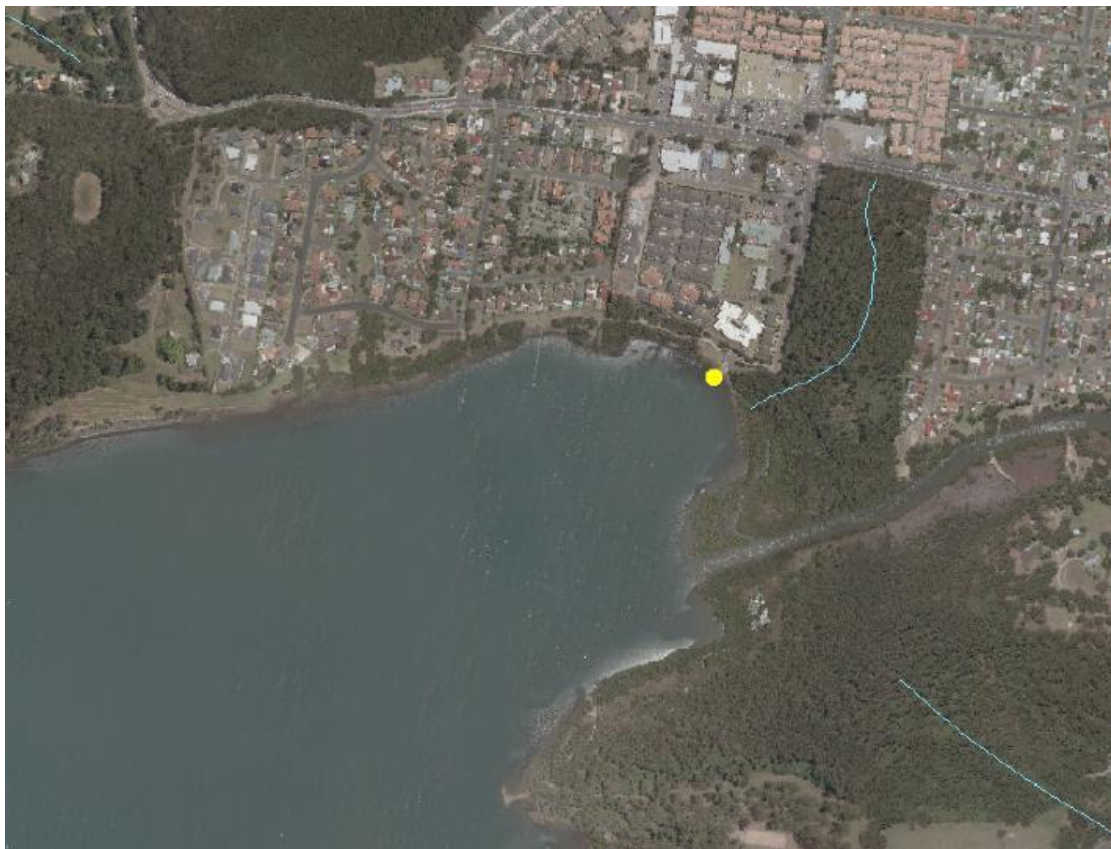
Figure 36. Kincumber Creek monitoring location indicated by yellow circle.

Kincumber Creek was monitored monthly during 2015. The monitoring location is close to the discharge point of Kincumber creek and is accessed from Carrak Road, Kincumber (Figure 36). The site is shallow, experiences tidal movements, has mangroves and the bottom substrate is muddy. It is frequented by ducks and is often turbid during tidal movements and windy conditions.
