Central Coast Council

Ordinary Council Meeting

2.1	DA/54551/2018 Woy	8 170-176 Blackwall Road and 8 Farnell Road, Woy	
	Attachment 1:	Development & Landscaping Plans	3
	Attachment 2:	Gosford Development Control Plan Compliance Table	27
	Attachment 4:	Draft Conditions of Consent	42
3.5	Terrigal Boardv	valk and Rock Pool	
	Attachment 1:	Attachment 1 - Terrigal Boardwalk Basis of Design	60
	Attachment 2:	Attachment 2 - Terrigal Boardwalk and Rockpool Design Drawings	
	Attachment 3:	Attachment 3 - Terrigal Boardwalk Peer Review	
	Attachment 4:	Attachment 4 - Terrigal Masterplan 1996	
	Attachment 5:	Attachment 5 - Terrigal Haven Plan of Management	
	Attachment 6:	Attachment 6 - Terrigal Boardwalk Review of Environmental Factors	
	Attachment 7:	Attachment 7 - Geotechnical Interpretive Report	430
	Attachment 8:	Attachment 8 - Terrigal Boardwalk Consultation Report

PROPOSED RESIDENTIAL FLAT DEVELOPMENT

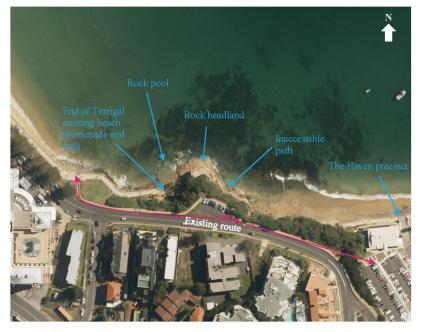
The existing rock headland and steep roadway currently prevents easy and safe access between Terrigal Beach promenade and The Haven precinct, as shown in Figure 1. An existing road-side path connects these destinations, although it is steep and results in a disconnected journey which prevents the public to have a direct marine foreshore experience.

Figure 1: Existing site condition Source: Arup / SIX Maps

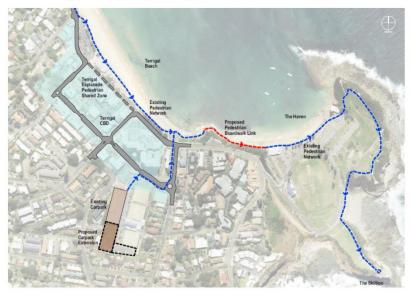
Figure 3: Site location Source: Central Coast Council Terrigal Master Plan Concept (2017)

The proposed boardwalk presented in Figure 3 (shown as the red dotted line) is located along the Terrigal Esplanade, at the southern end of Terrigal Beach.

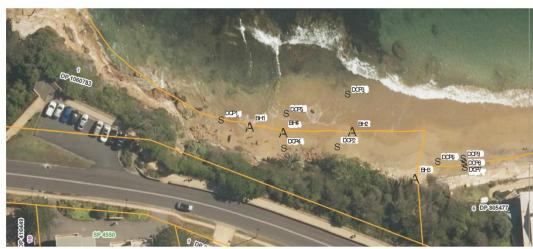
3.1 EXISTING CONSTRAINTS | Geotechnical Investigation

- » Rock was encountered at approximately 1m depth
- » Rock comprised of interbedded shale and sandstone
- » Based on the laboratory results, rock on first contact is suitable for an allowable bearing pressure of 1500kPa, improving to 8000kPa below RL-7mAHD.
- » Over the landside portion, bored cast in-situ piles are feasible. Temporary casing will be required through the sand to avoid collapse.
- » Over the seaside portion, driven circular piles into the top the wave cut platform, then extended further into the rock by auger to achieve required embedment.

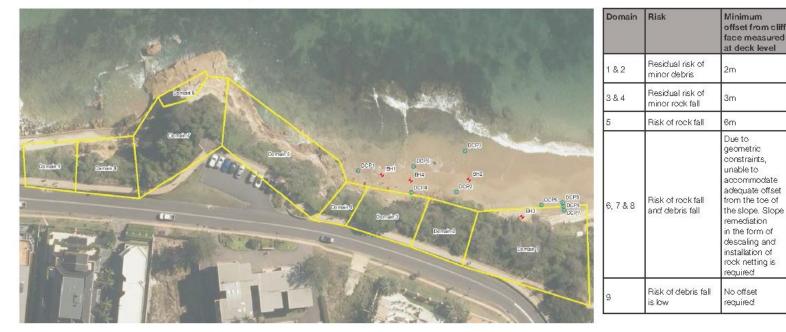
3.2 EXISTING CONSTRAINTS | Coastal Hazard Risk

Residual risk of minor debris slides. Minimum offset of 2m from the slope to be maintained to avoid destabilising slope. A 'catch ditch' to be provided along boardwalk as miligation for any debris fall, and be able to be deaned out as required. Boardwalk height to be a minimum of 1.5m above the base of the 'catch ditch'. Drainage path/outvert encountered in Domain 1. Must

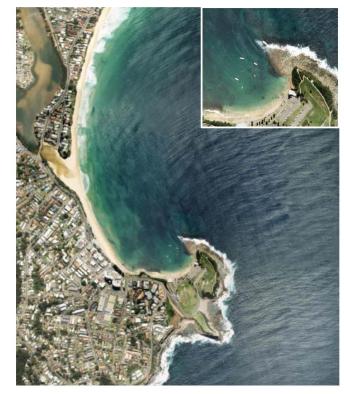
Aerial image of Terrigal Beach waves from the SE diffracting around the Terrigal headland

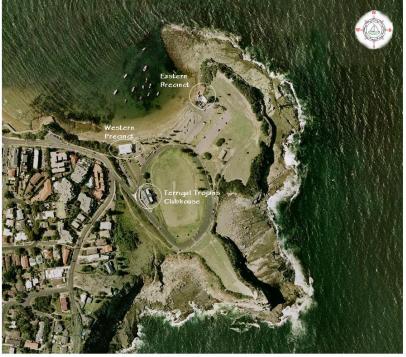
Figure 2.1 - Current leases and licences - Terrigal Haven

Terrigal Haven currently comprises three main tenures under the LPMA control and five under Council control. Figures 2.1 and 2.2 illustrate the current leases within the Haven.

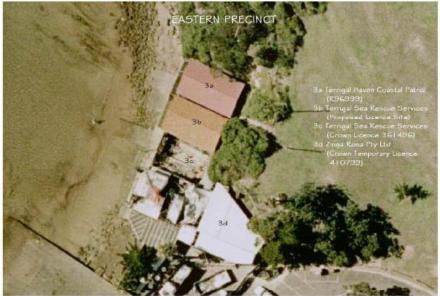
Figure 2.2 - Current Leases and Licences in the Eastern Precinct of Terrigal Haven Eastern Precinct

2b. Part of Lot 6 DP805477 - held under lease issued by Council as Terrigal Recreation (R48416) Reserve Trust and the LPMA to the Cove Café & Grill. Lease approved for a period of 10 years from 2001 with an option for a further 10 years.

2c. Part of Lot 6 DP805477 - held under lease issued by Council as Terrigal Recreation (R48416) Reserve Trust and the LPMA to the Terrigal Dive Centre. Lease approved for a period of 10 years from 1998 with an option for a further 10 years. Option taken up in 2008.

3a. Reserve 96999 for Non-Profit Making Organisation notified 7 October 1983. Terrigal Haven Coastal Patrol (R96999) Reserve Trust appointed 23 November 1990. Royal Volunteer Coastal Patrol is Corporate Trust Manager.

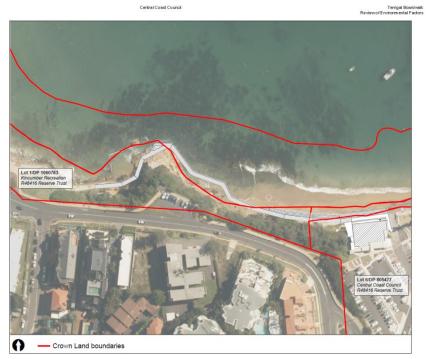
Figure 2: Crown Land boundaries

The proposal is located between the Terrigal Beach promenade and The Haven precinct, as outlined by the red dotted line on Figure 1. It is located across four *reserves* on Crown Land, including Lot 1/DP 1060783 (Kincumber Recreation R48956 Reserve Trust) and Lot 6/DP 805477 (Central Coast Council R48416 Reserve Trust). The other two Crown Land lots north of the established *reserves* were unable to be established at the time of writing (refer to Figure 2).

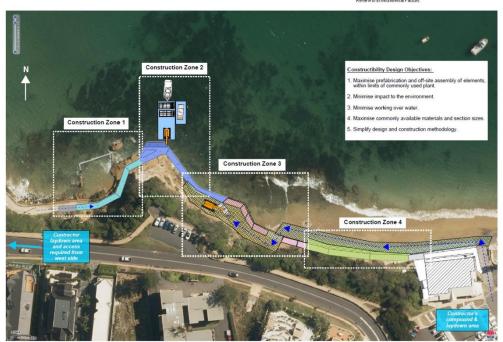
Figure 6: Proposed construction methodology

Table 3 identifies all the likely activities that would take place during construction across the four distinct zones presented in Figure 6, taking into consideration the access constraints along the Haven foreshore.

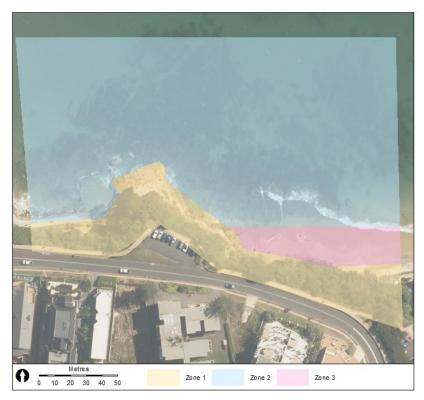
Figure 7: Distinct geomorphological zones across the proposal

The proposal footprint can be classified into three distinct geomorphological zones as shown in Figure 7.

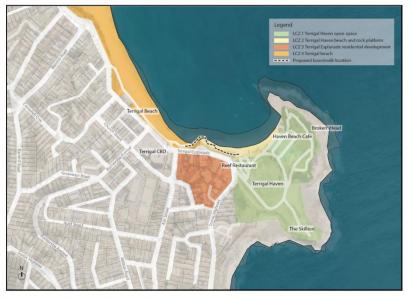
Figure 8: Landscape Character Zones

The study area was divided into four landscape character zones (LCZ) as shown in Figure 8.

To enable the assessment of potential landscape character impacts of the proposal, the following LCZs presented in Figure 8 have been determined within the study area:

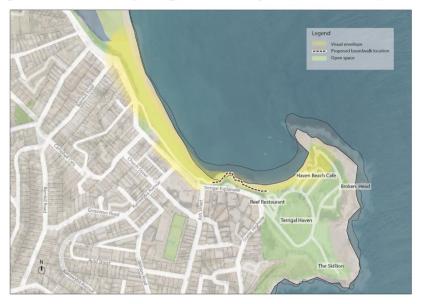
Figure 9: Visual envelope

Figure 9 shows the zone of visual influence or the visual envelope, which is the maximum area over which the proposal would be visible. It extends east and west along the foreshore and is limited to the south by vegetation and topography of the headland.

The figure does not include the extents from which the proposal would be visible from the ocean. This viewpoint would be presented as part of additional imagery provided to the community during the consultation period (refer to section 5).

The approximate extent of visibility of the proposal is indicated in the visual envelope diagram, Figure 9. Visibility of the proposal extends east and west along the foreshore and is limited to the south by vegetation and local topography. The figure does not include the extents from which the proposal would be visible from the ocean.

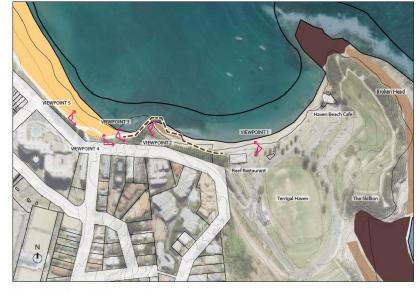
Figure 10: Viewpoints assessed

Five viewpoints (refer to Figure 10) were selected to represent the range of sensitive receivers in the visual envelope.

After a site visit, the following key viewpoints were selected for further analysis as shown in Figure 10:

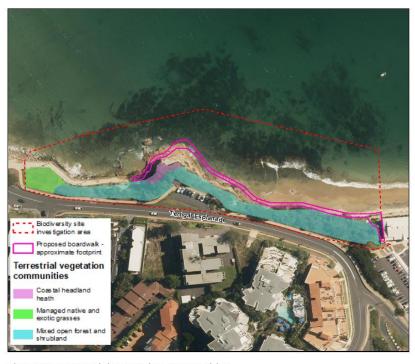
Figure 11: Terrestrial vegetation communities

The native vegetation cover within the proposal footprint is contained to small patches on steep slopes and upper crest of the headland. The condition of the vegetation communities across the proposal footprint can generally be described as a degraded condition. A summary of the vegetation communities identified within the proposal footprint is provided in Table 16 and Figure 11.

Vegetation community	Description	Photograph
Exotic and native grasses, vines and sedges	This vegetation community is not shown in Figure 11, as it only occurs on the steep seaward facing slopes of the headland. This area contains a mixture of native and exotic grasses, vines, sedges and forbs. There are large areas that are covered by <i>Aloe sp</i> .

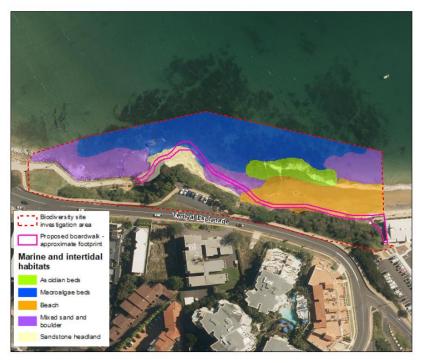
Figure 12: Marine and intertidal communities

The marine and intertidal habitat communities are described in Table 17 with their distribution in the proposal footprint shown in Figure 12.

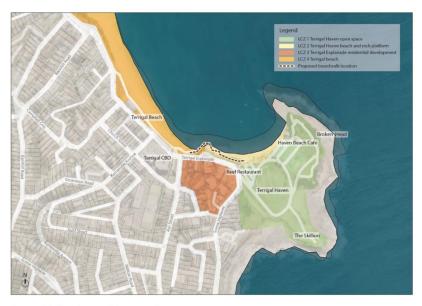
Figure 14: Landscape Character Zones

- LCZ 1: The Haven open space.
- LCZ 2: The Haven Beach and rock platform.
- LCZ 3: Terrigal Esplanade residential development.
- LCZ 4: Terrigal Beach.

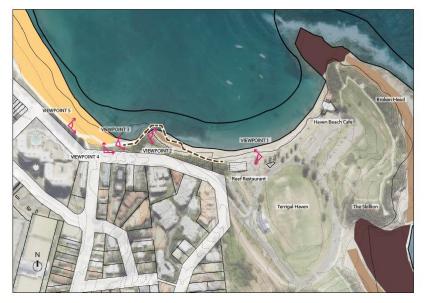
Figure 16: Viewpoints assessed

- 1. The Haven Beach near the Reef Restaurant looking west
- 2. Rock platform looking east
- 3. Terrigal Beach footpath near the Terrigal rockpool
- 4. Terrigal Esplanade footpath looking east
- 5. Terrigal Beach footpath looking east

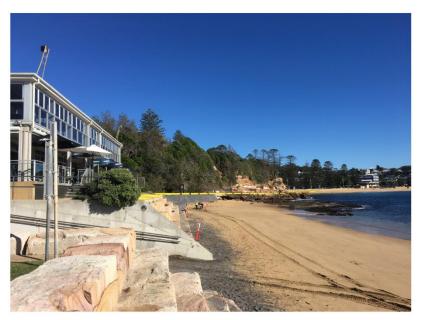
Viewpoint 1 - Looking west along The Haven Beach towards the rock platform and Terrigal Beach. The approximate location of the proposal is indicated in yellow, with the extended sea wall in grey.

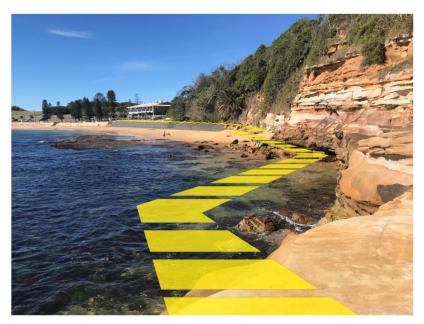
$\label{eq:Viewpoint 2-Looking east towards The Haven from the rock platform. The approximate location of the proposal is indicated in yellow, with the extended sea wall in grey.$

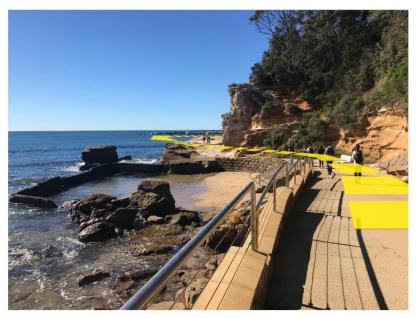
$\label{eq:Viewpoint 3-Existing view west from ramped pathway along southern end of Terrigal Beach. The approximate location of the proposal is indicated in yellow.$

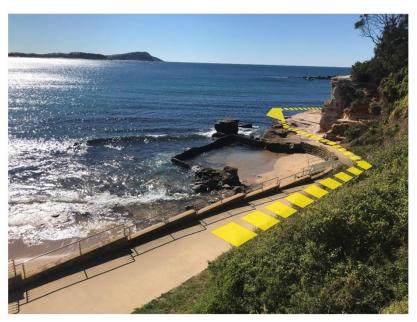
Viewpoint 4 – Existing view north west from path along Terrigal Esplanade. The approximate location of the proposal is indicated in yellow.

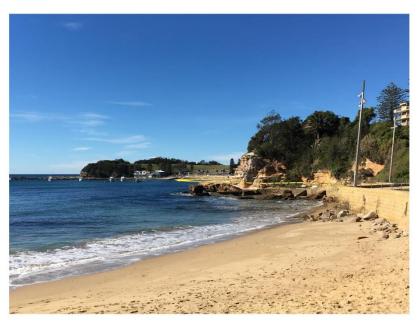
$\label{eq:Viewpoint 5-Existing view west from Terrigal Beach. The approximate location of the proposal is indicated in yellow.$

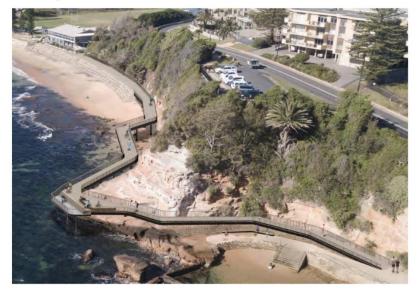
Figure 1 - Visualisation of proposed boardwalk (looking south-east)

Following consultation with the Council, the preferred option to carry through to Concept Design is an elevated boardwalk comprising of timber and perforated decking that would allow people to view the water beneath the viewing platforms. The eastern and western ends of the boardwalk, at The Haven and Terrigal Beach respectively, is to be on grade. While the portion adjacent to the existing rock platform and intertidal zone of The Haven are to be suspended on steel and concrete piers.

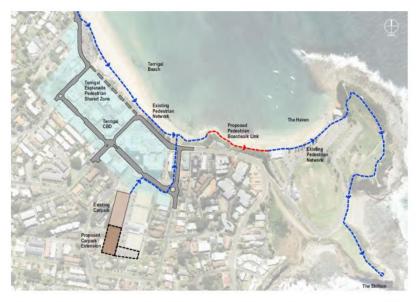
Figure 2 - Site location map (Central Coast Council Terrigal Master Plan Concept, 2017)

The extent of the proposed boardwalk is presented in Figure 1 (shown as the red dotted line), located along Terrigal Esplanade, Terrigal, NSW.

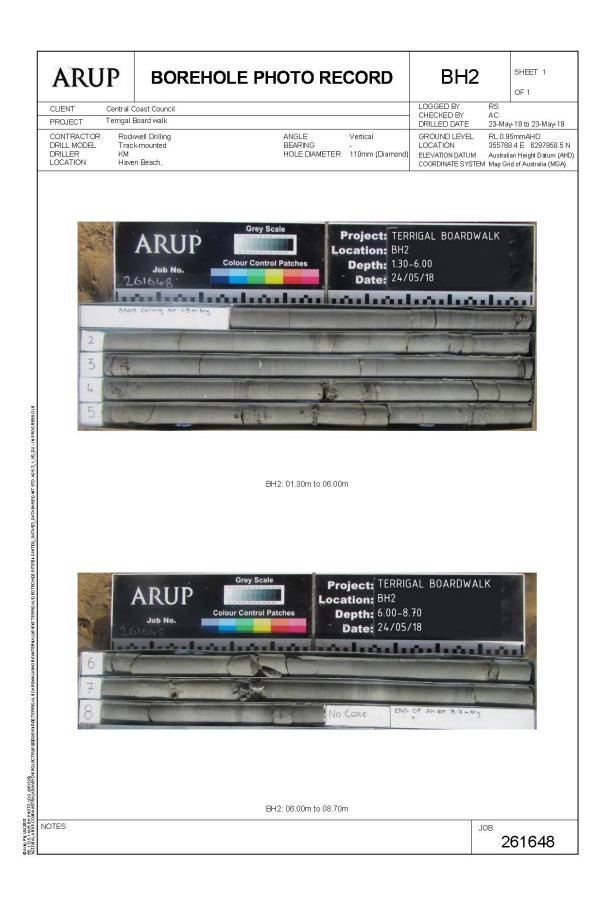
AR	UP			ION-CORED EHOLE RECORD	1	Bł	13	3	SHEET 1 OF 2
CLIENT PROJECT CONTRAC DRILL MOD DRILLER LOCATION	Terrigal TOR Roc DEL Trac KM	Coast Council Board walk kwell ck-mounted en Beach, Terriga		BEARING -	tical GR Dm LO	IGGED BY IECKED B RILLED DA ROUND LE ICATION EVATION DA IORDINATE	TE VEL ATUM	R 3 1 A	C 2-May-18 L 2.20m 55787.1 E 6297946.0 N ustralian Height Datum (AHD)
DRILLING		STRATA		MATERIAL DESCRIPTI	ON	с	ONDI	TION	OBSERVATION
& CASING & CASING WATER DRILLING PENETPATION	GROUNDWATER LEVELS SAMPLES		GROUP SYMBOL GRAPHIC LOG	SOIL TYPE Plasticity / Grain Size, Colour, Minor	Components	WATED /	MOISTURE	CONSISTENCY	Comments / Penetration Rate

- Ab/T - A	0.41114500nm (Д.400m SPT	SPT D,1,1 N-2 SPT 1,2,3 N-5 0,90 1,00	sw			-	м	VL	MAR Becoming dark grey
	5800m	1 1300 1.100	сн -	SANDSTONE: fine to medium grained, pale g plasticity Continued as cored borehole	rey. Recovered as CLAY,		v < PL	D	BRK
