Monday, 14 January 2008 STORAGES						
Storage	Capacity Full [MI]	Volume in Storage [MI]	Percent Full [%]	Storage Change over last Week		
Mangrove Dam	190000	37,195	19.6	Down 16 ML		
Mardi Dam	7400	7,249	98.0	Down 89 ML		
Mooney Dam	4600	4,600	100.0	Unchanged		
Total	202000	49,044	24.3	Down 105 ML

WATER USAGE & RAINFALL

C3 and C6 Inter Connecting Sewer Lines

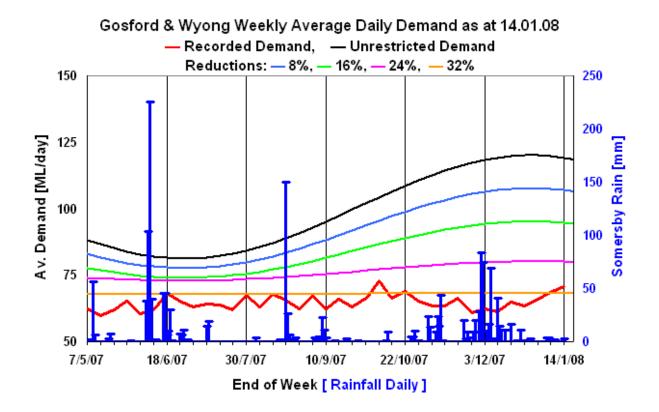
1 Black LineWyong Shire's normal demand when no restrictions are in place.2 Blue line8% reduction (based on the 'black line') over the entire year.3 Green Line16 % reduction (based on the 'black line') over the entire year.4 Pink Line24% reduction (based on the 'black line') over the entire year.5 Orange Line32% reduction (based on the 'black line') over the entire year.6 Blue barsRainfall at Somersby in mm/day.7 Red lineWyong Shire's average daily demand.

Period	Water Usage [MI]	Rainfall [mm]					
		Somersby WTP	Mardi WTP	Mangrove Dam			
Week to date	495	4	4	12			
Previous week	480	8	10	14			
Current week last year	499	0	0	3			
This year to date	975	12	14	27			
Same period last year	981	21	12	7			
Week to date consumption was 495 ML, 0.8% less than the same week last year and 3.1% more than the previous week. Consumption this year to date is 975 ML, 0.6% less than the same period last year.

Level 4 Water Consumption Target for the week ending Monday, 21 January 2008 is 475 ML
