SUMMARY

194 Geotextile Bag Investigations

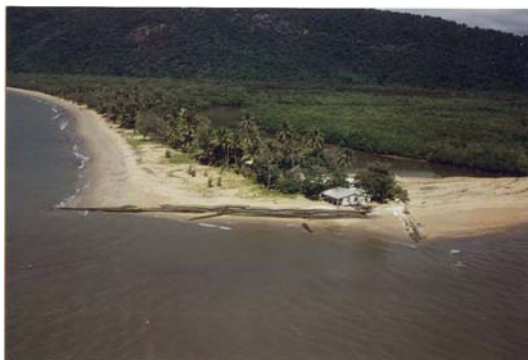
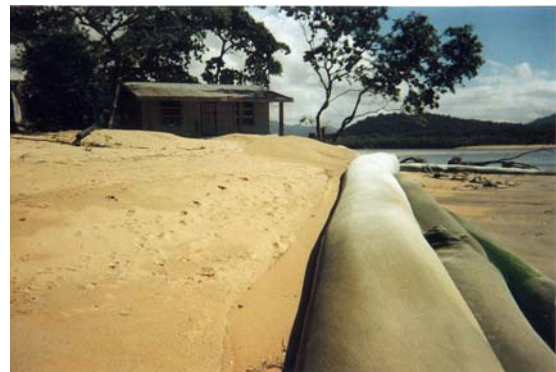
Russell Heads 2002

Geotextile container systems have been used with great success in the past 10 -15 years. The technology was first introduced in the mid 1980's and was primarily based on long, small volume, hydraulically filled tubes, employing a trial and error design methodology. The long term performance of these initial structures was mixed, some examples are Russell Heads groyne constructed in 1993-94 using 1.2m diameter tubes which is still performing well, however Kirra Groyne constructed in 1985 using 1.2m diameter tubes failed. The lessons learnt from the initial works has lead to the development of systems which are better suited to the dynamic coastal environment. This has meant a move away from large/long tubes to smaller individual units designed to withstand the specific conditions encountered at the site. It should also be noted that geotextile manufacture and sewing technology has improved significantly since the first geotextile containers were trialed in the 1980's allowing designers to make use of the containers in longer term projects.

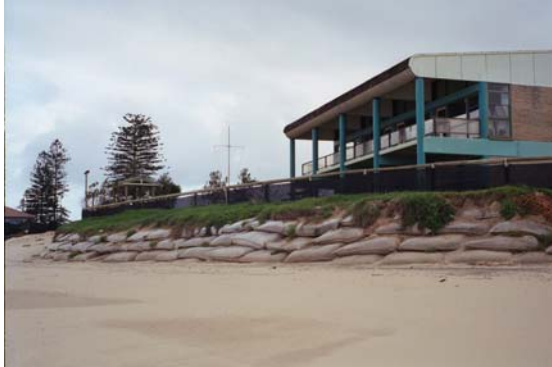
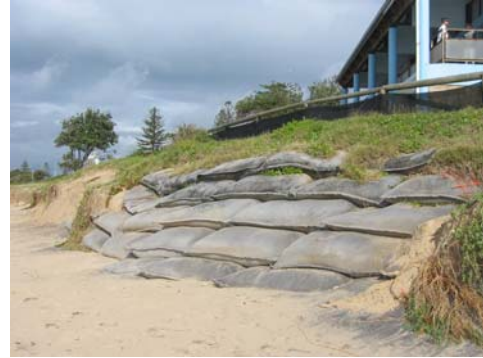
Stockton Beach in NSW was constructed in 1996 with 0.75m³ containers, with no vandal deterrent covering. The initial design requirement was for a 6-month design life.

1999

2008

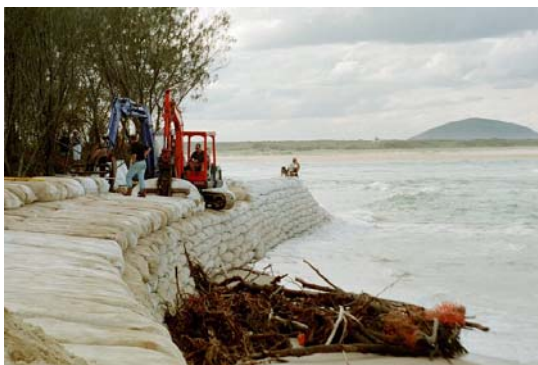
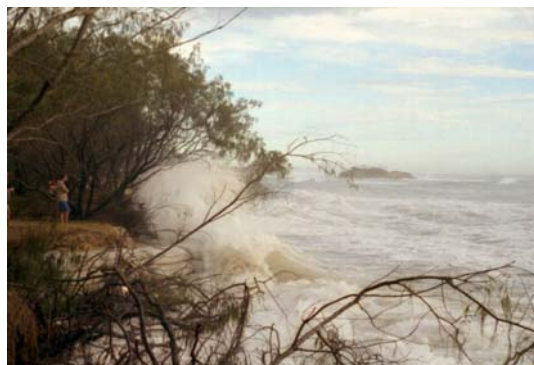
Maroochy Beach emergency sea wall was constructed in 1999 using 0.75m³ containers, with no vandal deterrent covering.

1999

January 2002

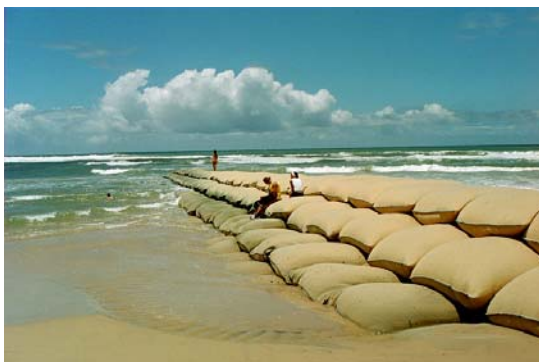
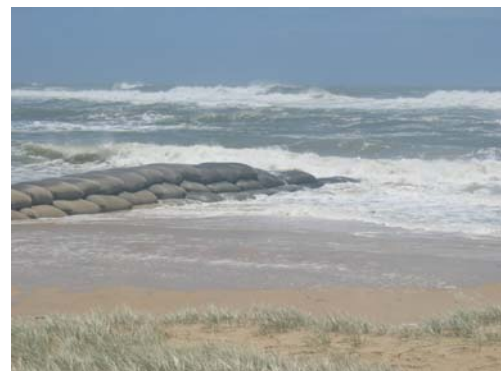
Maroochy beach groynes - 4 x 100m long groynes were constructed in 2001 and 2002 using 2.5m³ containers. The vandal deterrent geotextiles were developed specifically for this project.

2002

2008

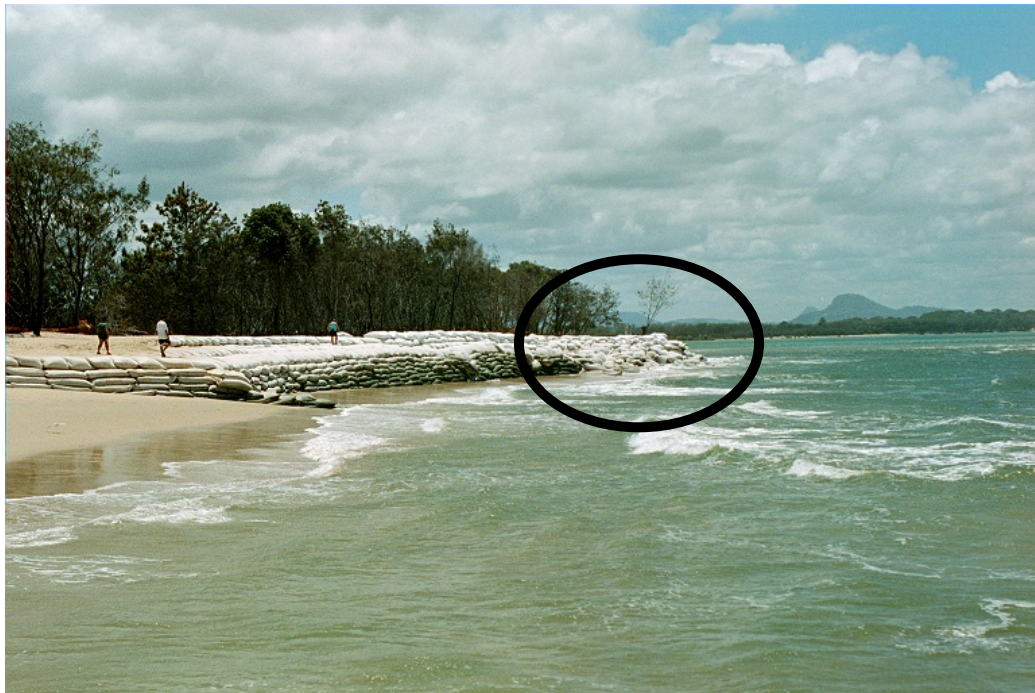
35m rubble section

While we agree that construction during a storm event is not ideal we believe that a sand container structure will perform as well if not better than a rock structure constructed in similar conditions. The Maroochy beach wall was constructed under emergency conditions i.e. under wave attack which prevented the construction of what would normally be considered adequate toe protection. As a result of this a 35m section out of a total of 200m collapsed to form a rubble structure not dissimilar in appearance to a rock revetment (see photo below), it did not however result in loss or damage to the containers.

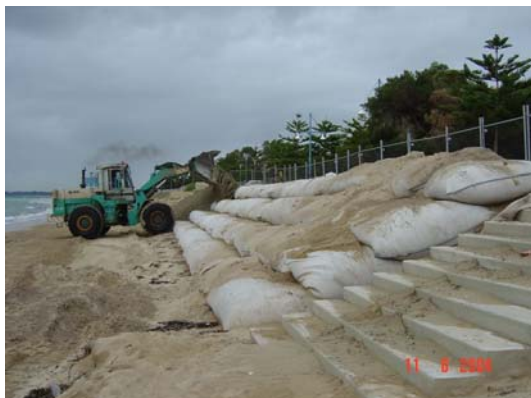
8. The bags may also be used in dune rehabilitation projects where they could be stacked at right angles to the beach front.

We would agree that this application is an important role for sand containers in ongoing rehabilitation of sand dunes both in coastal and inland waters. By providing an improved beach profile and dune system, protection of assets would be achieved at an early stage and at an inexpensive cost compared to remedial structures based on longer term damage.
