Attachment 1: Gosford Library Building Review - Draft Report - 20 December 2024 – Complete Urban 3

GOSFORD LIBRARY BUILDING REVIEW
DRAFT REPORT | 20 DECEMBER 2024

GOSFORD LIBRARY BUILDING REVIEW

PREPARED FOR	CENTRAL COAST COUNCIL
AUTHOR	COMPLETE URBAN PTY LTD
REVISION	A
REVISION DATE	20 DECEMBER 2024
ISSUED BY	SCOTT WILLIAMS

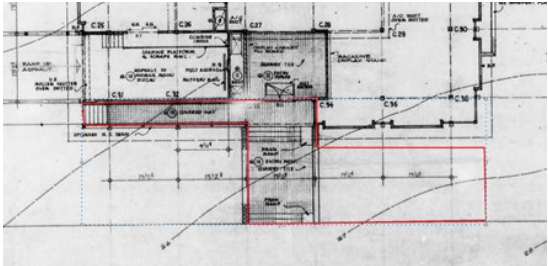
<p>Average condition.</p>	<p>Non-compliant ramp at front entry. Gradients appear too steep, no TGSIs, handrail non-compliant</p>
<p>Entry steps. Insitu exposed aggregate concrete, painted steel handrails, brick kerbs.</p>

<p>Average condition</p>	<p>Non-compliant steps at main entry. Non-compliant handrail.</p>

Average condition	<p>The security bollard reduces access width from the west.</p>

ITEM	RECOMMEND SCOPE OF WORK	GENERAL EXTENT OF WORK EXTENT	High level order of cost range (excluding GST) including builder's preliminaries (15%) and margin (10%), authority fees and charges (0.5%), client project management costs (1%), design costs (12.5%), design contingency (10%) and escalation (4% to December 2025).
<p>2. External ramps and stairs</p>	<p>Rectify existing ramps and stairs to comply with AS1428. Works include new balustrades, handrails, TGS's contrasting nosing, removal of bollard to front walkway.</p>

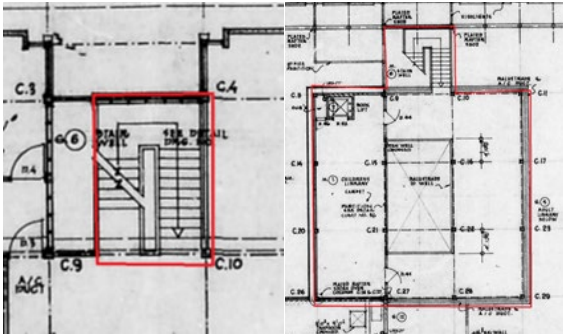
<p>Good condition. However, there is some termite damage to rear wall.</p>	<p>Stairs do not comply with current NCC. Balustrade height is too low, lack of handrails, lack of TGSi's, lack of contrasting nosing.</p>
<p>Timber panelling. Horizontal timber panelling to stairs.</p>

<p>\$200,000 - \$250,000</p>
<p>3. internal stairs and mezzanine balustrade</p>	<p>Install handrails to timber balustrade, TGS's and compliant nosing to stairs.</p>

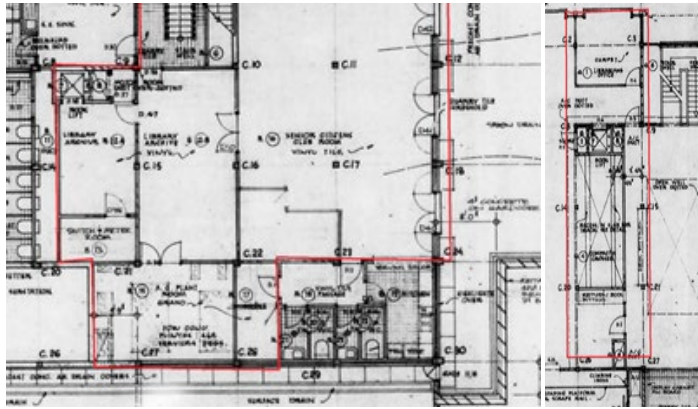
<p>Good condition.</p>	<p>Doors and door frames may not provide correct level of visual contrast in accordance with AS1428. Door leaves are typically 850-915mm wide and may not provide minimum clear opening width of 850mm. Due to nature of construction modification to provide correct width could be difficult.</p>

GOSFORD LIBRARY BUILDING REVIEW			
ITEM	RECOMMEND SCOPE OF WORK	GENERAL EXTENT OF WORK EXTENT	High level order of cost range (excluding GST) including builder's preliminaries (15%) and margin (10%), authority fees and charges (0.5%), client project management costs (1%), design costs (12.5%), design contingency (10%) and escalation (4% to December 2025).
4. Existing internal doors	Modify non-compliant door opening widths and provide 30% contrast between wall and door to comply with AS1428

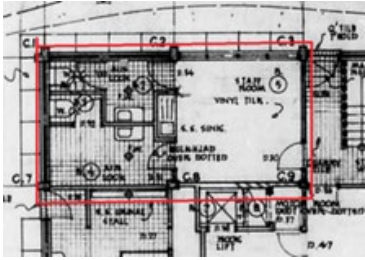
<p>Good condition.</p>	<p>Compliance with current NCC unlikely. There is no compliant PWD. No designated ambulant cubicles. Depending on thickness of wall finishes achieving a compliant width may not be possible without considerable demolition.</p>

<p>Reasonable condition</p>	<p>Location of kitchenette in proximity to toilets may not comply with current NCC.</p>

ITEM	RECOMMEND SCOPE OF WORK	GENERAL EXTENT OF WORK EXTENT	High level order of cost range (excluding GST) including builder's preliminaries (15%) and margin (10%), authority fees and charges (0.5%), client project management costs (1%), design costs (12.5%), design contingency (10%) and escalation (4% to December 2025).
6. upgrade staff area	Upgrade staff area to provide complaint toilets, and kitchenette space.

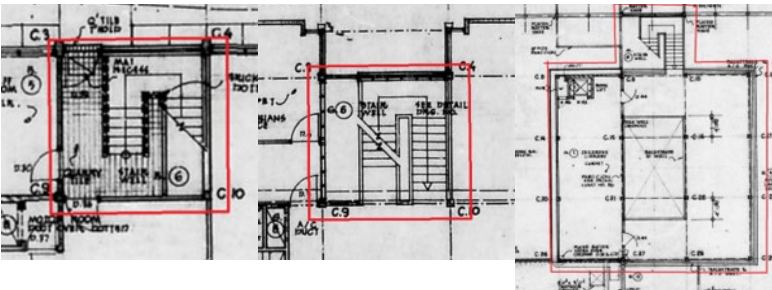
<p>Good condition. However, there is some termite damage to rear wall.</p>	<p>Unknown extent of termite damage.</p>
<p>Doors and door frames. Feature timber doors and door frames throughout.</p>

\$50,000 - \$75,000
10. Termite damage	Repair termite damaged timber linings to stairs, and balustrades. Full removal and replacement with new cladding.

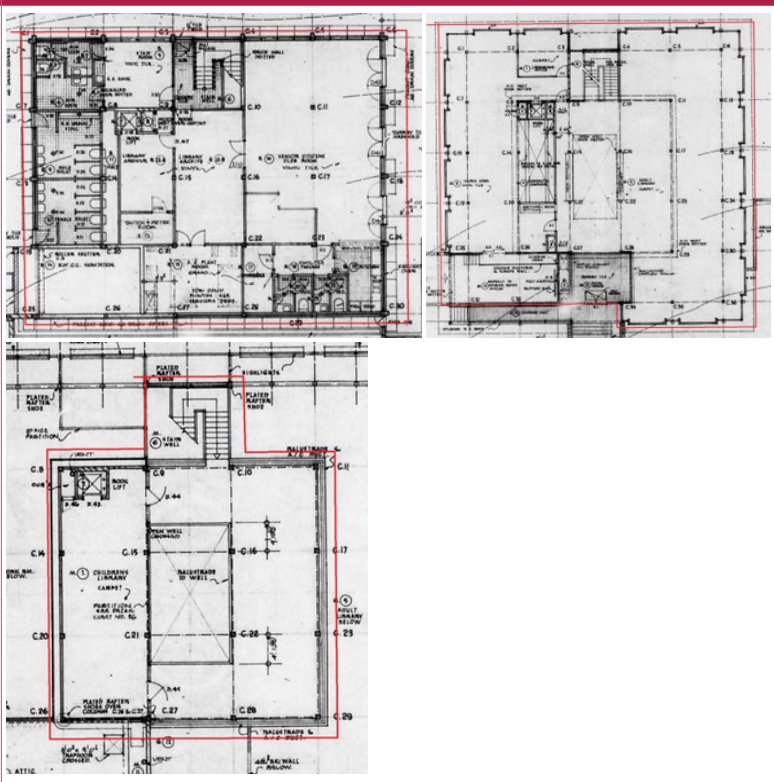
ITEM	PHOTO	COMMENTARY ON CONDITION	IDENTIFICATION OF CONCERN
<p>Lighting levels.</p>	 	<p>Average</p>	<p>It appears that original lighting has been replaced. However, there are still some areas where lighting levels appear too low. Eg on lower floor and in centre of mezzanine floor.</p>
<p>Mechanical Services.</p>		<p>Average</p>	<p>The existing mechanical system is in various locations around the building, including under the ground floor space at the front of the building. Maintenance access is confined. Additionally given the age of the units, the existing refrigerant should be checked for compliance with current legislation</p>

ITEM	RECOMMEND SCOPE OF WORK	GENERAL EXTENT OF WORK EXTENT	High level order of cost range (excluding GST) including builder's preliminaries (15%) and margin (10%), authority fees and charges (0.5%), client project management costs (1%), design costs (12.5%), design contingency (10%) and escalation (4% to December 2025).
12. Lighting	Upgrade lighting levels, exit and emergency lighting to compliant levels

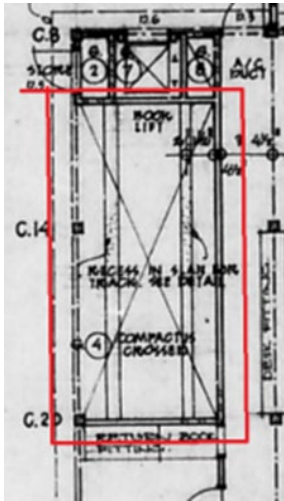
<p>Good</p>	<p>Ramped threshold unlikely to comply with current NCC and could be a tripping hazard.</p>
<p>Toilets.</p>

ITEM	RECOMMEND SCOPE OF WORK	GENERAL EXTENT OF WORK EXTENT	High level order of cost range (excluding GST) including builder's preliminaries (15%) and margin (10%), authority fees and charges (0.5%), client project management costs (1%), design costs (12.5%), design contingency (10%) and escalation (4% to December 2025).
13. Compactus	Provide compliant ramped threshold to compactus base

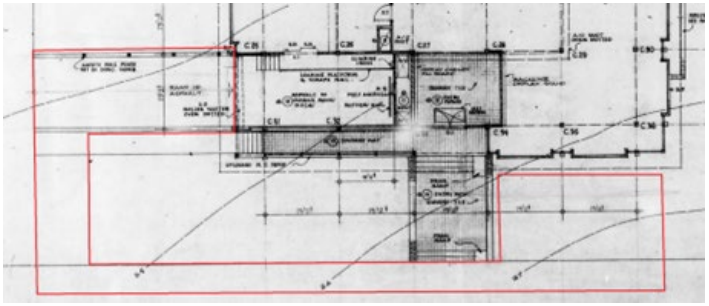
Average condition	<p>The pedestrian path from the west does not provide an accessible path of travel. The kerb separating the path and the parking could create a tripping hazard.</p>

\$750,000 - \$1,000,000
16. accessible path of travel	Provide accessible path of travel to comply with DDA. Reconfigure carpark to ensure complaint accessible carparking including installation of new line marking, bollards and access ramps. Removal of kerb separating carparking and western entry path and make good
