REPORT ON THE SAFETY OF NAVIGATION SHOULD TRAINING WALLS
BE ESTABLISHED AT THE BARWAY ENTRY TO THE ENTRANCE IN NEW
SOUTH WALES.

Prepared by Captain Charles Weston

24th April 2013

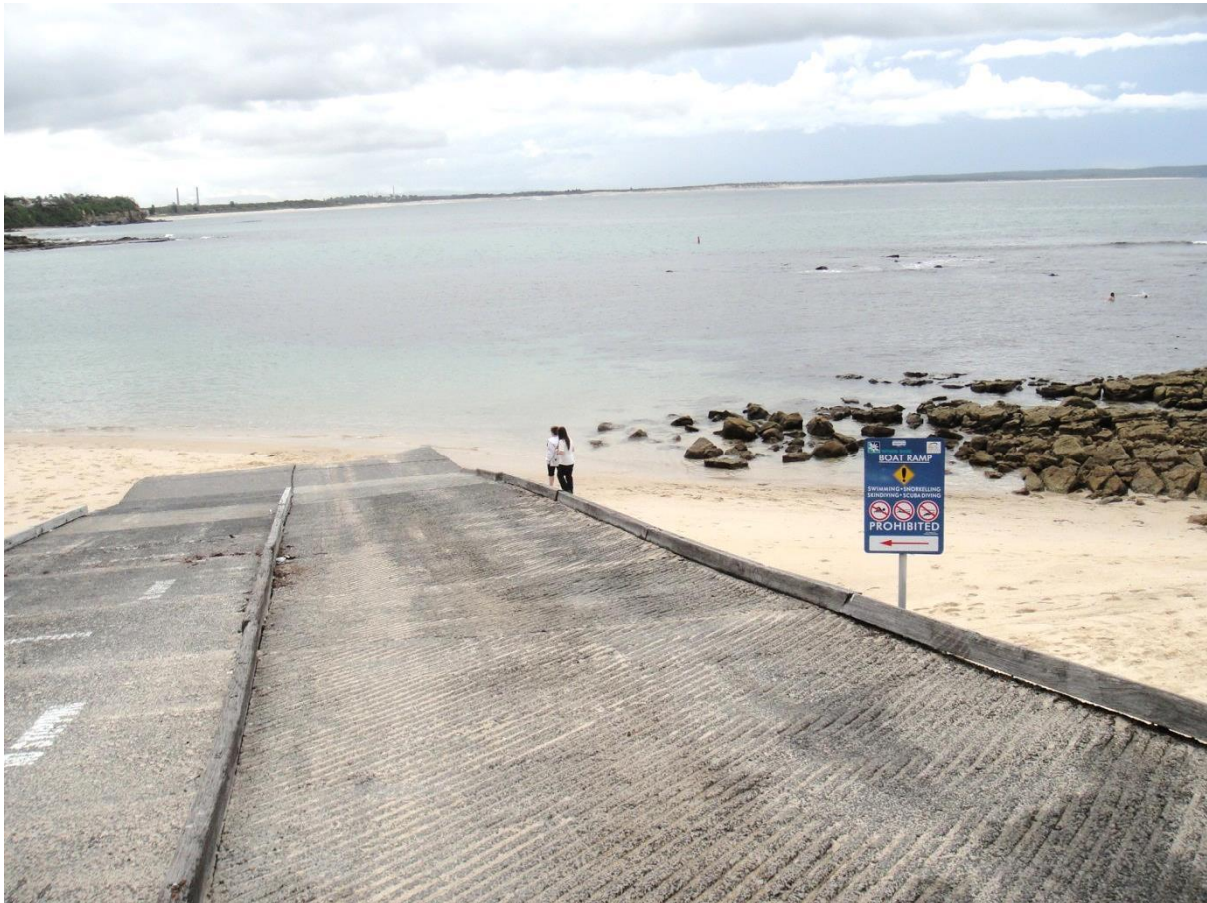
To the north is the Cabbage Tree Harbour boat ramp at Norah Head. This ramp is approximately 12 km distant and is reasonably sheltered. To the south is the Terrigal Haven boat ramp, which is sheltered and used by both recreational and commercial boaters. In both instances, these ramps would be a much better alternative for access to the sea and can be used at any state of the tide.

The Cabbage Tree Harbour boat ramp at Norah Head
