CLIFF LINE HAZARD DEFINITION STUDY
at
TUDIBARING HEADLAND
COPACABANA NSW

Undertaken on Behalf of
GOSFORD CITY COUNCIL

Our Ref: 210896RN.DOC\X017-5

Prepared: 30 September, 1996

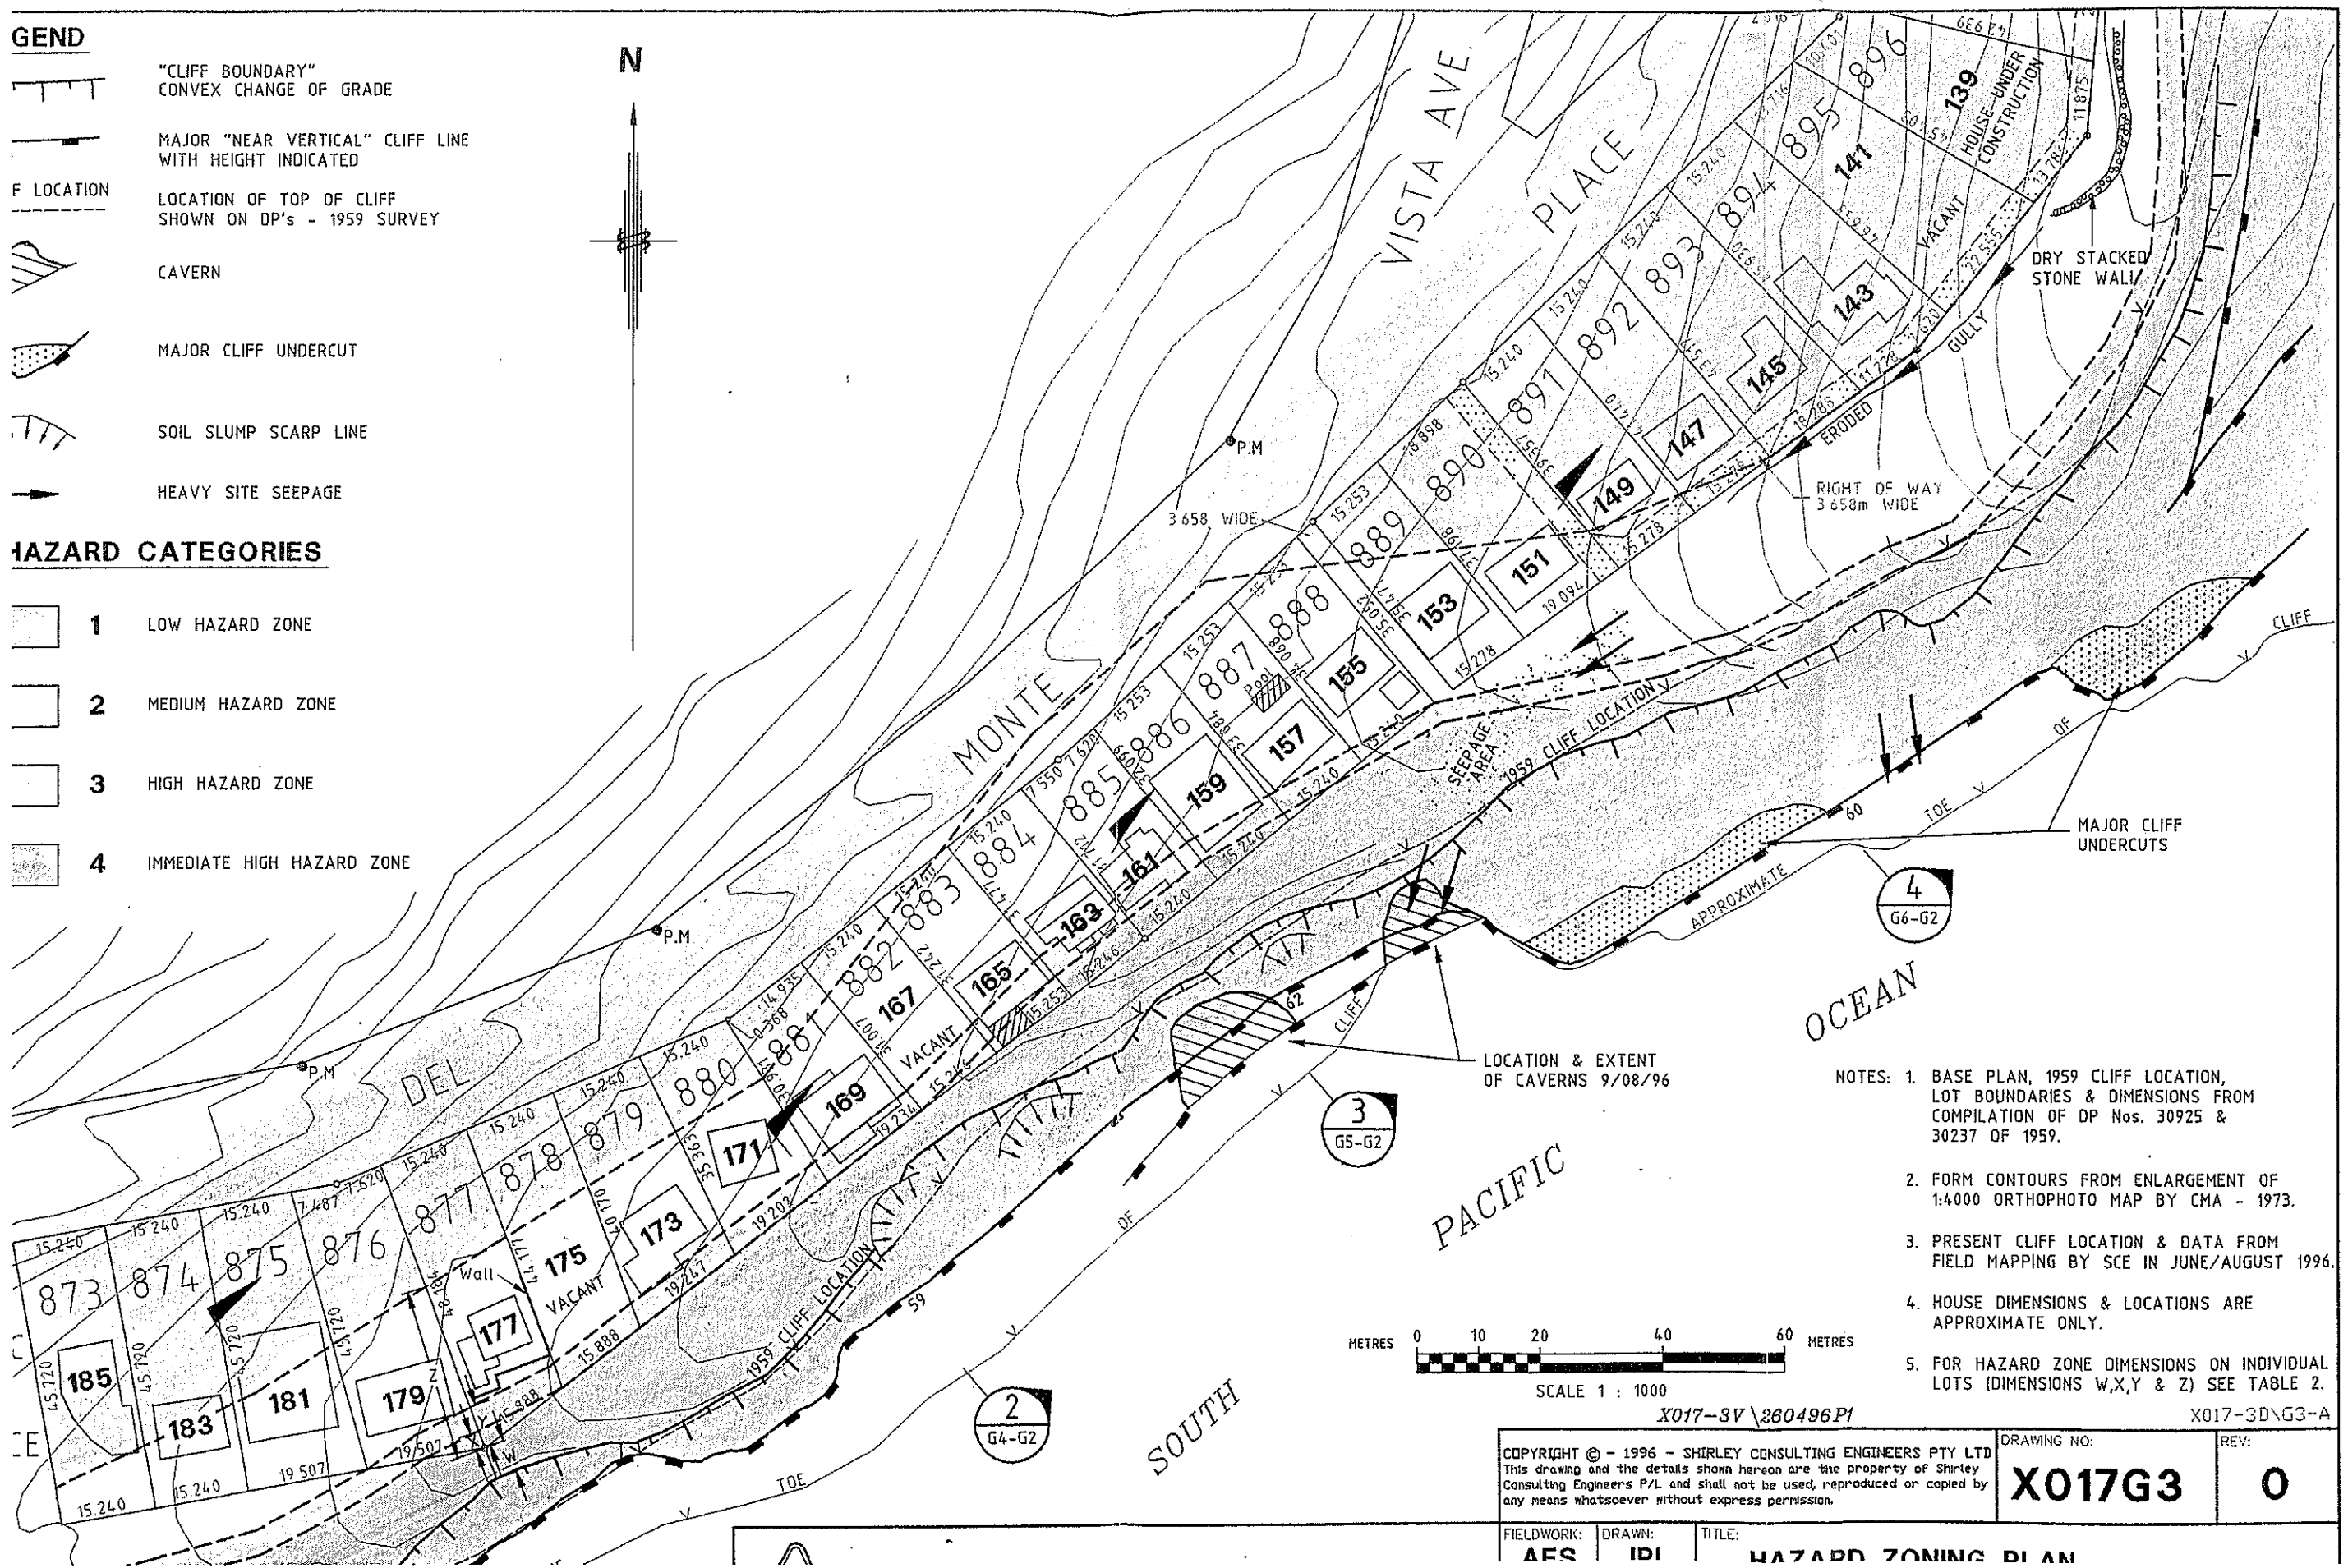
- i] the strength stability of the rock face & cliff varies considerably over the exposed rock face and cliff line, and
- ii] there were many "near vertical" open joints trending north west, with some open joints being as wide as 150 mm, and
- iii] recent [i.e. last 12 months] rock falls had occurred within the caverns and along the cliff face area, and
- iv] there was an area of extensive seepage over the cliff near Lot No. 887 [see heavy seepage noted on the Hazard Zoning Plan].

Near the rear of Lots No. 889 & 890 [see seepage area noted on the Hazard Zoning Plan] the ground conditions during the entire study period were wet underfoot and considered symptomatic of both:

It was also apparent that the concentrated run-off from the drain on the right of way was being channelled in the direction indicated on the Hazard Zoning Plan; as such, this concentrated run-off could be having a significant effect upon the long term stability of the cliff line in this area.

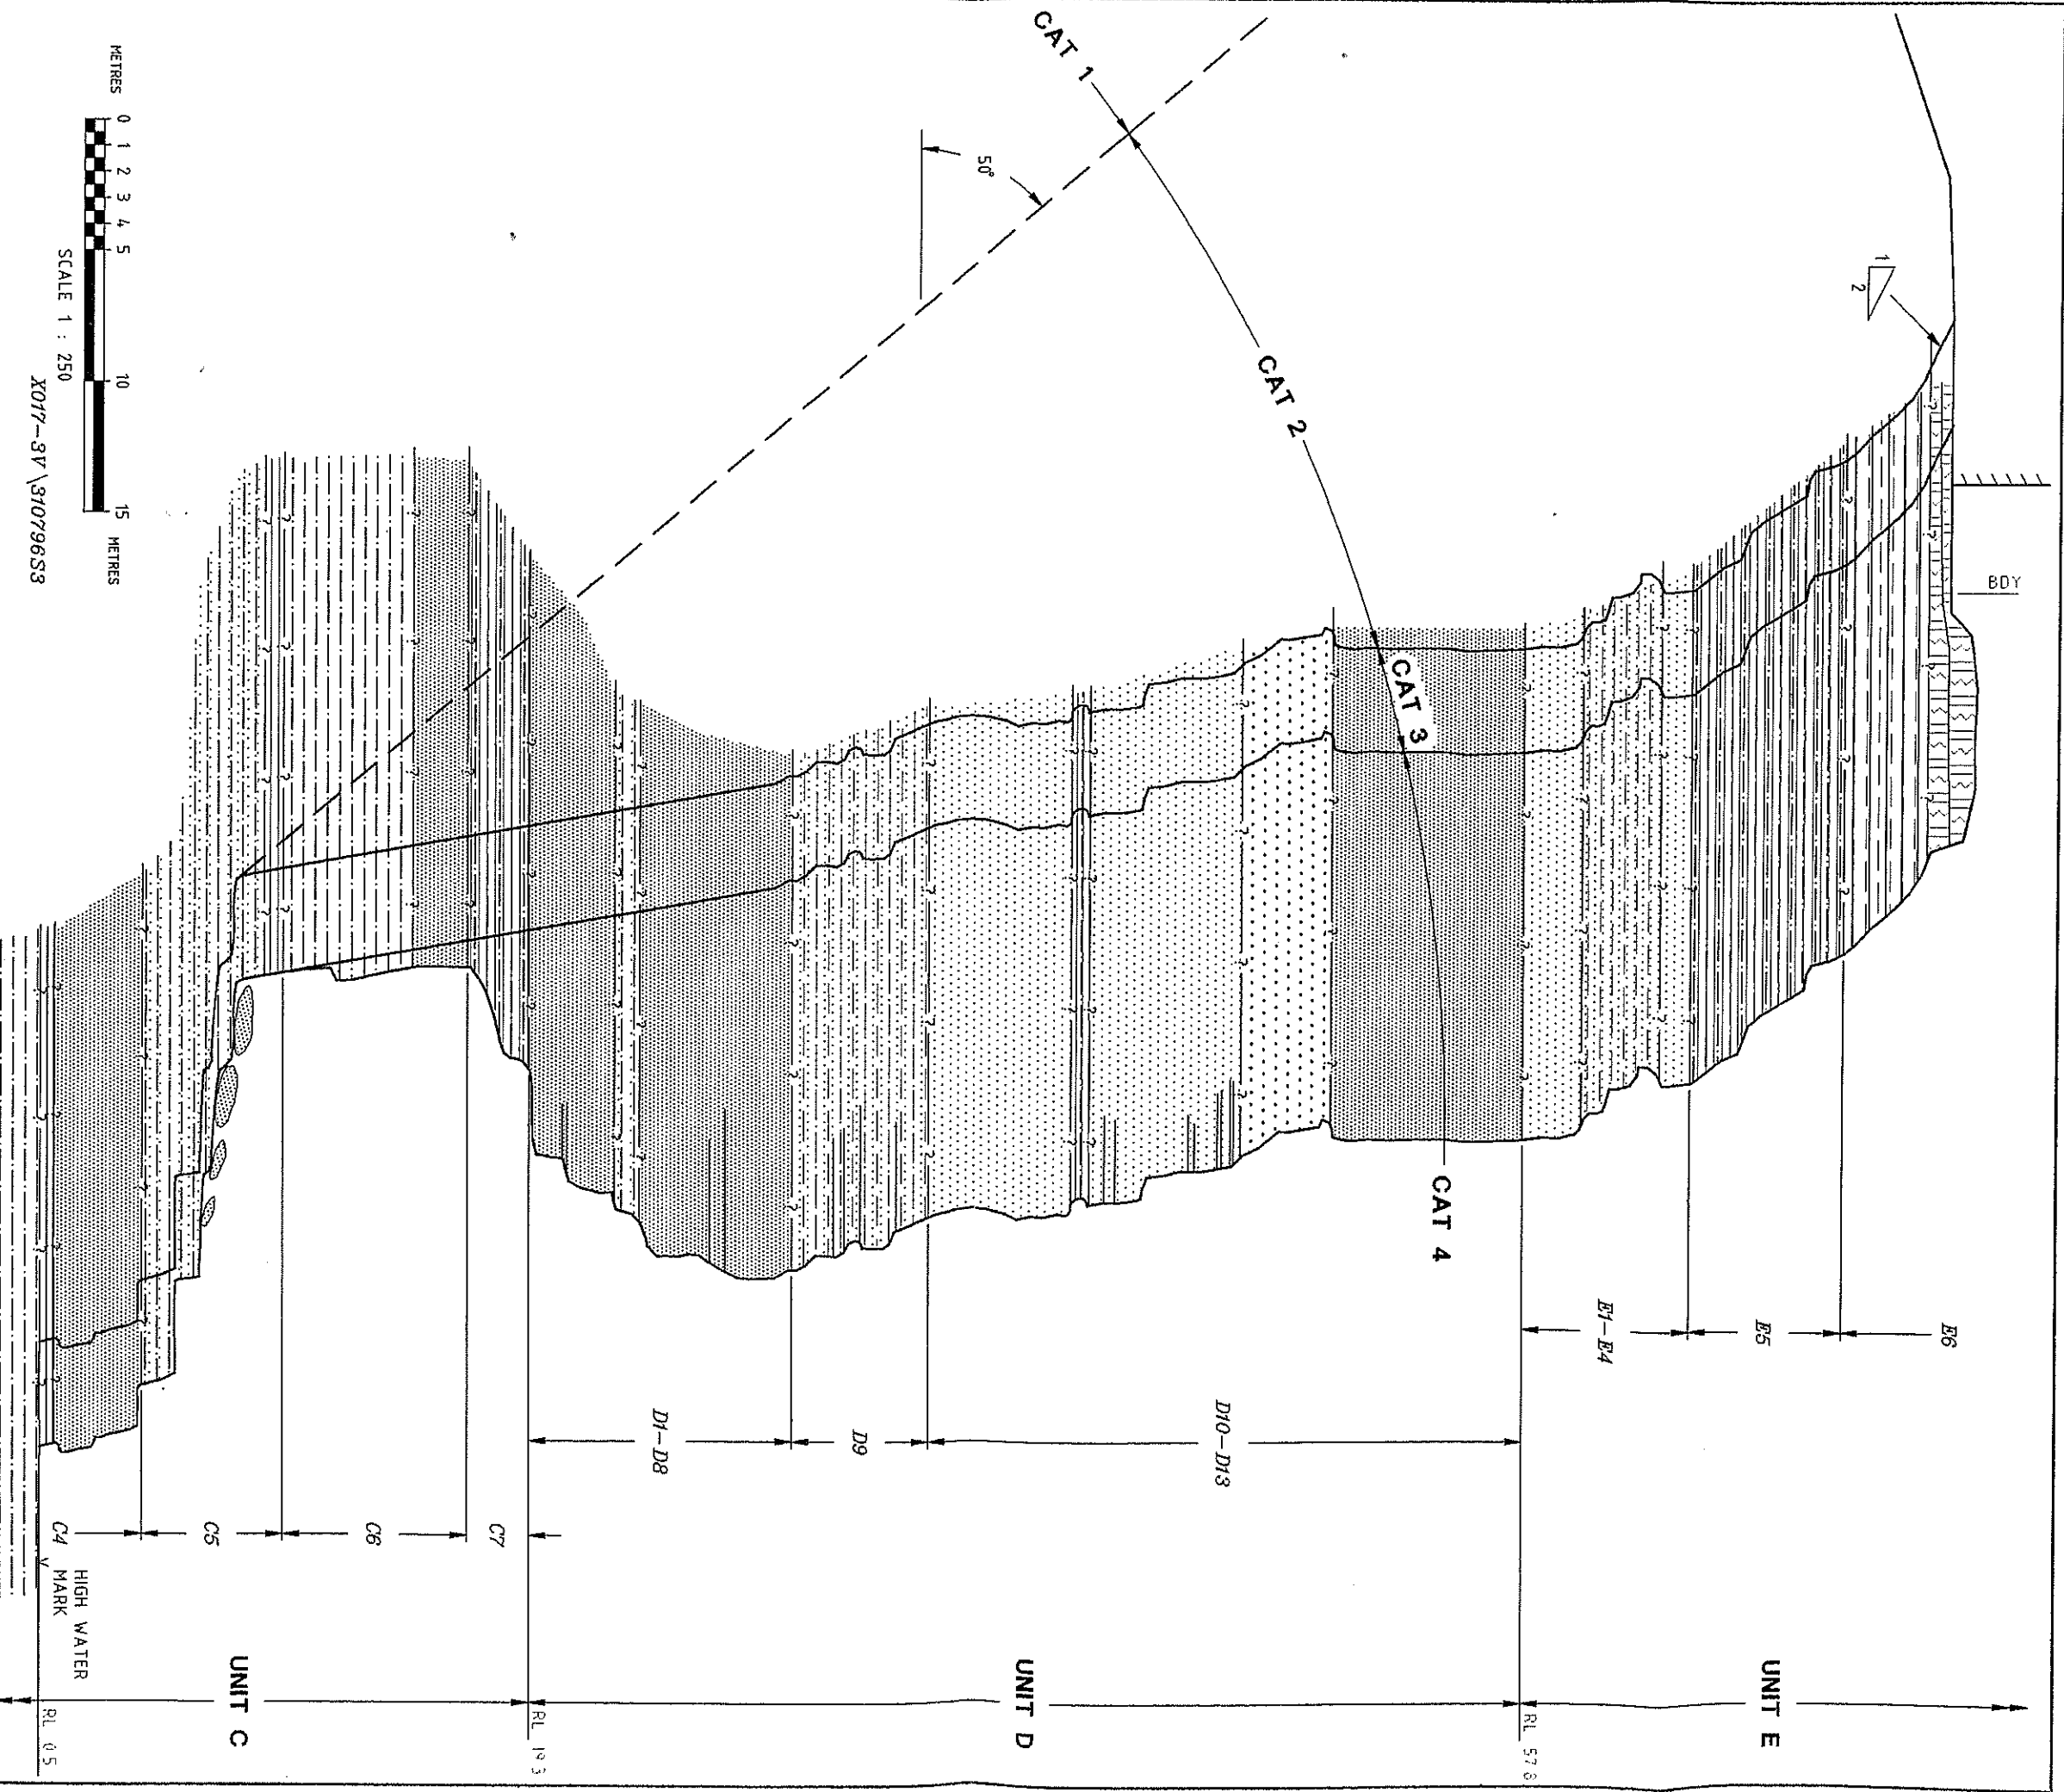
TITLE: **GEOLOGICAL SECTION 3
CLIFF LINE HAZARD DEFINITION STUDY
TUDIBARING HEADLAND, COPACABANA**
CLIENT: **GOSFORD CITY COUNCIL**

The unit is weak to very weak and weathers rapidly. In many locations weathering of the claystone / siltstone profiles of up to four [4] metres were noted. In addition, two large caverns have formed near Section 3 [Drawing No. X017G6] which have weathered out depths of between 14 & 16 metres. The weakness of this unit is responsible for the main failure mechanism of the cliff face and the cliff line recession [or regression] process.
