**GOSFORD CITY COUNCIL**

**TERRIGAL LAGOON  
FLOODPLAIN MANAGEMENT STUDY**

**NOVEMBER 2001**

**WEBB, McKEOWN & ASSOCIATES PTY LTD**

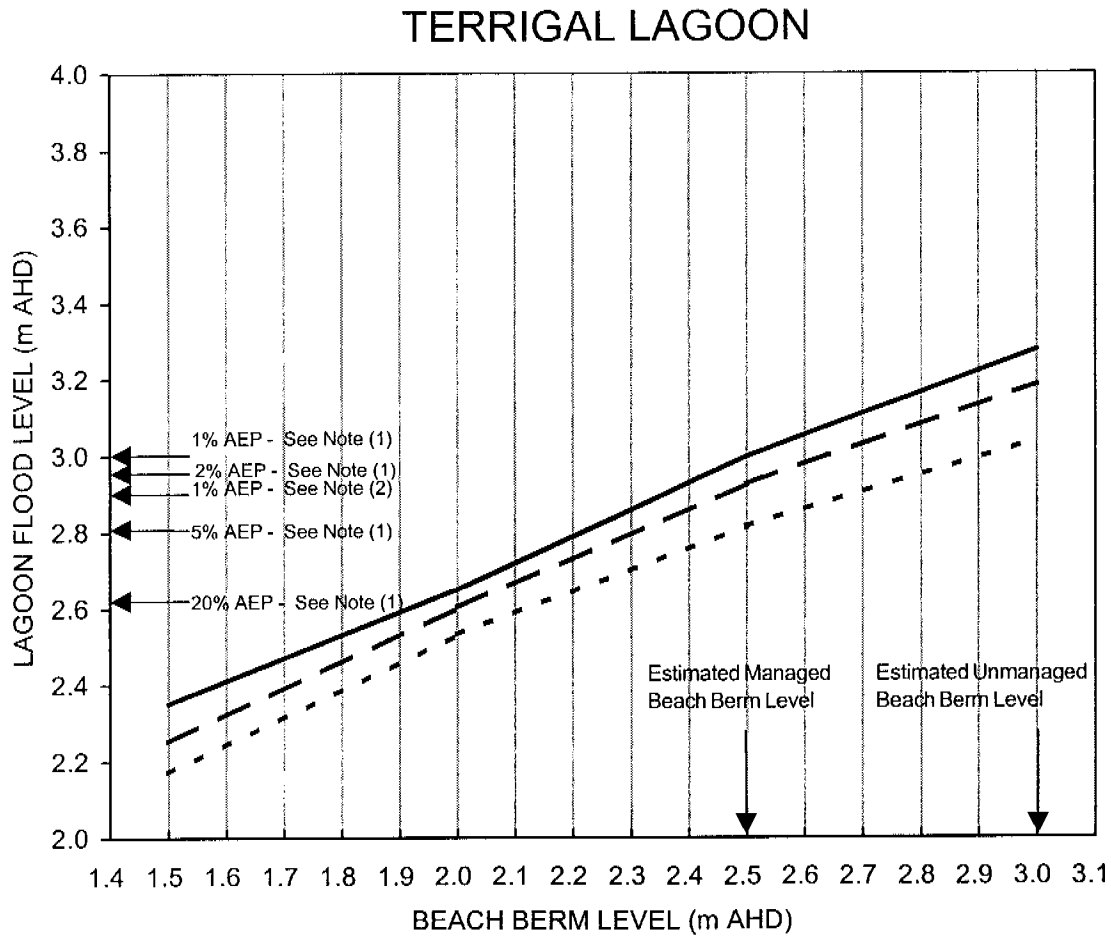
**SENSITIVITY OF DESIGN LAGOON LEVELS TO BEACH BERM LEVEL**

**NOTES:**

- (1) Flood heights determined in the Flood Study
- (2) Flood height determined prior to the present Flood Study

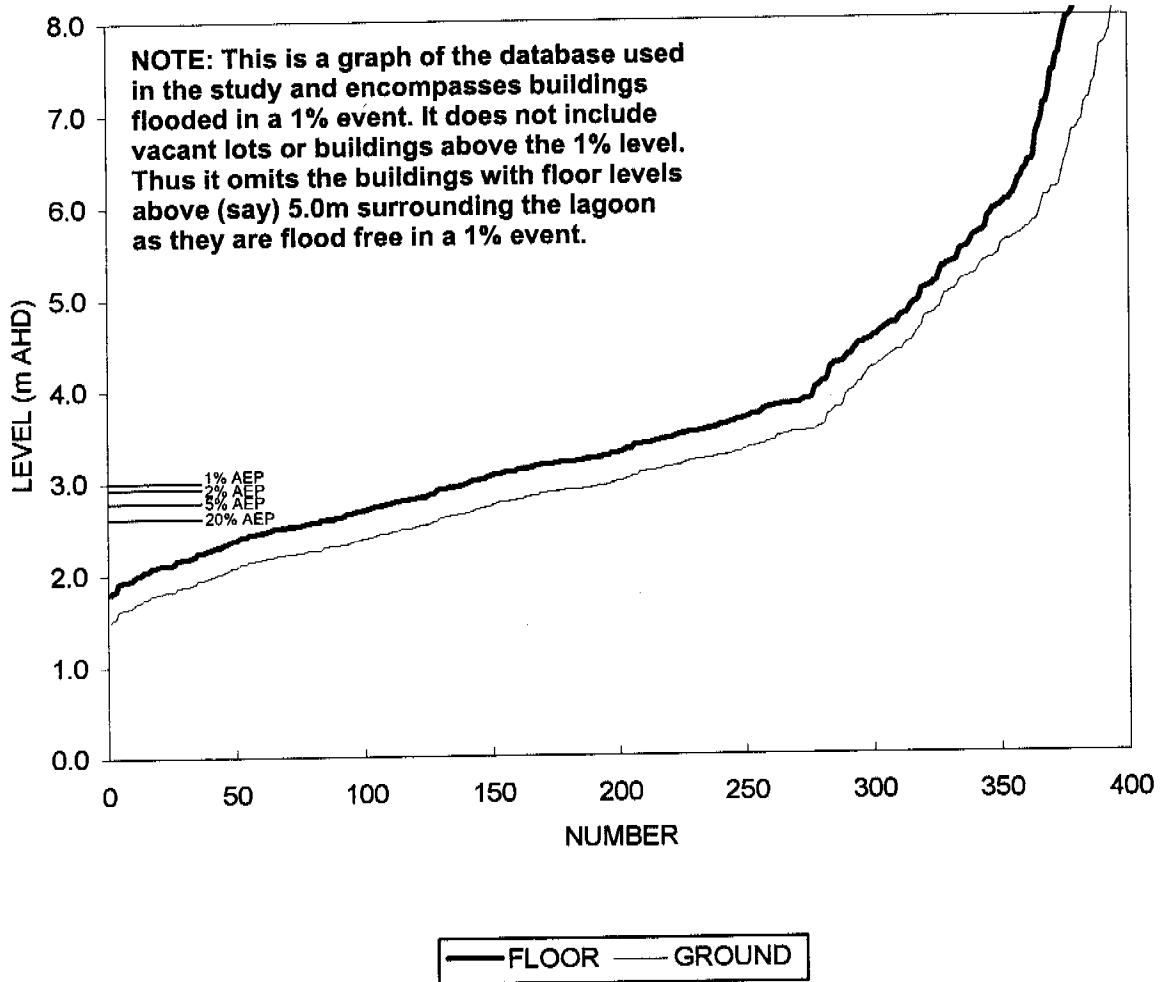
**TERRIGAL LAGOON  
FLOOR AND GROUND LEVELS**

**NOTE:** One of the adopted floodplain management measures is for Council to maintain the entrance berm. Consequently the resulting design flood levels will be lower than indicated on this Figure. For Terrigal Lagoon the 1% AEP level will be reduced from 3.0m AHD to 2.9m AHD.

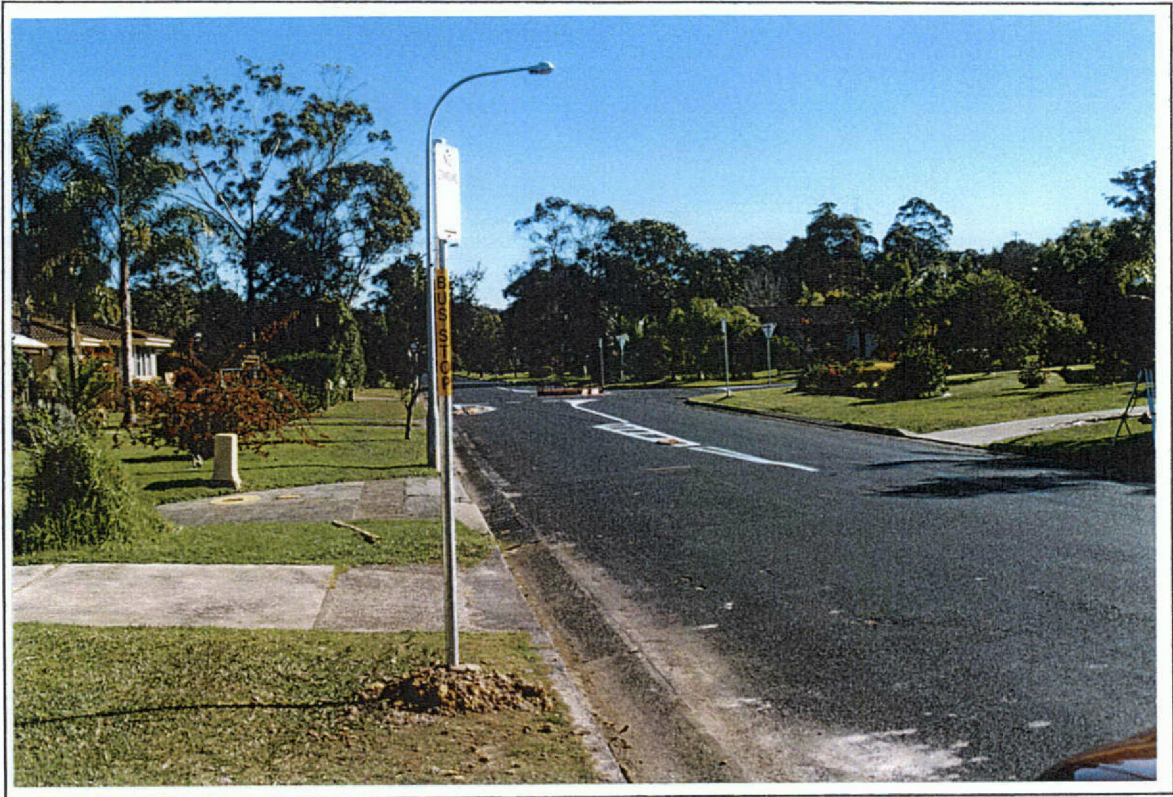
Photograph C1: Windsor Road Facing West of Main Low Point

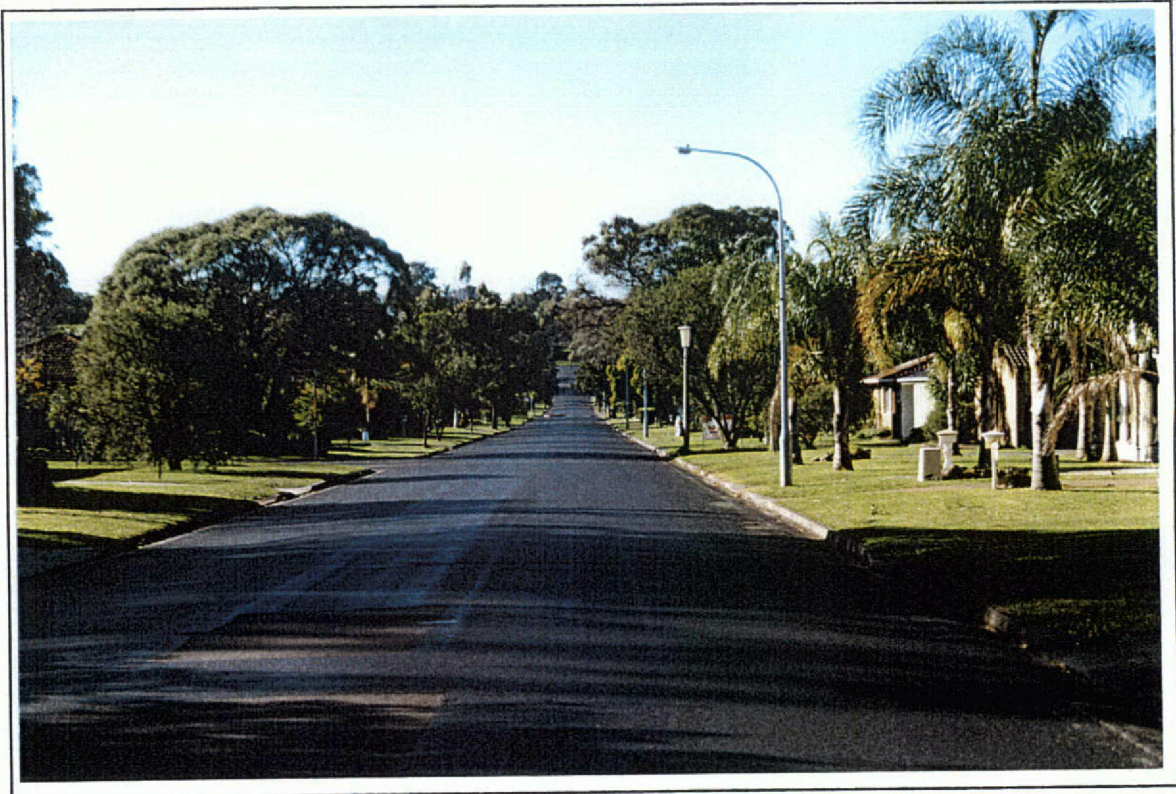
Photograph C2: Windsor Road Facing East of Main Low Point

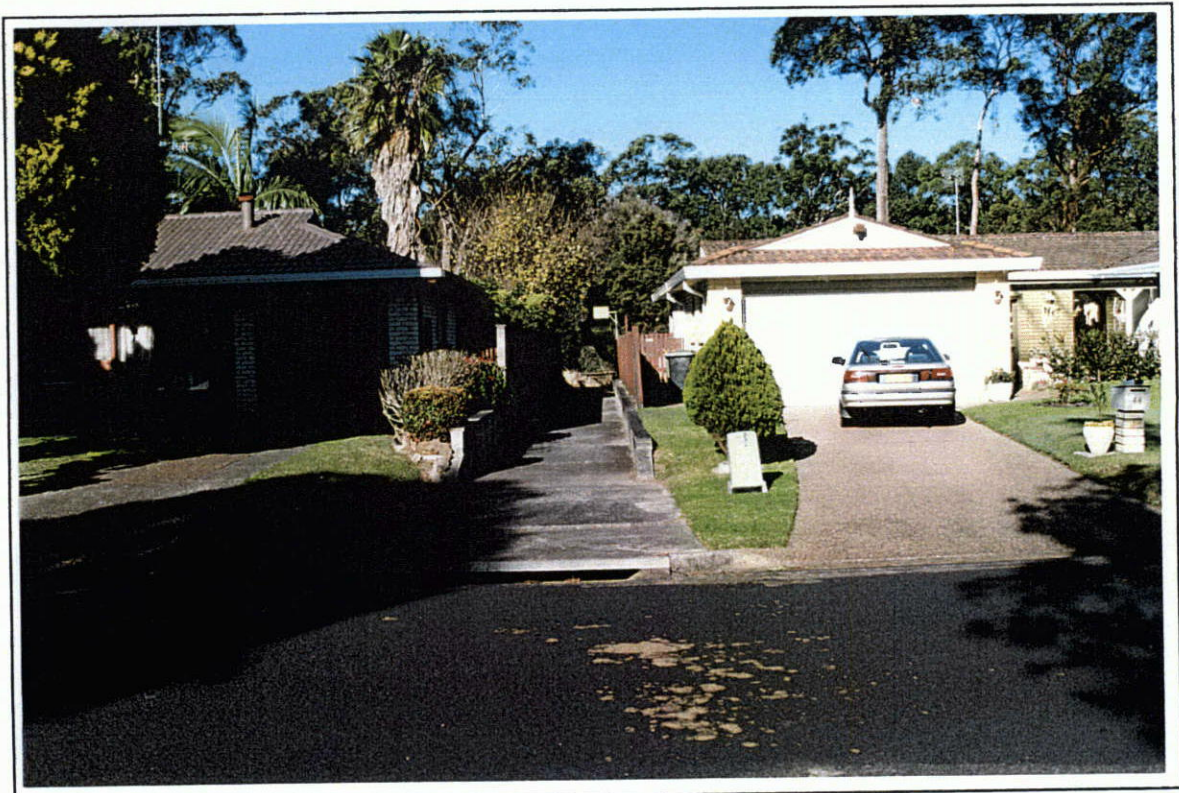
Photograph C4: Causeway between Property No's 42 & 44
