Long-Term Environmental Management Plan

Gosford Regional Library

123A Donnison Street, Gosford NSW

Project 83343.04

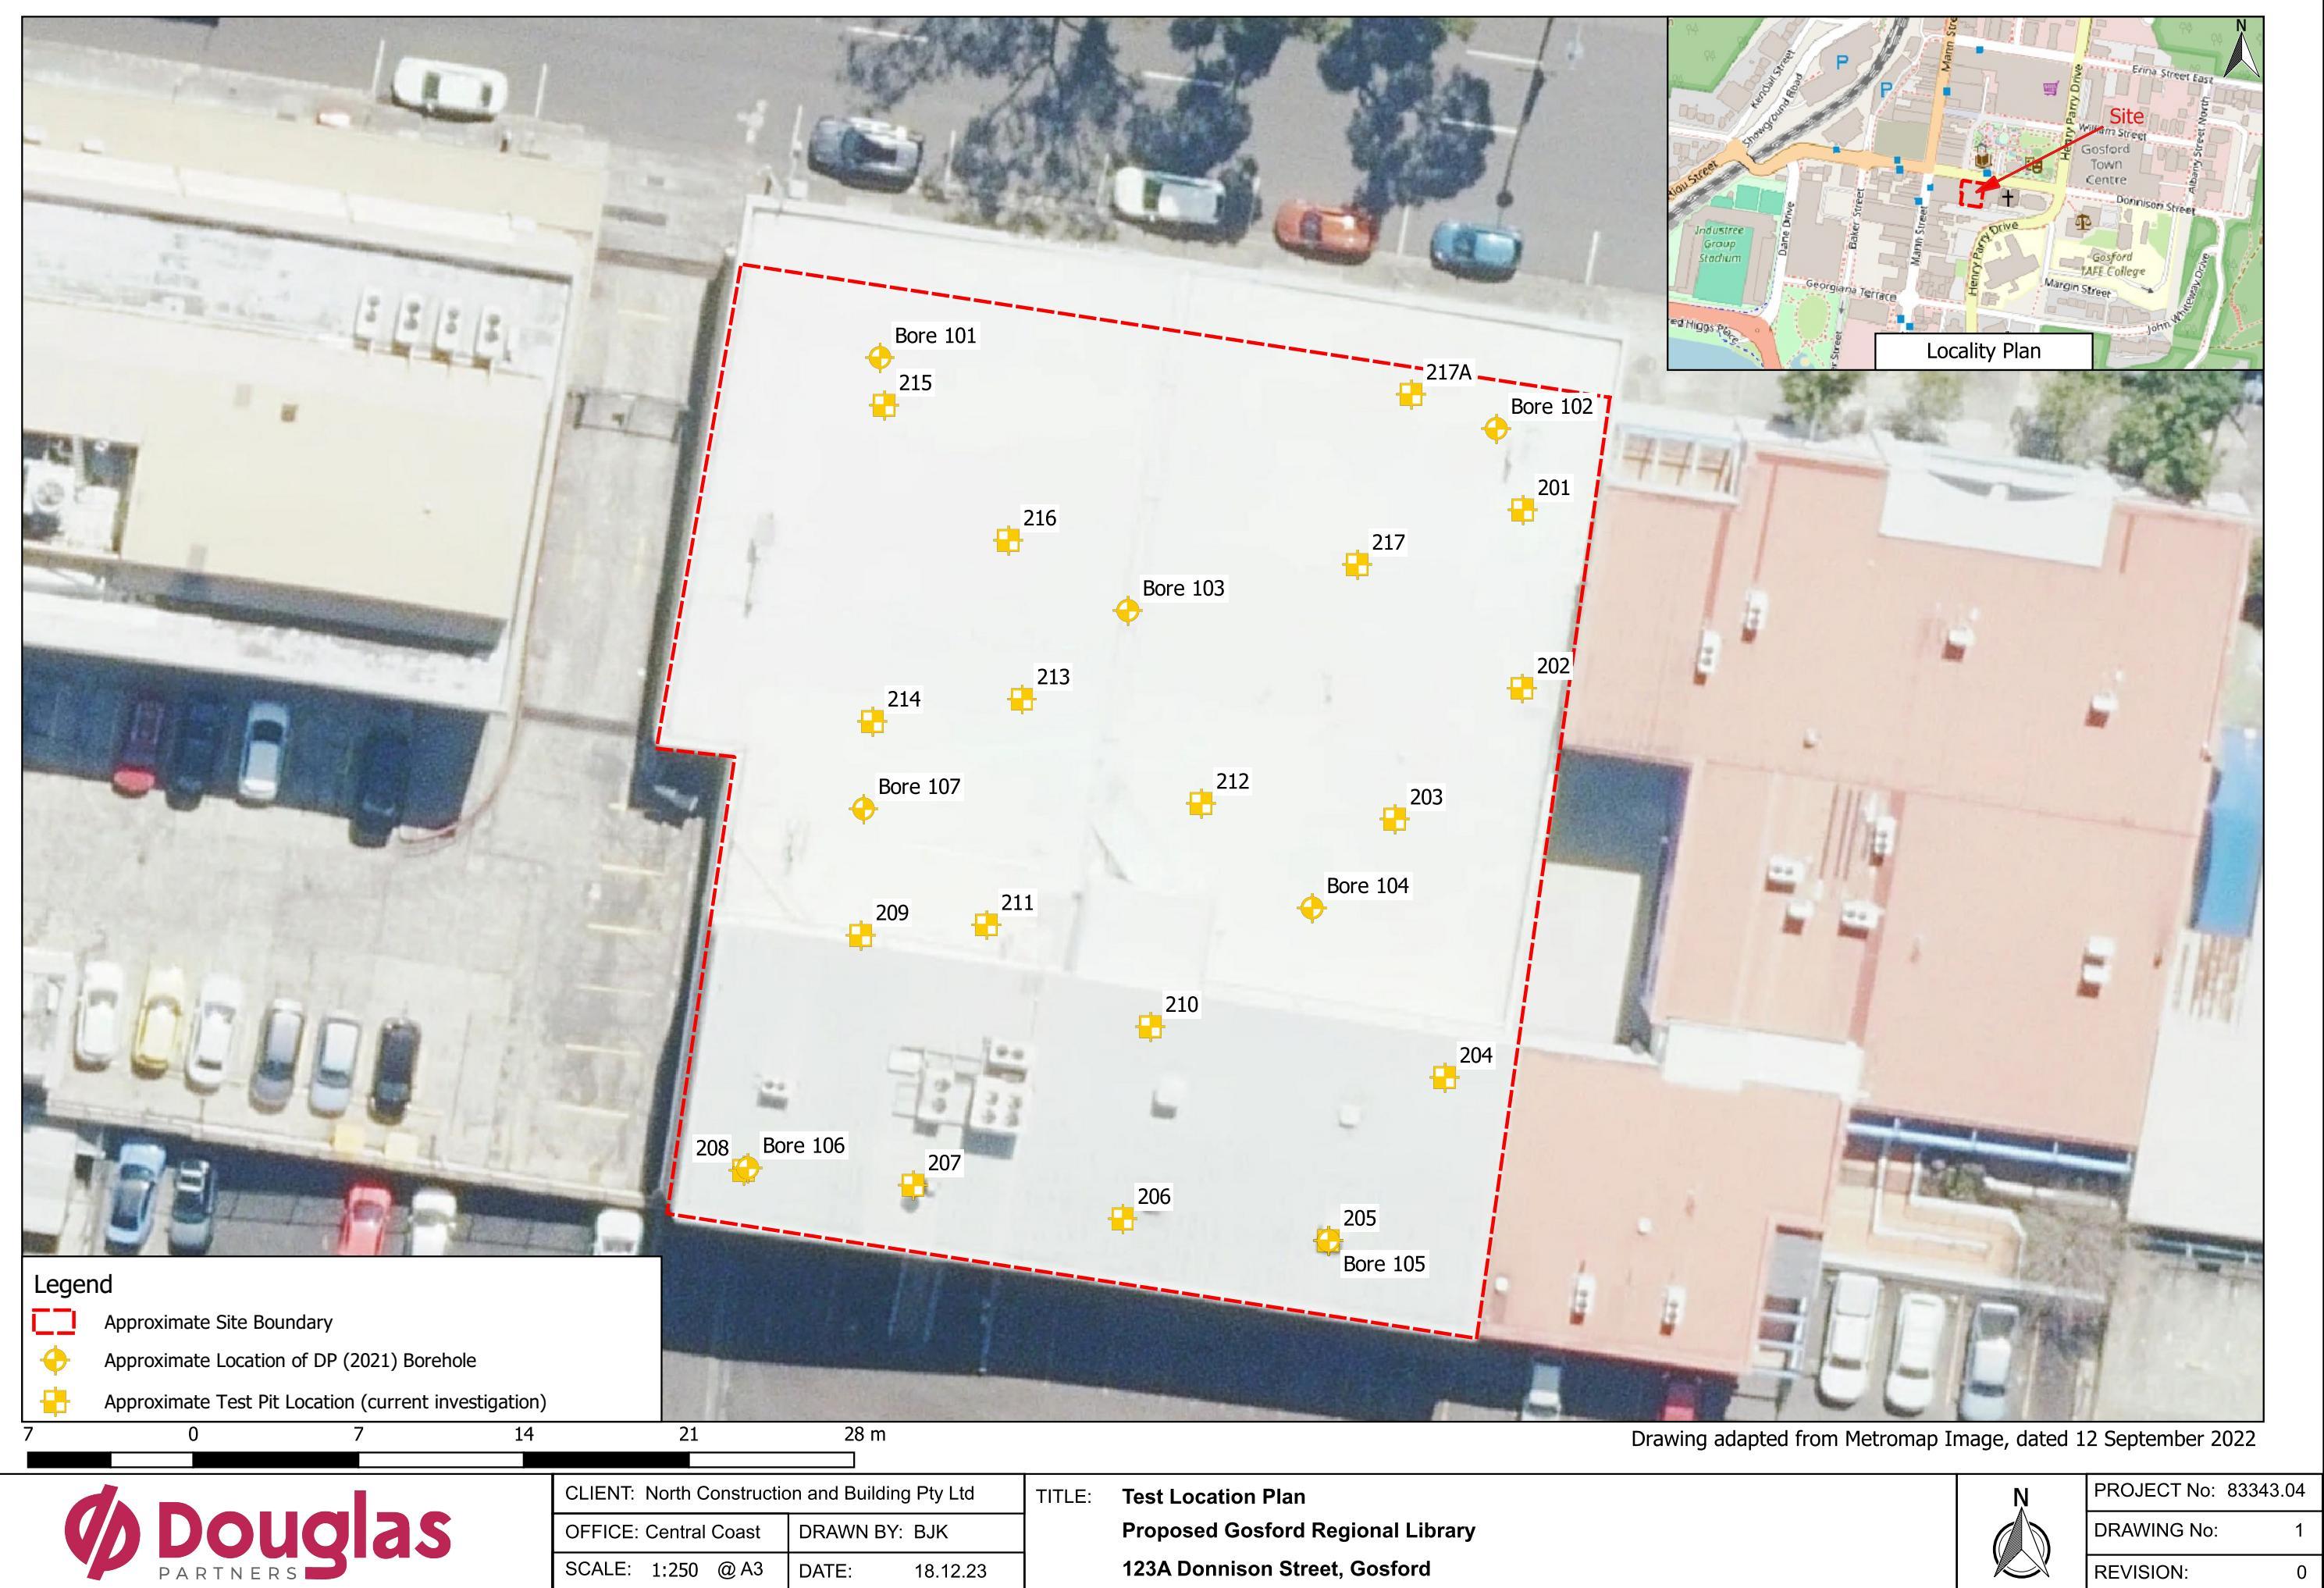
I	PROJECT No:	83343.04
Ø	DRAWING No:	1
×	REVISION:	C

The site and test location plan prepared for DP (2023b) is provided in Appendix B. An extract of the architectural plans and construction plans (ground floor) are also provided in Appendix B.

Site and Test Location Plan (DP, 2023b)

A notation is to be placed on the S10.7 Certificate for the site indicating that contaminated soils are present and capped on-site as shown on Drawing 1, Appendix B.

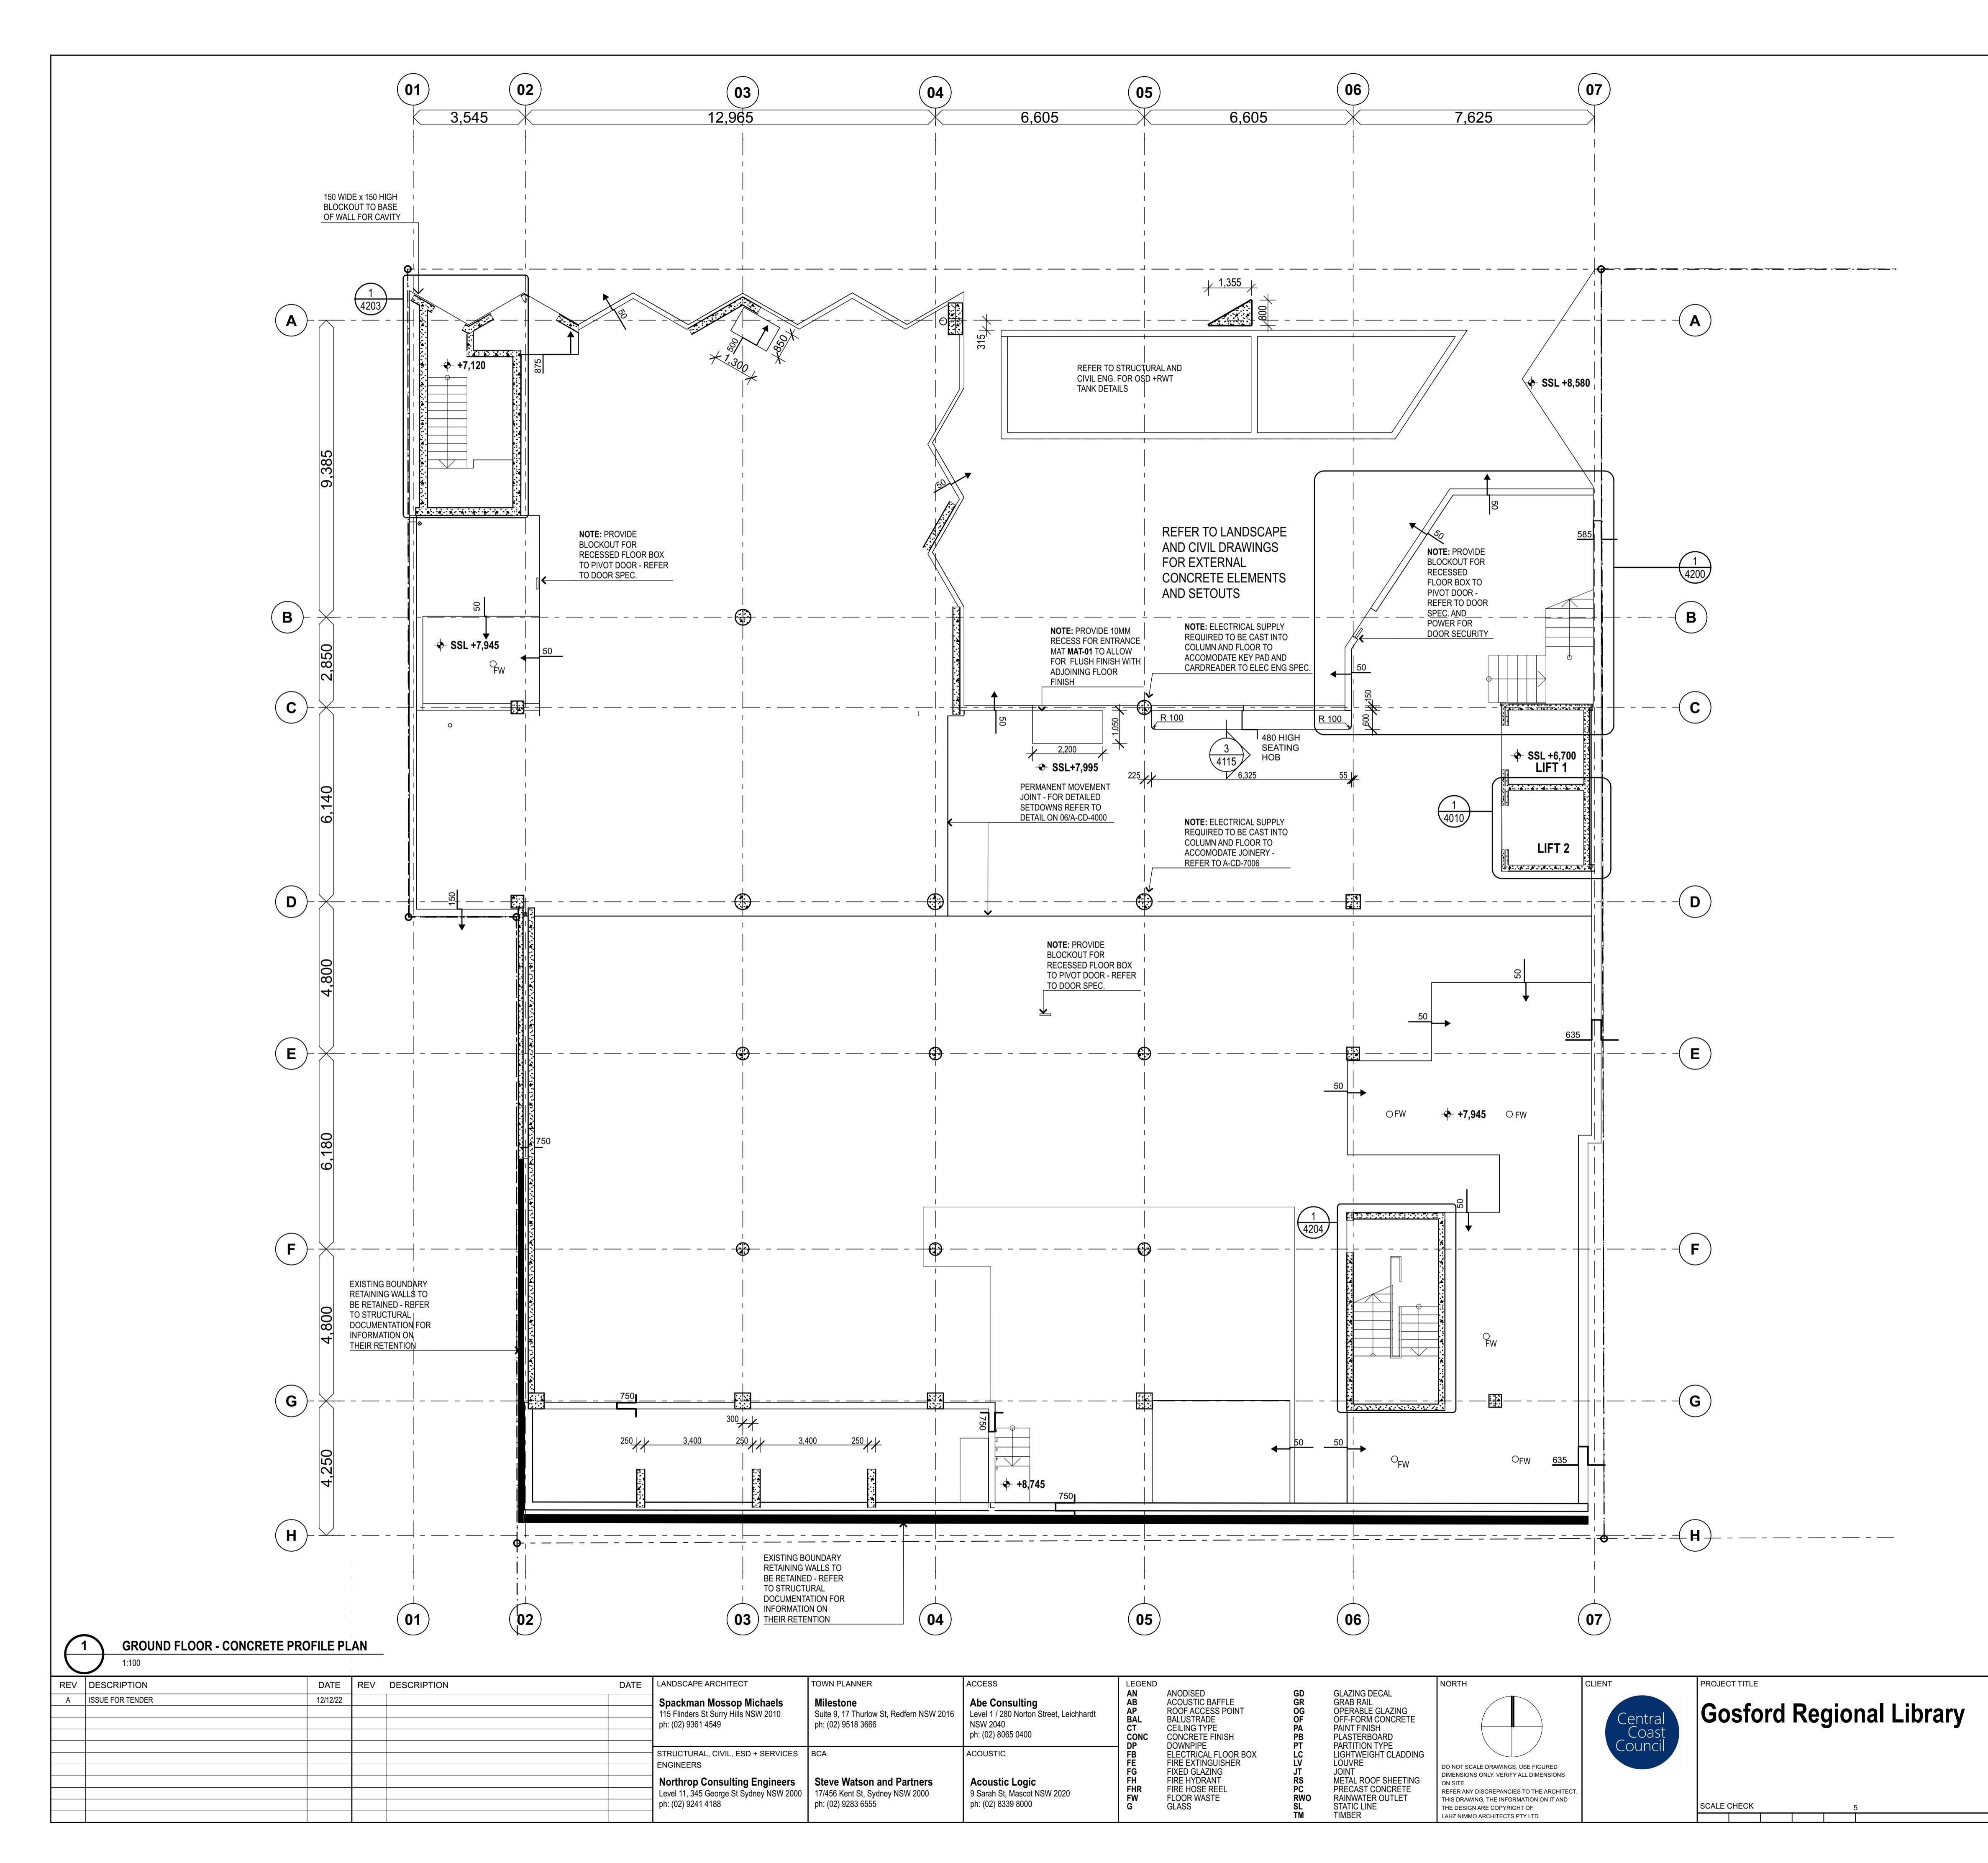
lahznimmo architects							
	Suite 404, Flourmill Studios T 02 9550 3 Gladstone St F 02 9550 Newtown NSW 2042 Australia www.lahz		T 02 9550 5 F 02 9550 5 www.lahzni	PROFILE PLAN				
	REVIEW	DIRECTOR SIGNATURE		DATE	DRAWN	PLOT DATE	SCALE @A1	SCALE @A3
	TENDER	Mun Mun .		12/12/22	HC/SGG	13/12/22	1:100	
		/~ 000 00000C			CHECKED	PROJECT NO.	DRAWING NO.	REV. NO
10	CONST				AN	20-04	A - C D - 1 3 0 0	A

The ACM impacted fill is presumed to be present beneath the entire site. The details of the capping construction are capping using a minimum 100 mm thick concrete slab.

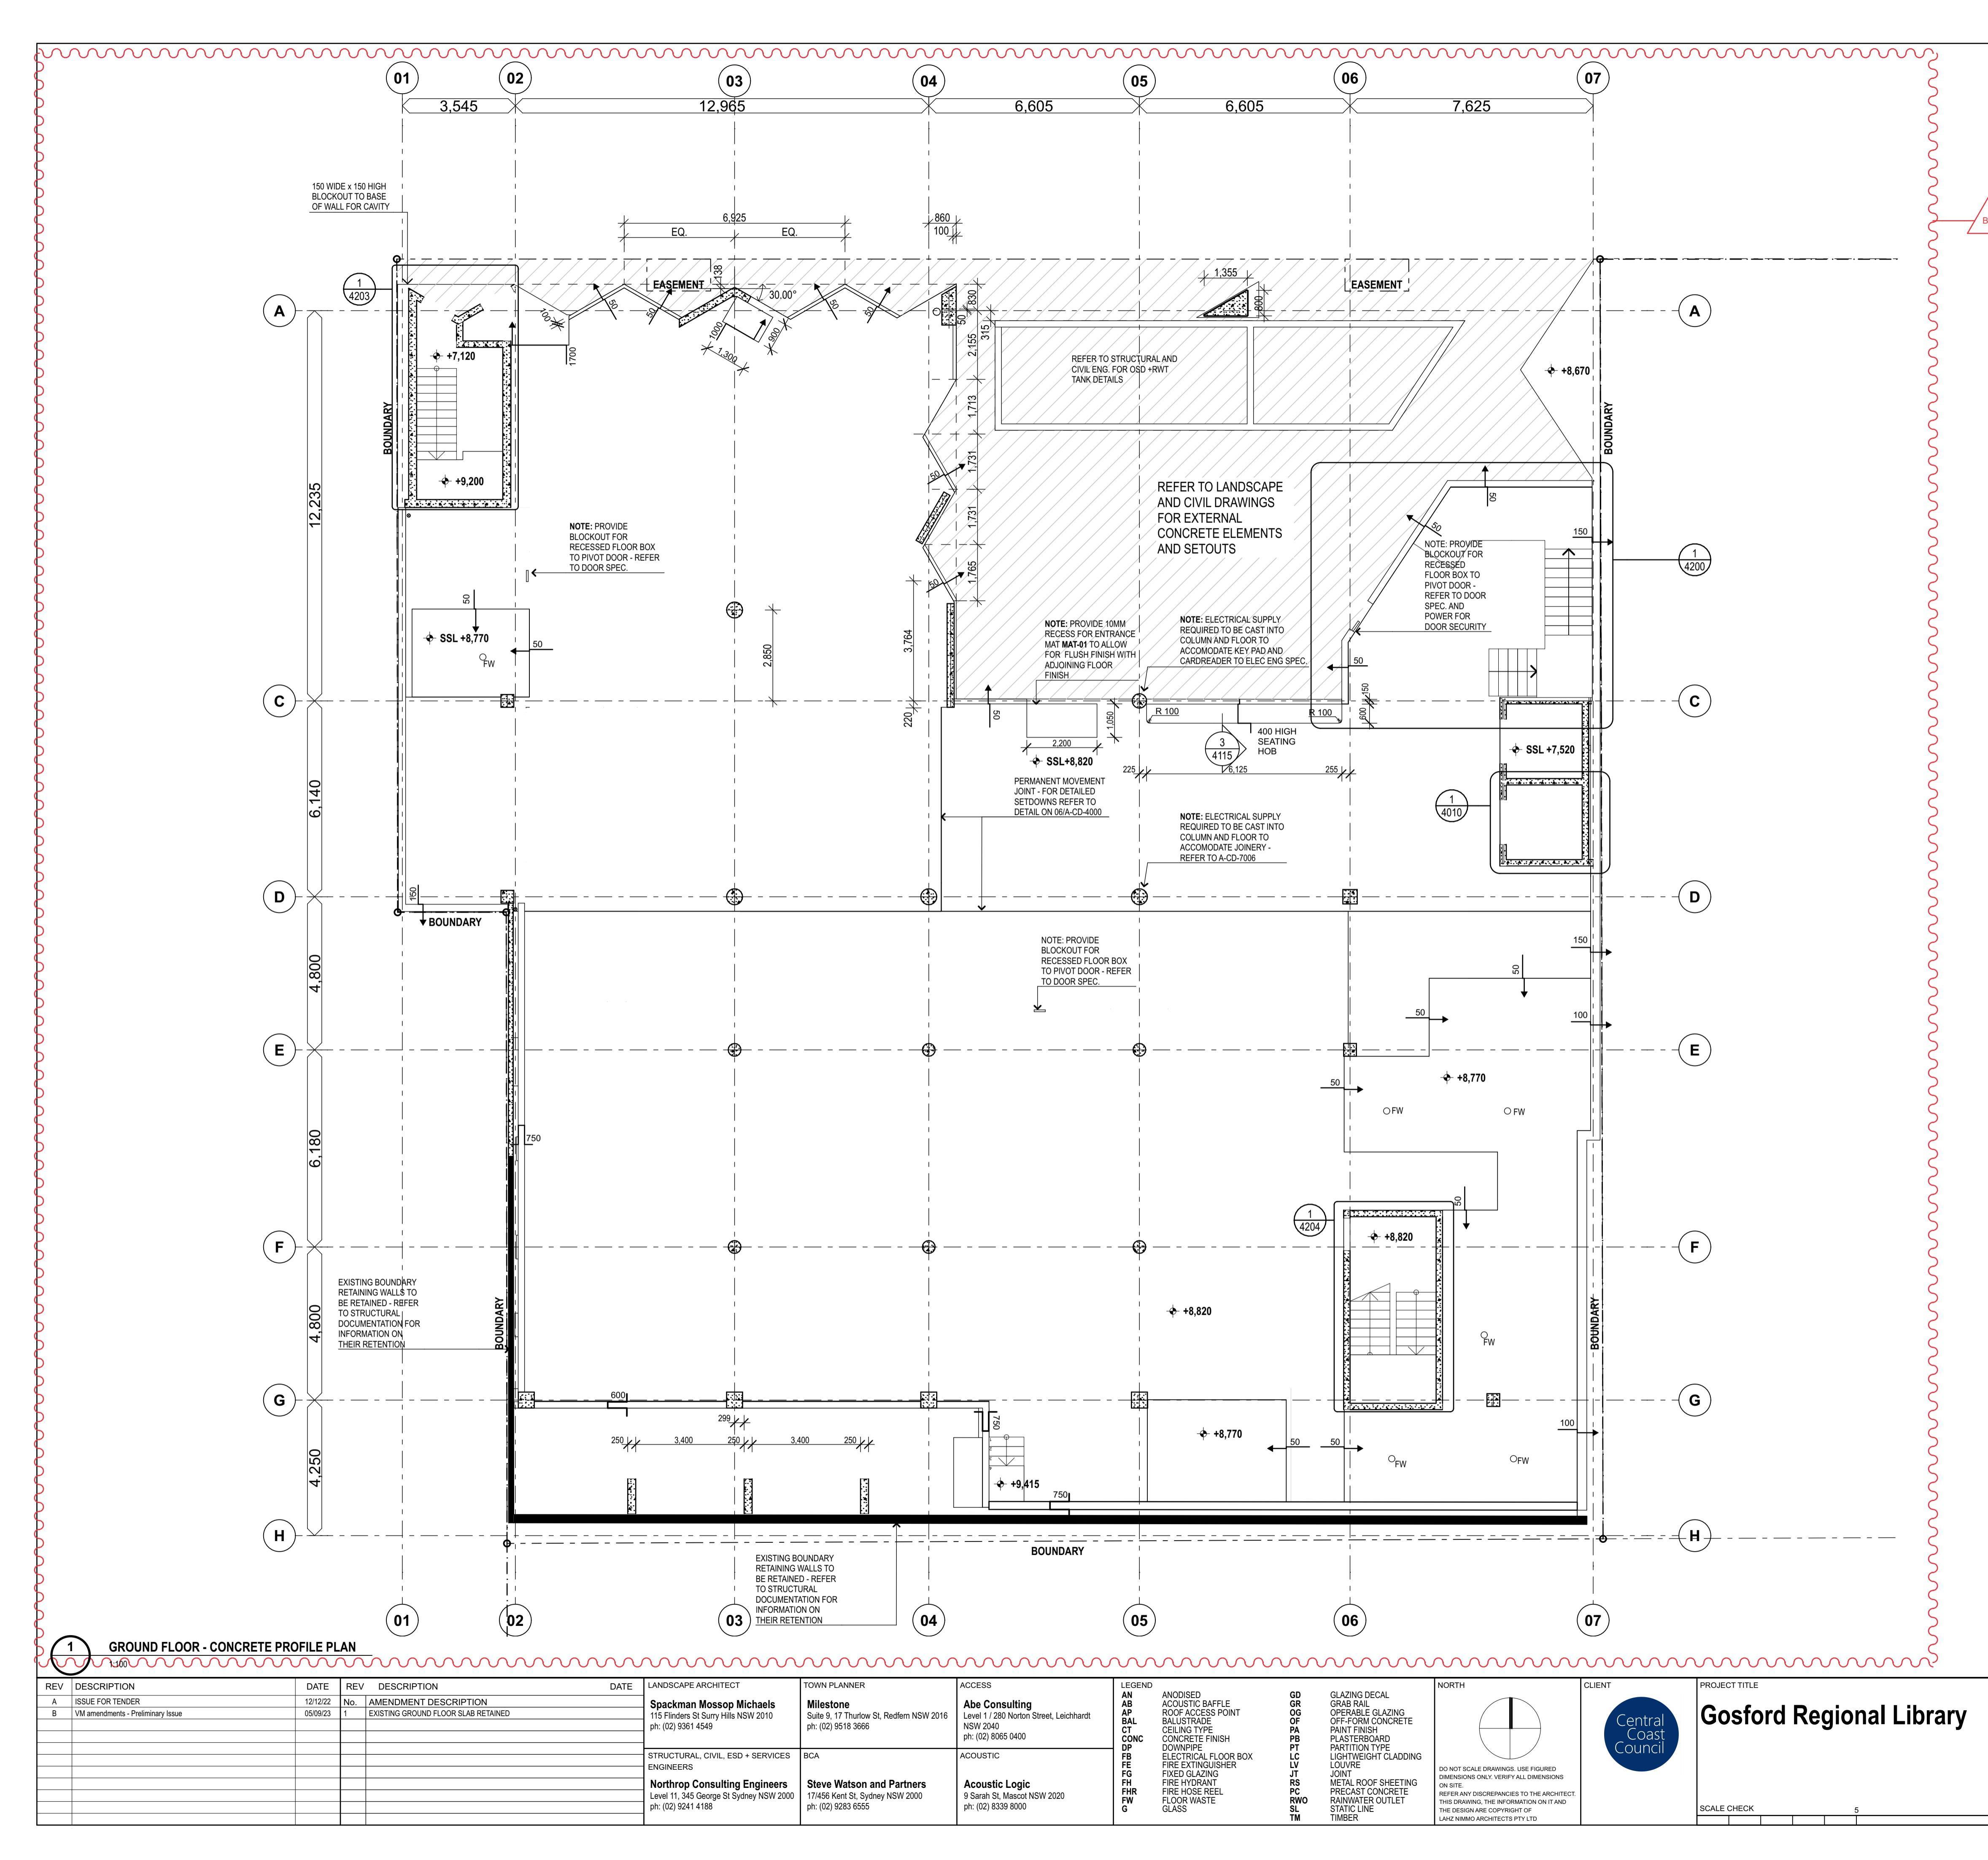
Lahznimmo architects Suite 404, Flourmill Studios 3 Gladstone St Newtown NSW 2042 Australia		T 02 9550 5200 F 02 9550 5233 www.lahznimmo.com		GROUND FLOOR - CONCRETE PROFILE PLAN				
	REVIEW	DIRECTOR SIGNATURE		DATE	DRAWN	PLOT DATE	SCALE @A1	SCALE @A3	
	TENDER	Al. Mar	. 12/12	12/12/22	HC/SGG	5/9/23	1:100		
		/ Man Mun		12/12/22	CHECKED	PROJECT NO.	DRAWING NO.	REV. NO	
10	CONST				AN	20-04	A - C D - 1 3 0 0	B
