### **Entrance Dynamics and Beach Condition at The Entrance and North Entrance Beaches**

Wyong Shire Council

April 2011

Project Director:	Pam Dean-Jones	
Project Manager:	Pam Dean-Jones	
Report No.	1869/RO5/Final	Date: APRIL 2011

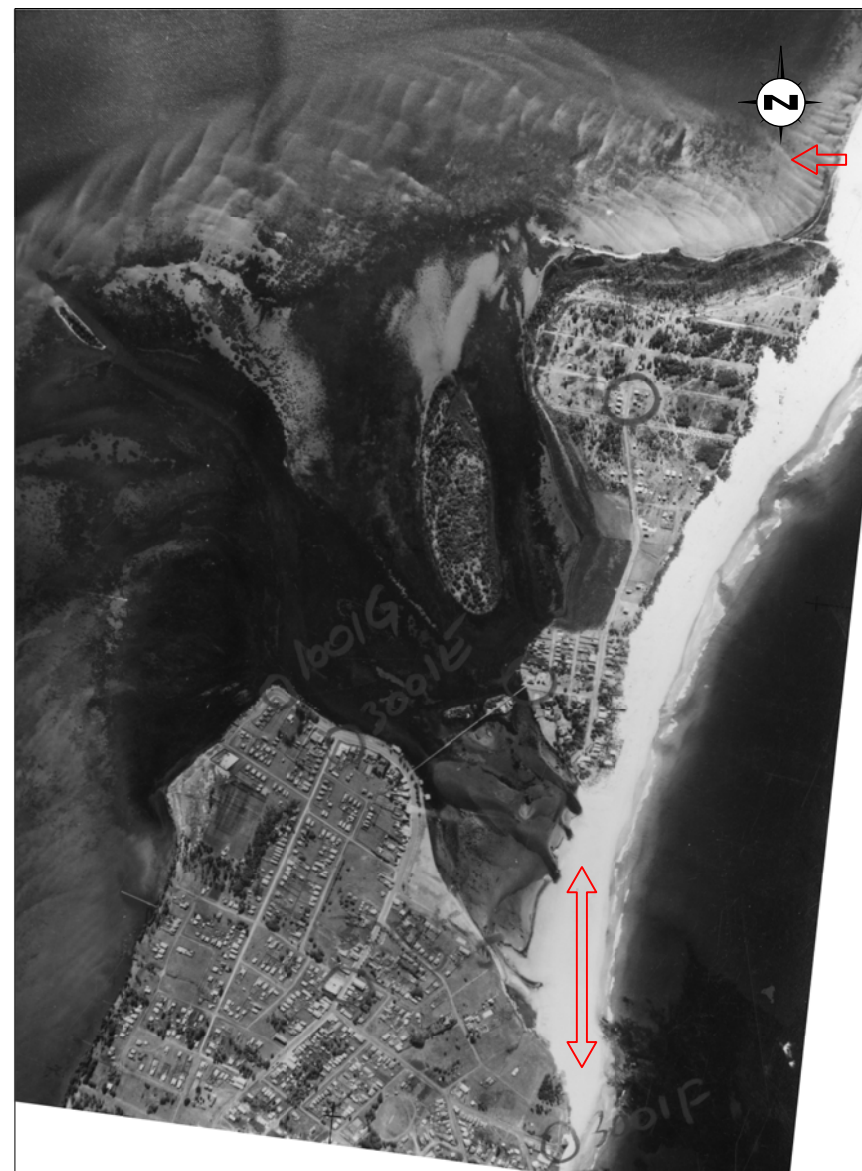
**FIGURE 2.1**  
**Channel and Tidal Delta**  
**changes at The Entrance**

**1941**

- Active blowout transferring sand from North Entrance Beach (Curtis Pde area) across the barrier to outer edge of tidal delta
- Entrance closed. Long shore sediment transport building The Entrance Beach
- Very wide beach at North Entrance

**1954**

- Entrance open on southern side
- Sand stripped from The Entrance Beach and from outer tidal delta
- Extensive tidal flats off main channel on western side of tidal delta
- Limited delta activity to northern side

- Active blowout continues at North Entrance
- Sand from blowout moving west across outer margin of delta
- Eastern side of delta strongly shoaled
- Wide beach at North Entrance, but low sand volume at The Entrance Beach

From **Figure 2.1** a number of sand accumulation areas around the Entrance and North Entrance can be discerned. These are noted in **Table 4.1**. Estimates of the volume of material in these storages are *preliminary and indicative*. They are based on assumptions about the thickness of sand deposits in the entrance area and on rounded numbers for the 2D dimensions of the various deposits

The morphology of the entrance to Tuggerah lakes over the last 20 years (and beyond to 70 years) has changed significantly. A narrowing of the entrance berm can be observed. However, other significant changes such as dredging of deep channels across the inner and outer parts of the tidal delta, removing sand from the tidal system into reclaimed foreshore and placing dredged sand onto North Entrance Beach have interfered with natural estuary entrance processes. In addition, until the late 1960s, sand was being contributed to the distal margin of the tidal delta, not from tidal processes, but from a transgressive dune at North Entrance (see **Figure 2.1**). This transfer process has now stopped.

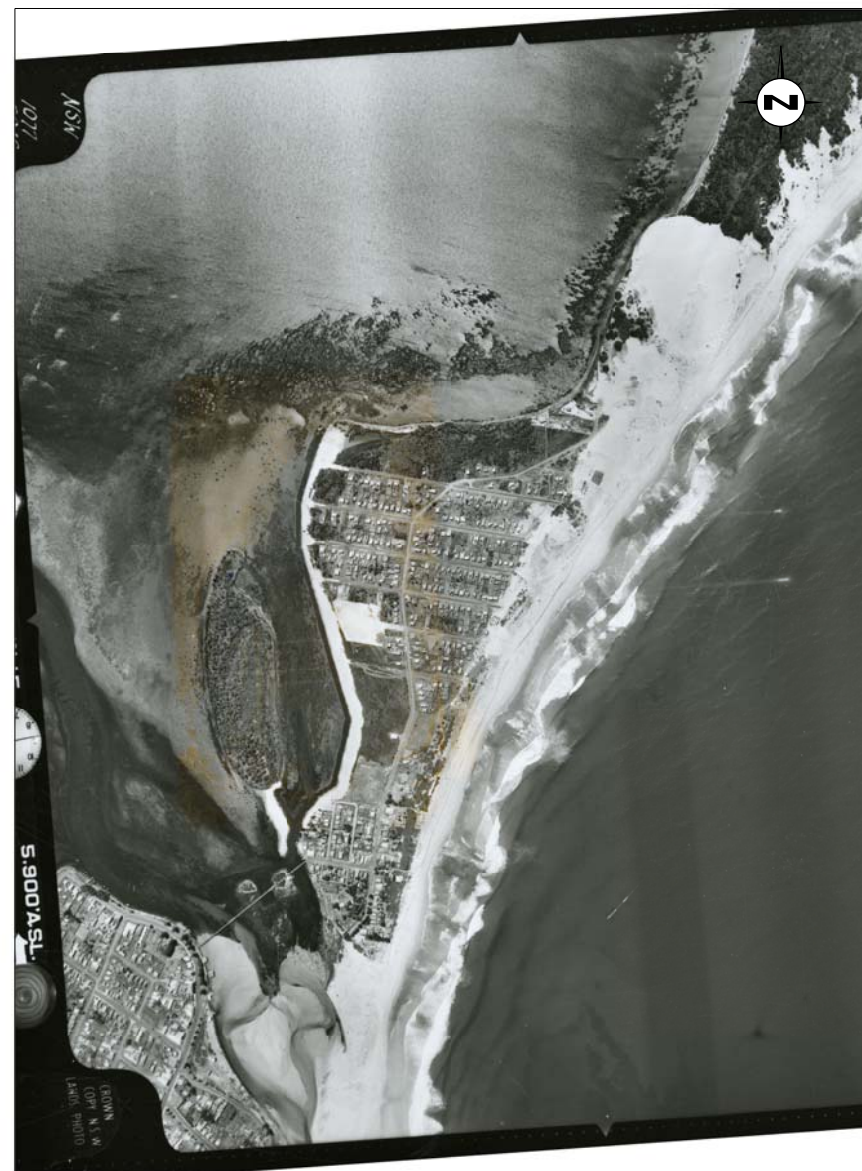
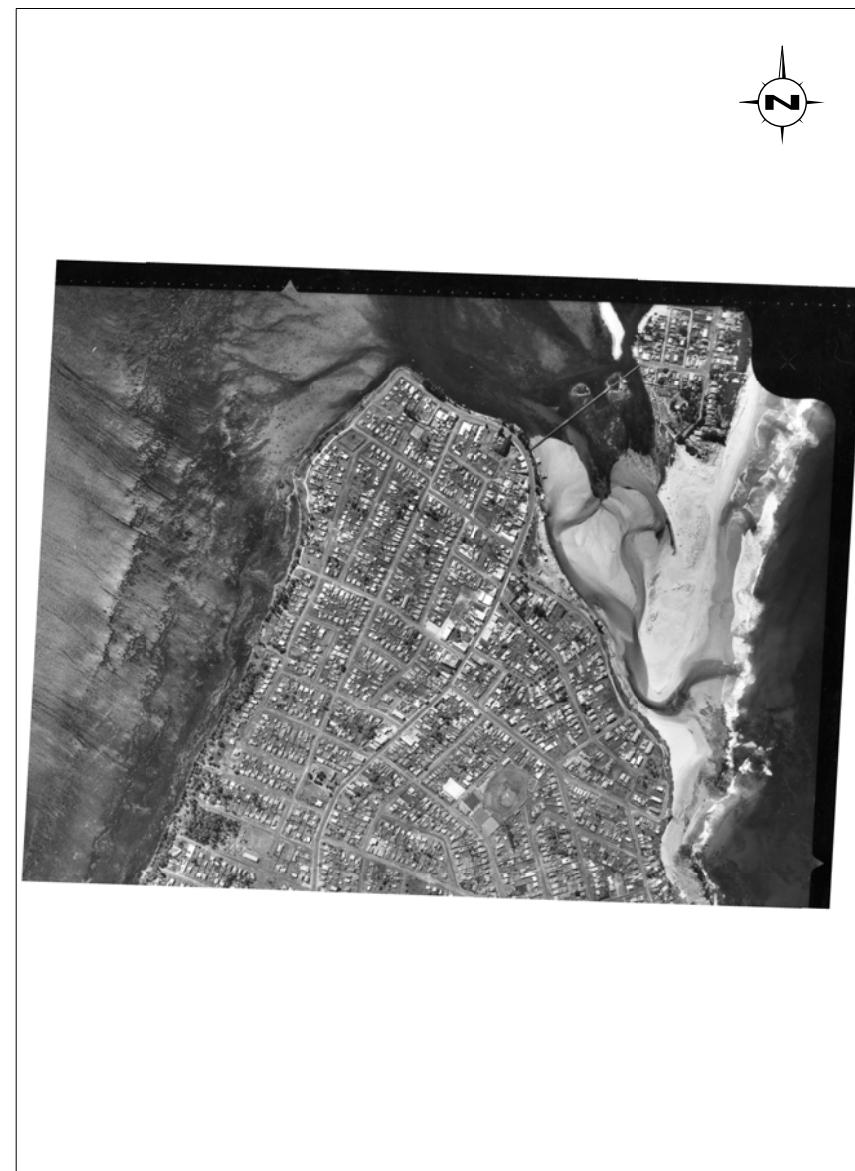
**FIGURE 2.2**  
Channel and Tidal Delta  
changes at The Entrance

**1961**

- New alignment of lake shore at North Entrance, with sea wall
- large bars in nearshore, storing sand; large rip cells off Hutton Rd and in front of blowout

- Limited sand on The Entrance Beach; isolated from North Entrance by entrance channel
- Limited stabilisation of the sand spit across The Entrance - spinifex colonisation?

**1965**

- Entrance shoal and spit trimmed by migrating channel
- Many small beach cusps, reduced rip cell circulation

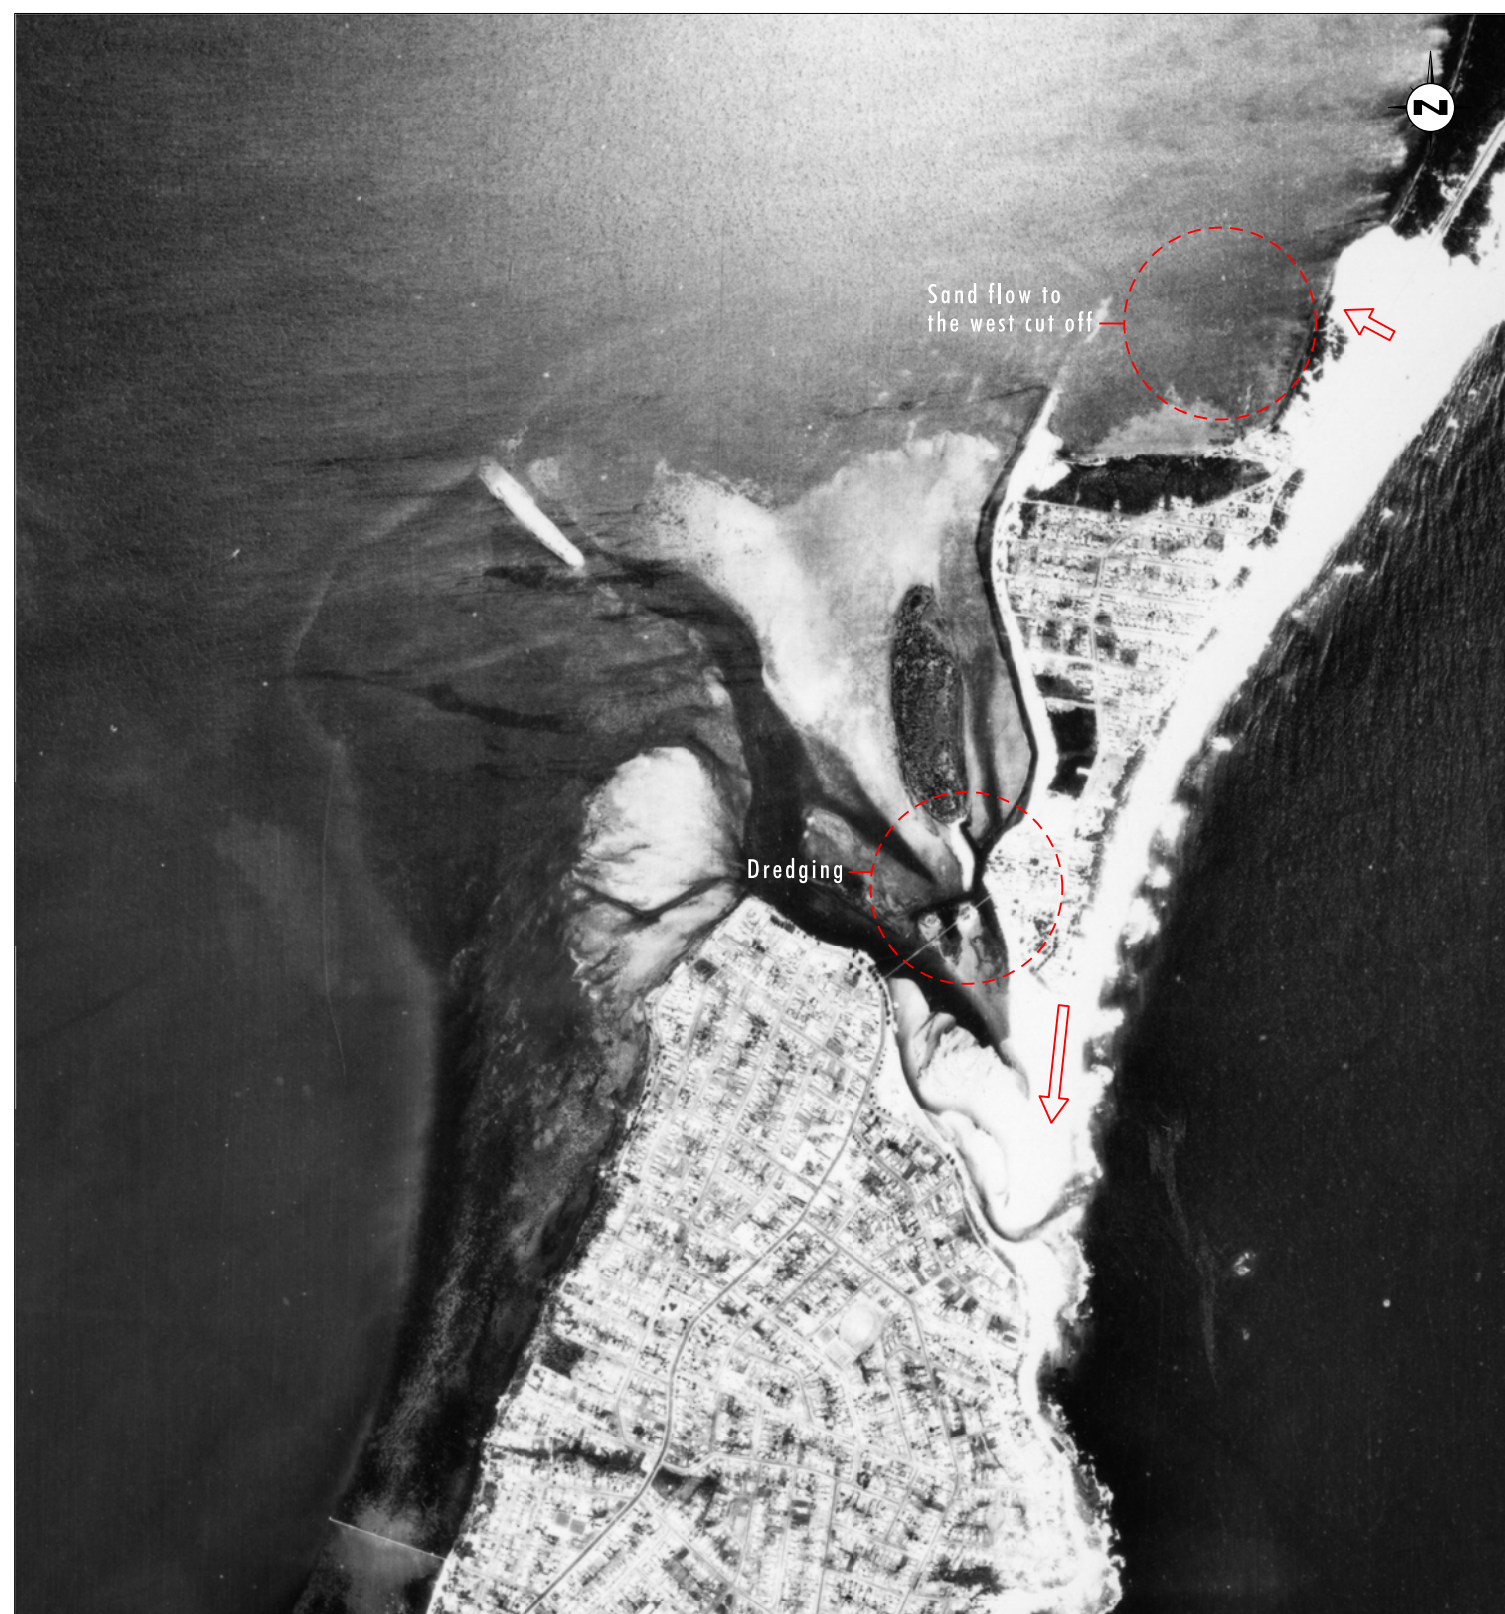
**FIGURE 2.3**  
**Channel and Tidal Delta**  
**changes at The Entrance**

#### 1966

- Dune blowout at North Entrance still active, diverting sand from the beach back to the lake shore
- Entrance channel almost closed, sand moving south along the southern part of North Entrance Beach and spit, but limited transfer to The Entrance Beach

#### 1969

- Entrance open with wide channel on southern side
- Erosion of shoals in outer tidal delta
- Reduced sand volume south of entrance channel
- Open channel trimming spit to north
- Closely spaced rip cells on southern part of beach. Many cusps in surf club area

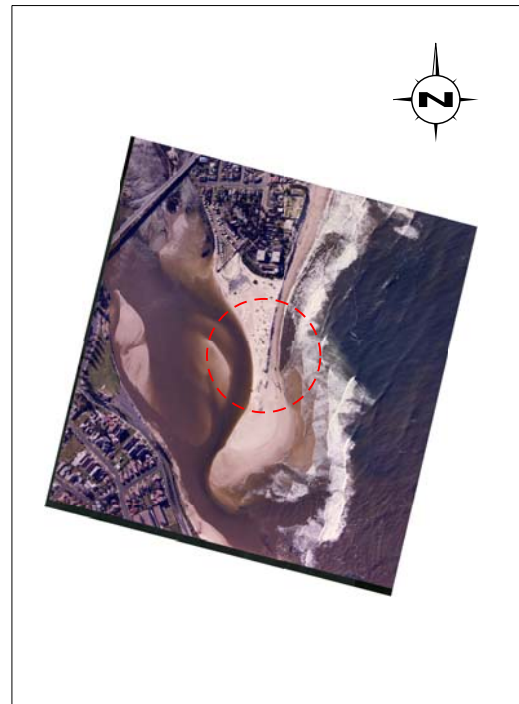
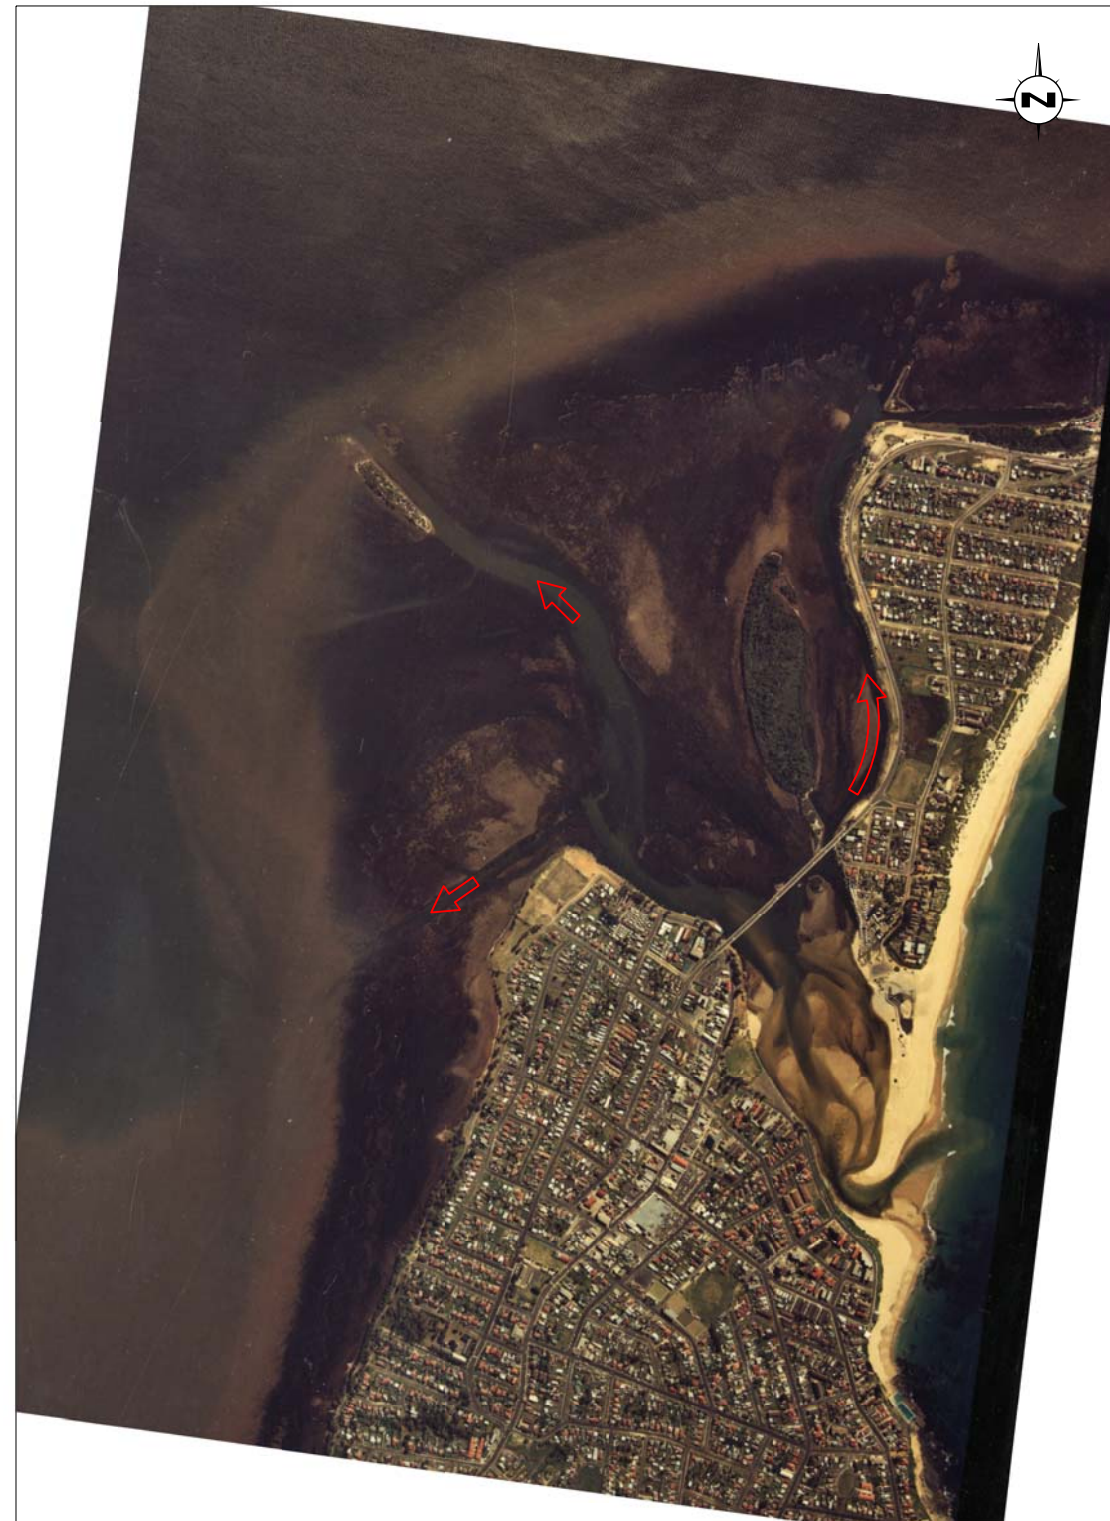
**FIGURE 2.4**  
**Channel and Tidal Delta**  
**changes at The Entrance**

**1978**

- Entrance open with wide channel
- Sand spit severely depleted from entrance channel migration and storm bite into the frontal dune

**1982**

- Multiple dredged channels - outside and inside the bridge
- Accretion on ocean side of the entrance spit. Some recovery of shoaling in the entrance outside of the bridge
- The Entrance Beach in accreted condition

**1986**

- Entrance channel broken through on northern side of spit, isolating the southern entrance shore and The Entrance Beach from the main beach
- Reclamation and further dredging on western shore, inside the bridge reclamation

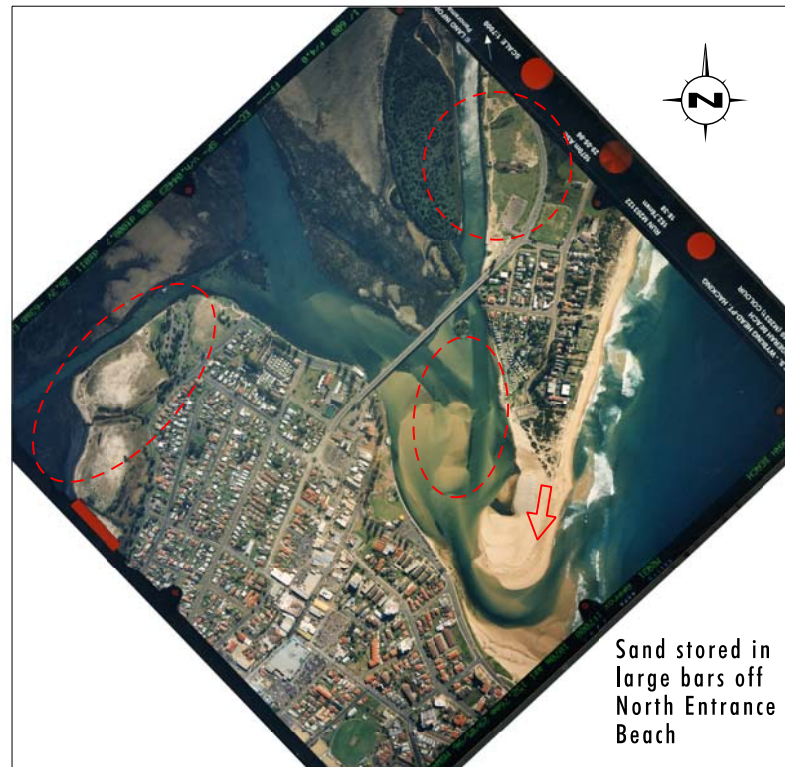
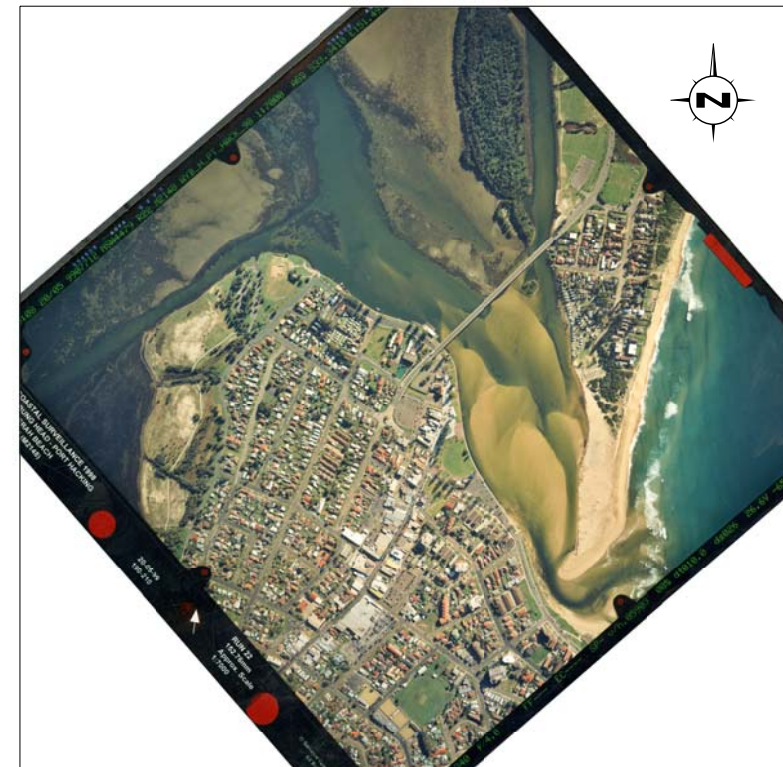
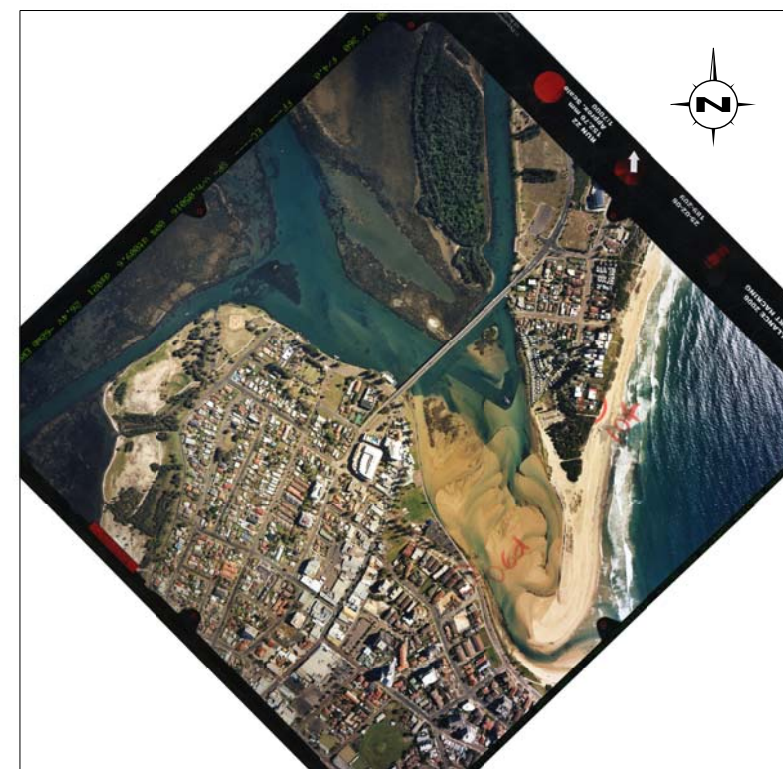
**FIGURE 2.5**  
**Channel and Tidal Delta**  
**changes at The Entrance**

**1996**

- Straightening and reclamation of lake foreshore and channel dredging to north of bridge, in outer entrance area, and along the western foreshore inside the bridge
- Recurve on spit shows sand moving south and into the entrance. Wide curved entrance channel separates an accreted Entrance Beach from North Entrance

**1999**

- Entrance almost closed, with straight spit and widespread shoaling in the outer entrance
- Deep channels (dredged) control flows upstream of the bridge
- Reduced sand volumes on The Entrance Beach and North Entrance Beach sand has moved into The Entrance
- Significant volume of sand from the tidal delta are locked into the reclaimed foreshores to the north east and west of the entrance (minimum estimate ~200,000m<sup>3</sup>)

**2001**

- Dredged channels in outer entrance area have reduced shoaling. North Entrance Beach accreted
- Reclaimed areas and dredged channels control flows and sediment movement inside the bridge

**2006**

- Entrance almost closed and channels heavily shoaled. North Entrance Beach is narrow (as per 1999)
- Sand volume stored in the spit and entrance shoals
- Shoal areas inside bridge vegetated and relatively stable
- Sand also accumulating in nearshore area of North Entrance Beach

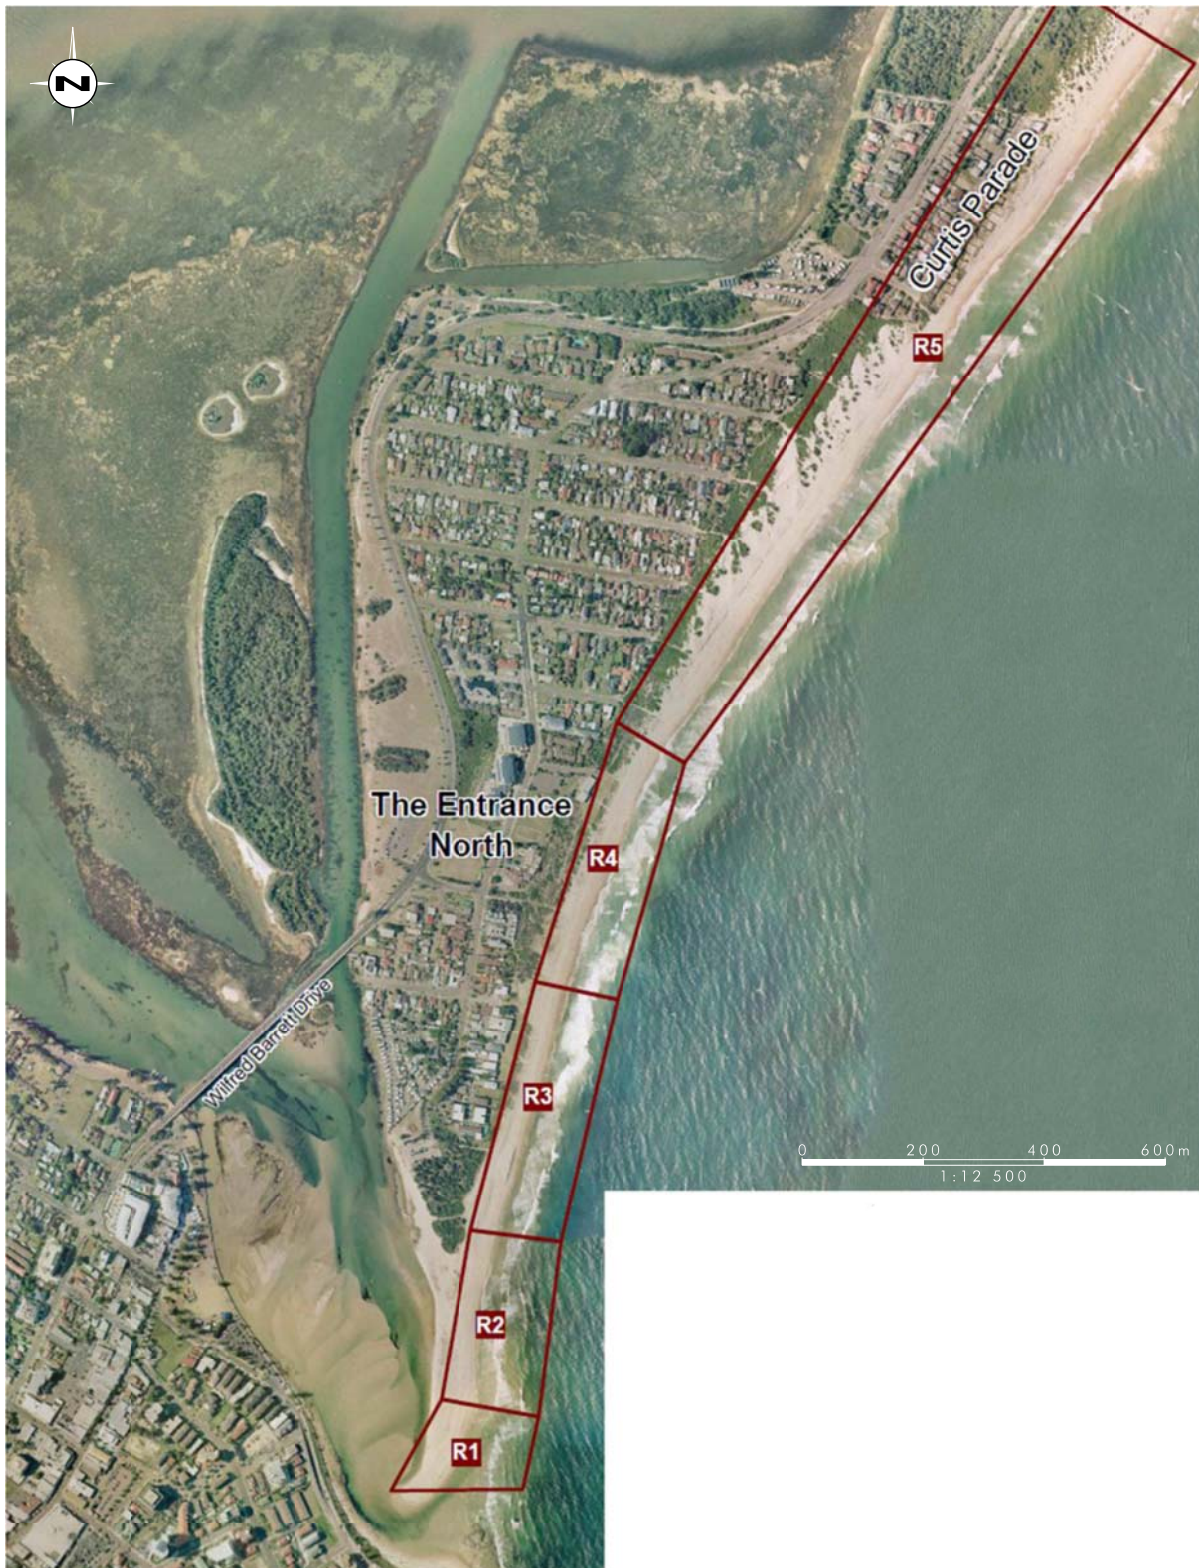
FIGURE 3.1

Section of North Entrance Beach  
for Analysis of Long Shore  
Sediment Transport

SMEC split North Entrance Beach into five sections of relatively uniform shore angle for the analysis (**Figure 3.1**). They used two different methods to derive **potential** long shore sediment transport rates at different points along North Entrance Beach:
