FIG NO. M13 **FIGURE TITLE** Terrigal-Wamberal Beach Coastal Hazard Lines and Potentially Inundated Lots

PROJECT NO.
301020-02641

PROJECT TITLE
Open Coast and Broken Bay Beaches
Coastal Processes and Hazard Definition Study

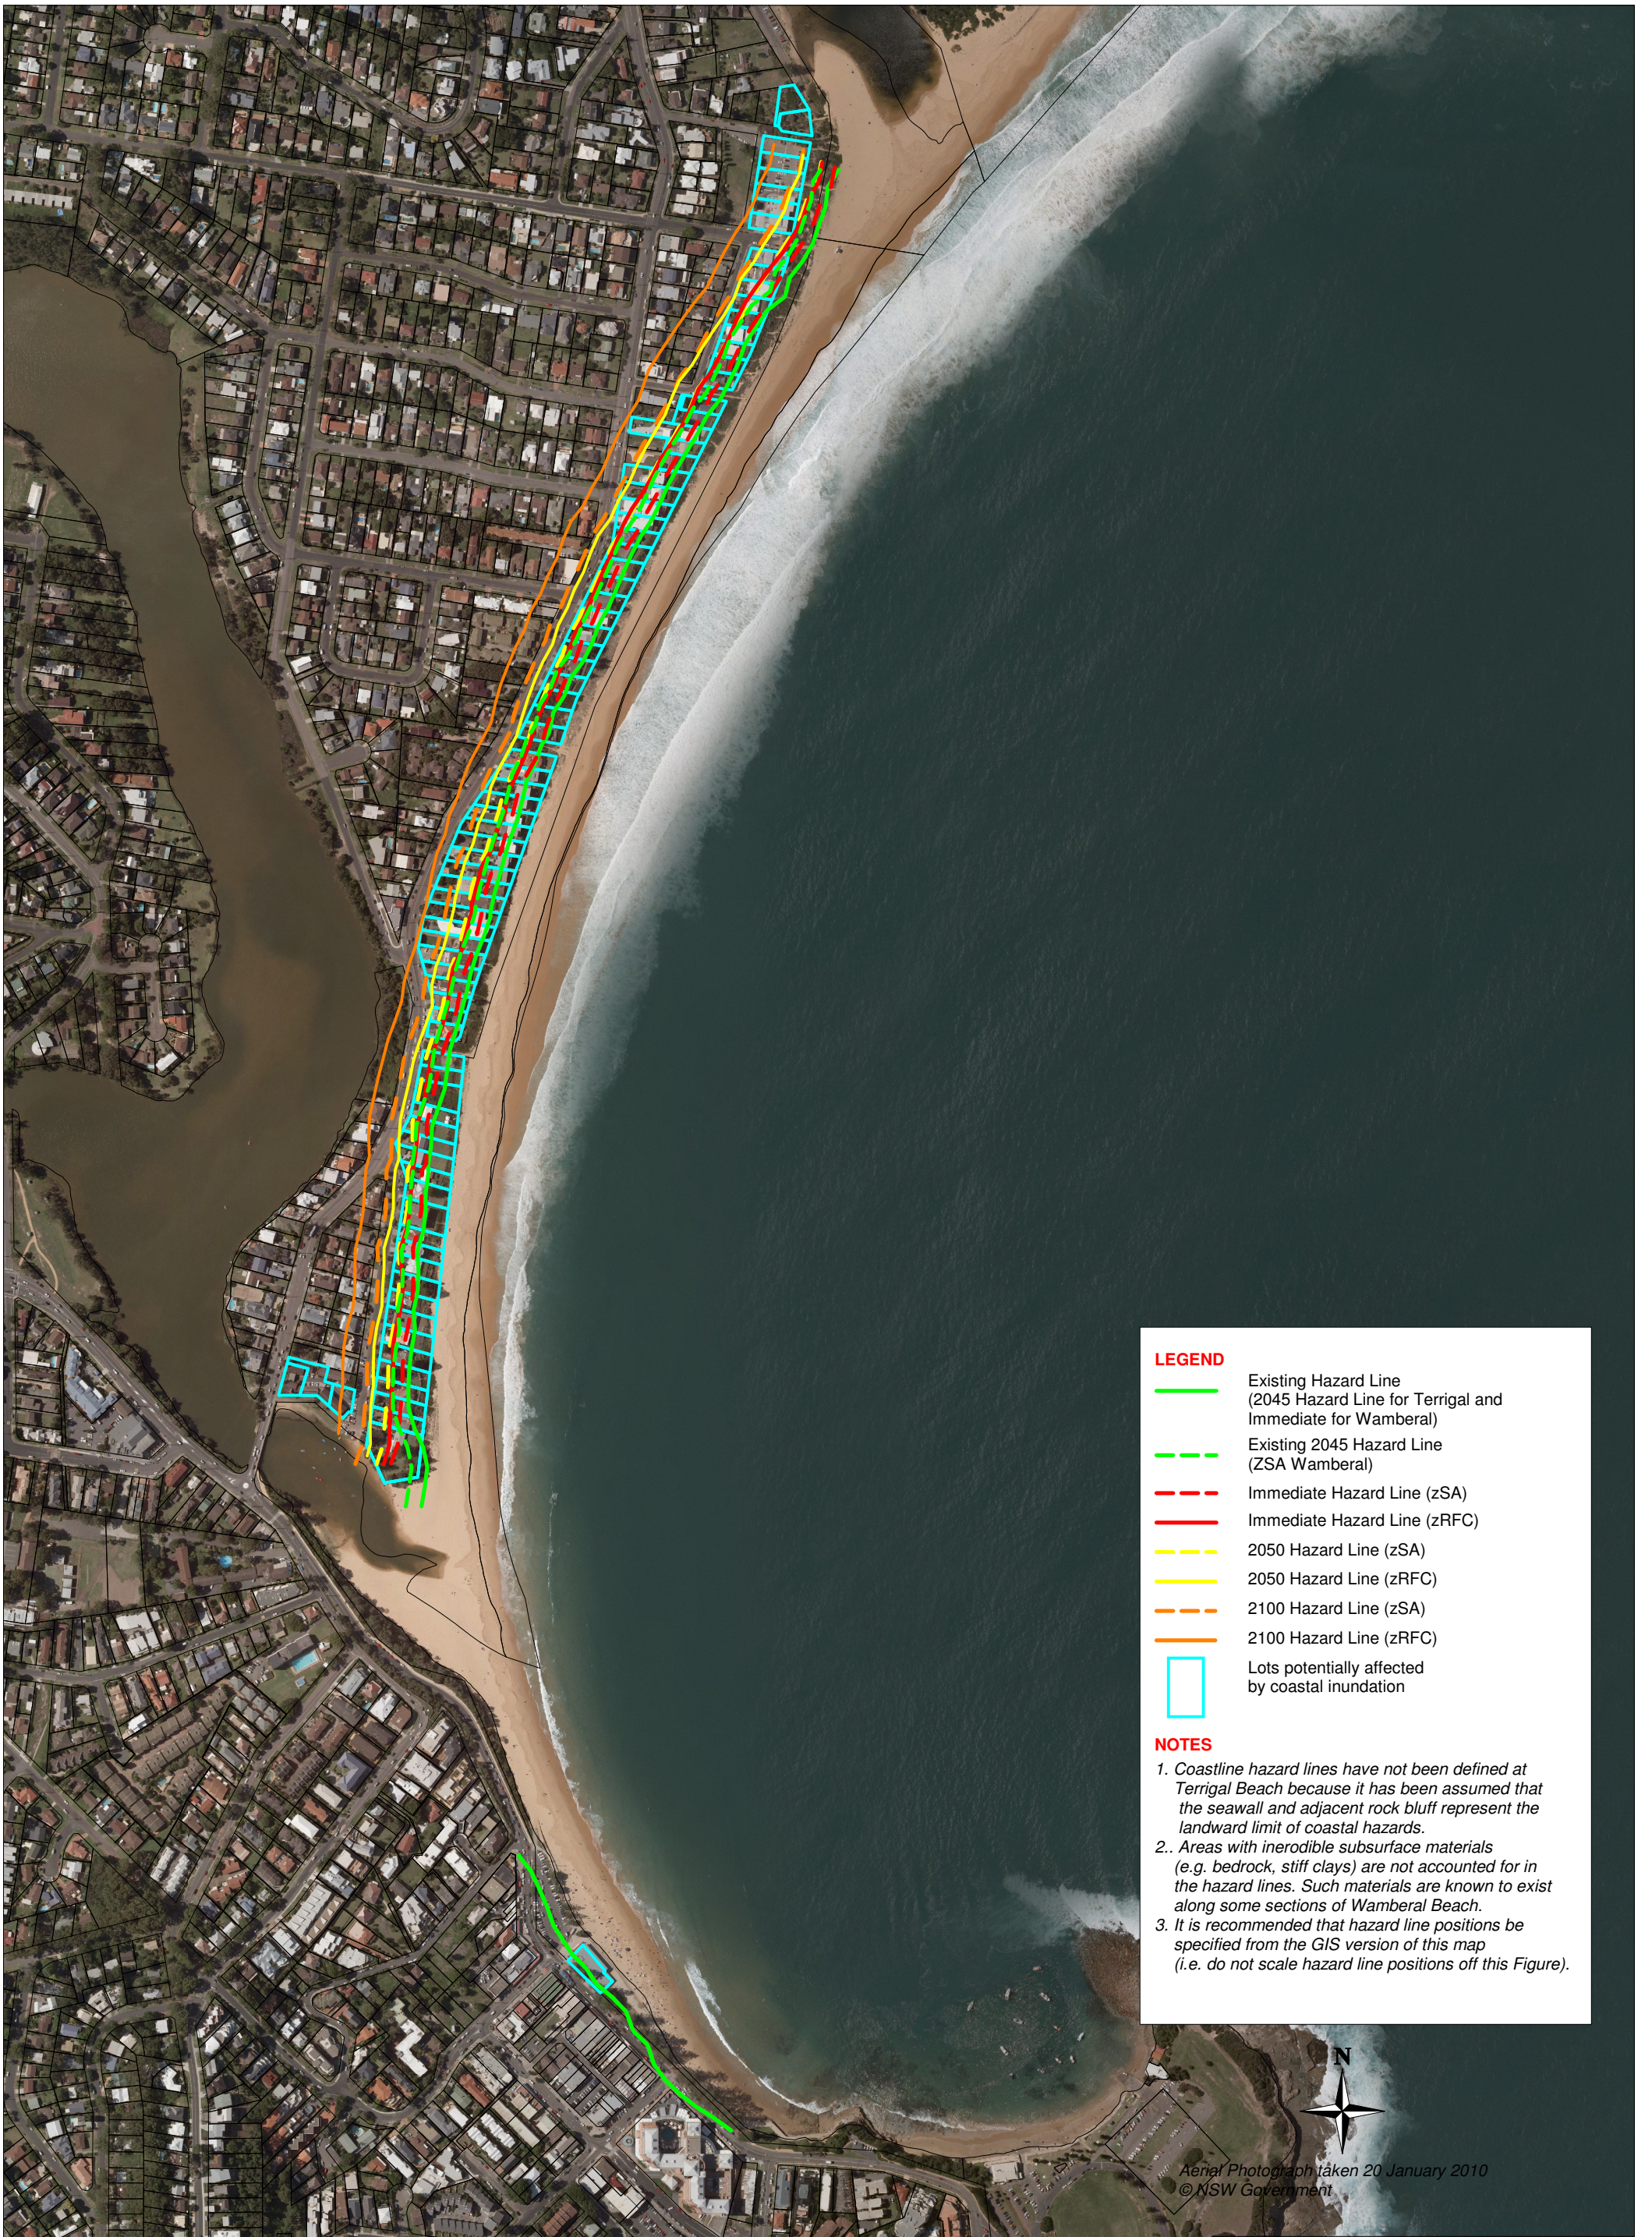
1. Coastline hazard lines have not been defined at Terrigal Beach because it has been assumed that the seawall and adjacent rock bluff represent the landward limit of coastal hazards.
2. Areas with inerodible subsurface materials (e.g. bedrock, stiff clays) are not accounted for in the hazard lines. Such materials are known to exist along some sections of Wamberal Beach.
3. It is recommended that hazard line positions be specified from the GIS version of this map (i.e. do not scale hazard line positions off this Figure).
